Contamination Screening Evaluation Report

**SR-9/I-95 @ SR 842/Broward Boulevard (Broward
Boulevard from West of SW 24th Avenue to East of
NW/SW 18th Avenue)
Project Development & Environment (PD&E) Study**

Efficient Transportation Decision Making (ETDM) No.: 14226

**Broward County, Florida
Financial Project ID Number: 435513-1-22-02**

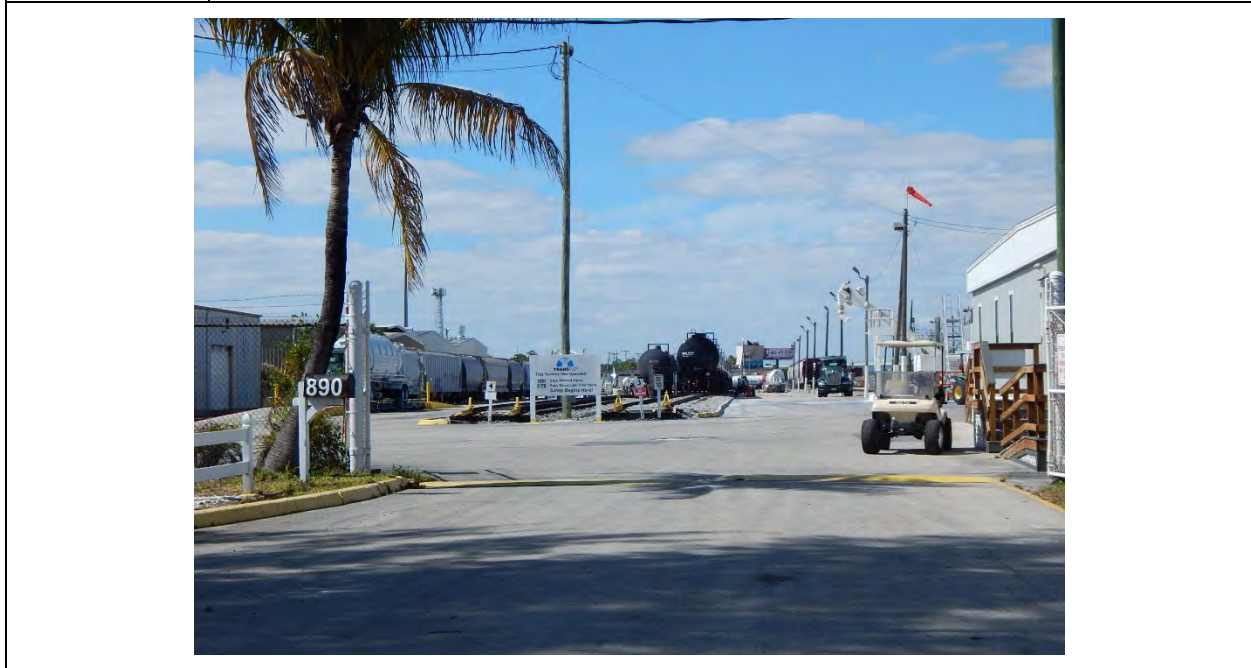
Photo 21-2

Site No. 21 – Transflo Terminal Services, Inc. – View Towards the North

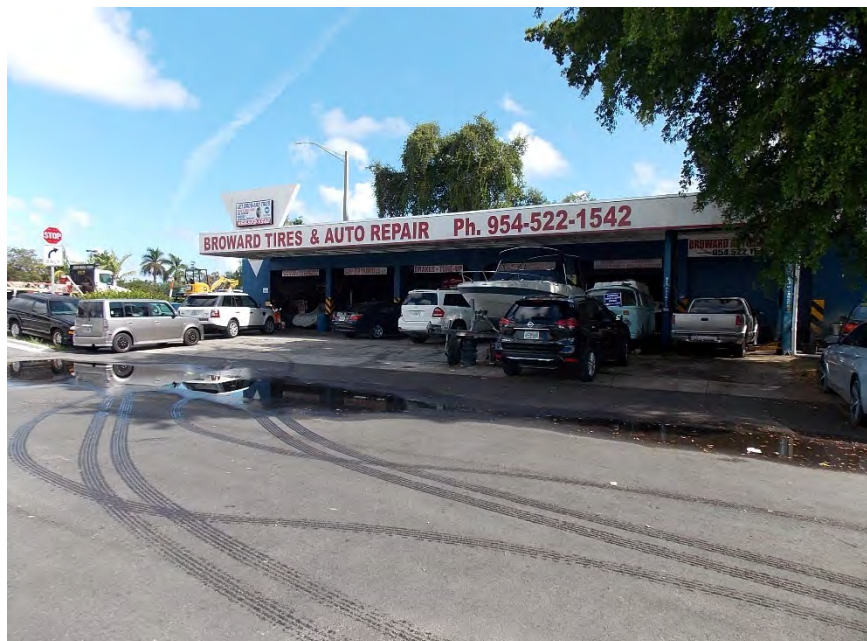
Photo 53-2

Site No. 53 – Broward Tires & Auto Repair
View towards the Northeast

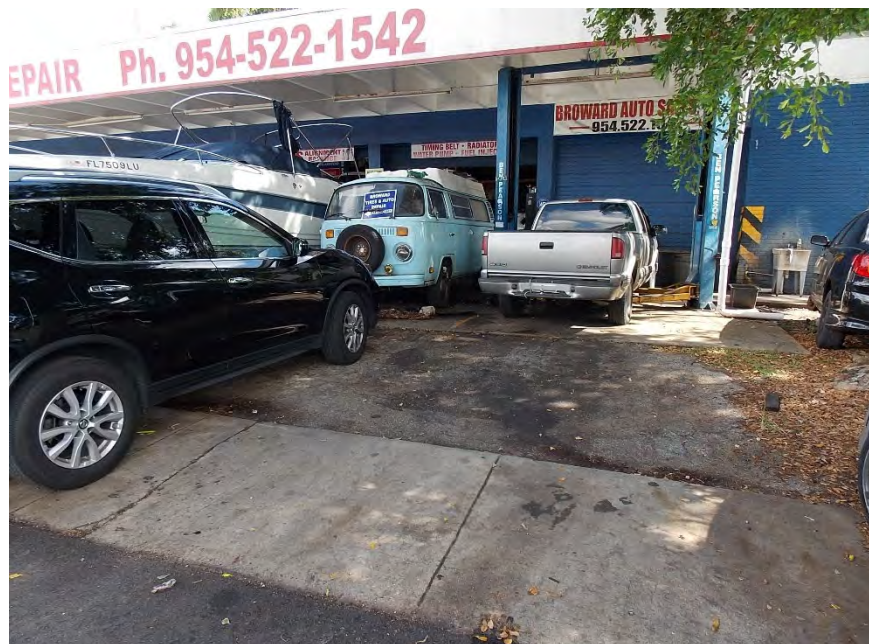
Photo 53-3

Site No. 53 – Broward Tires & Auto Repair
View towards the Northeast

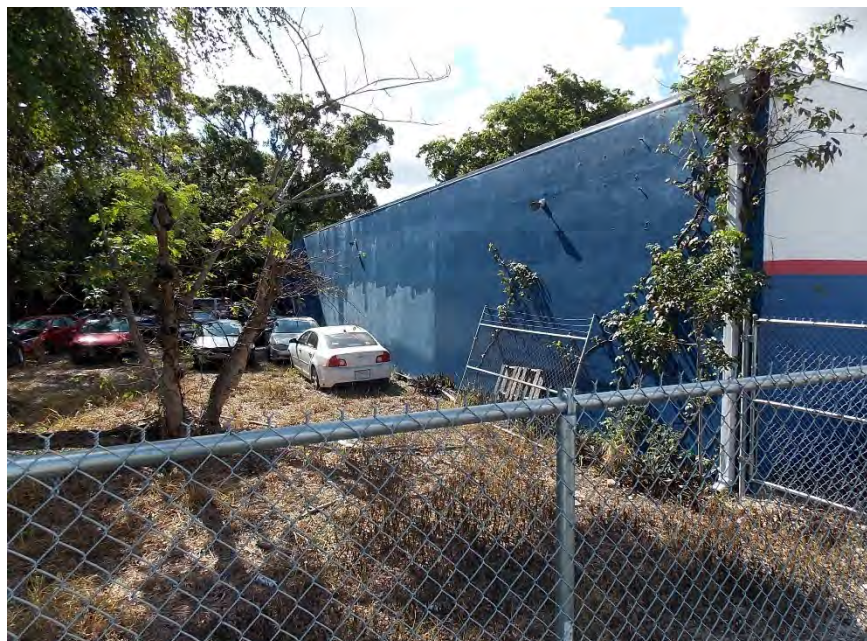
Photo 53-4

Site No. 53 – Broward Tires & Auto Repair
View towards the Southwest

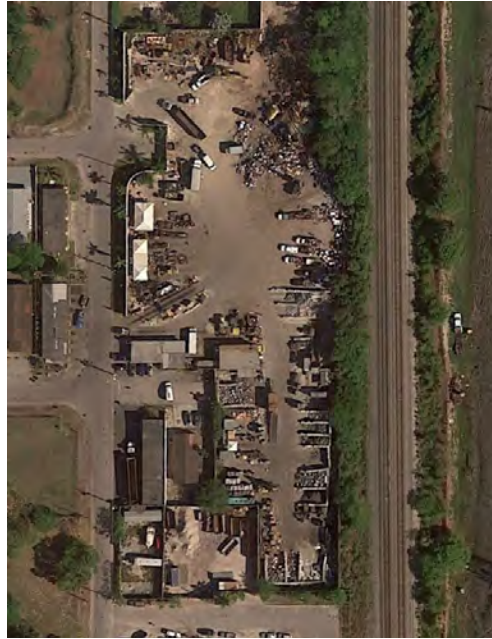
Photo 66-2

Site No. 66 - Salvage Auto Repair, Inc. – View Towards the South
