Cultural Resource Assessment Survey Addendum

**SR-9/I-95 @ SR 842/Broward Boulevard (Broward
Boulevard from West of SW 24th Avenue to East of
NW/SW 18th Avenue)
Project Development & Environment (PD&E) Study**

**Broward County, Florida
Financial Project ID Number: 435513-1-22-02**

April 2019

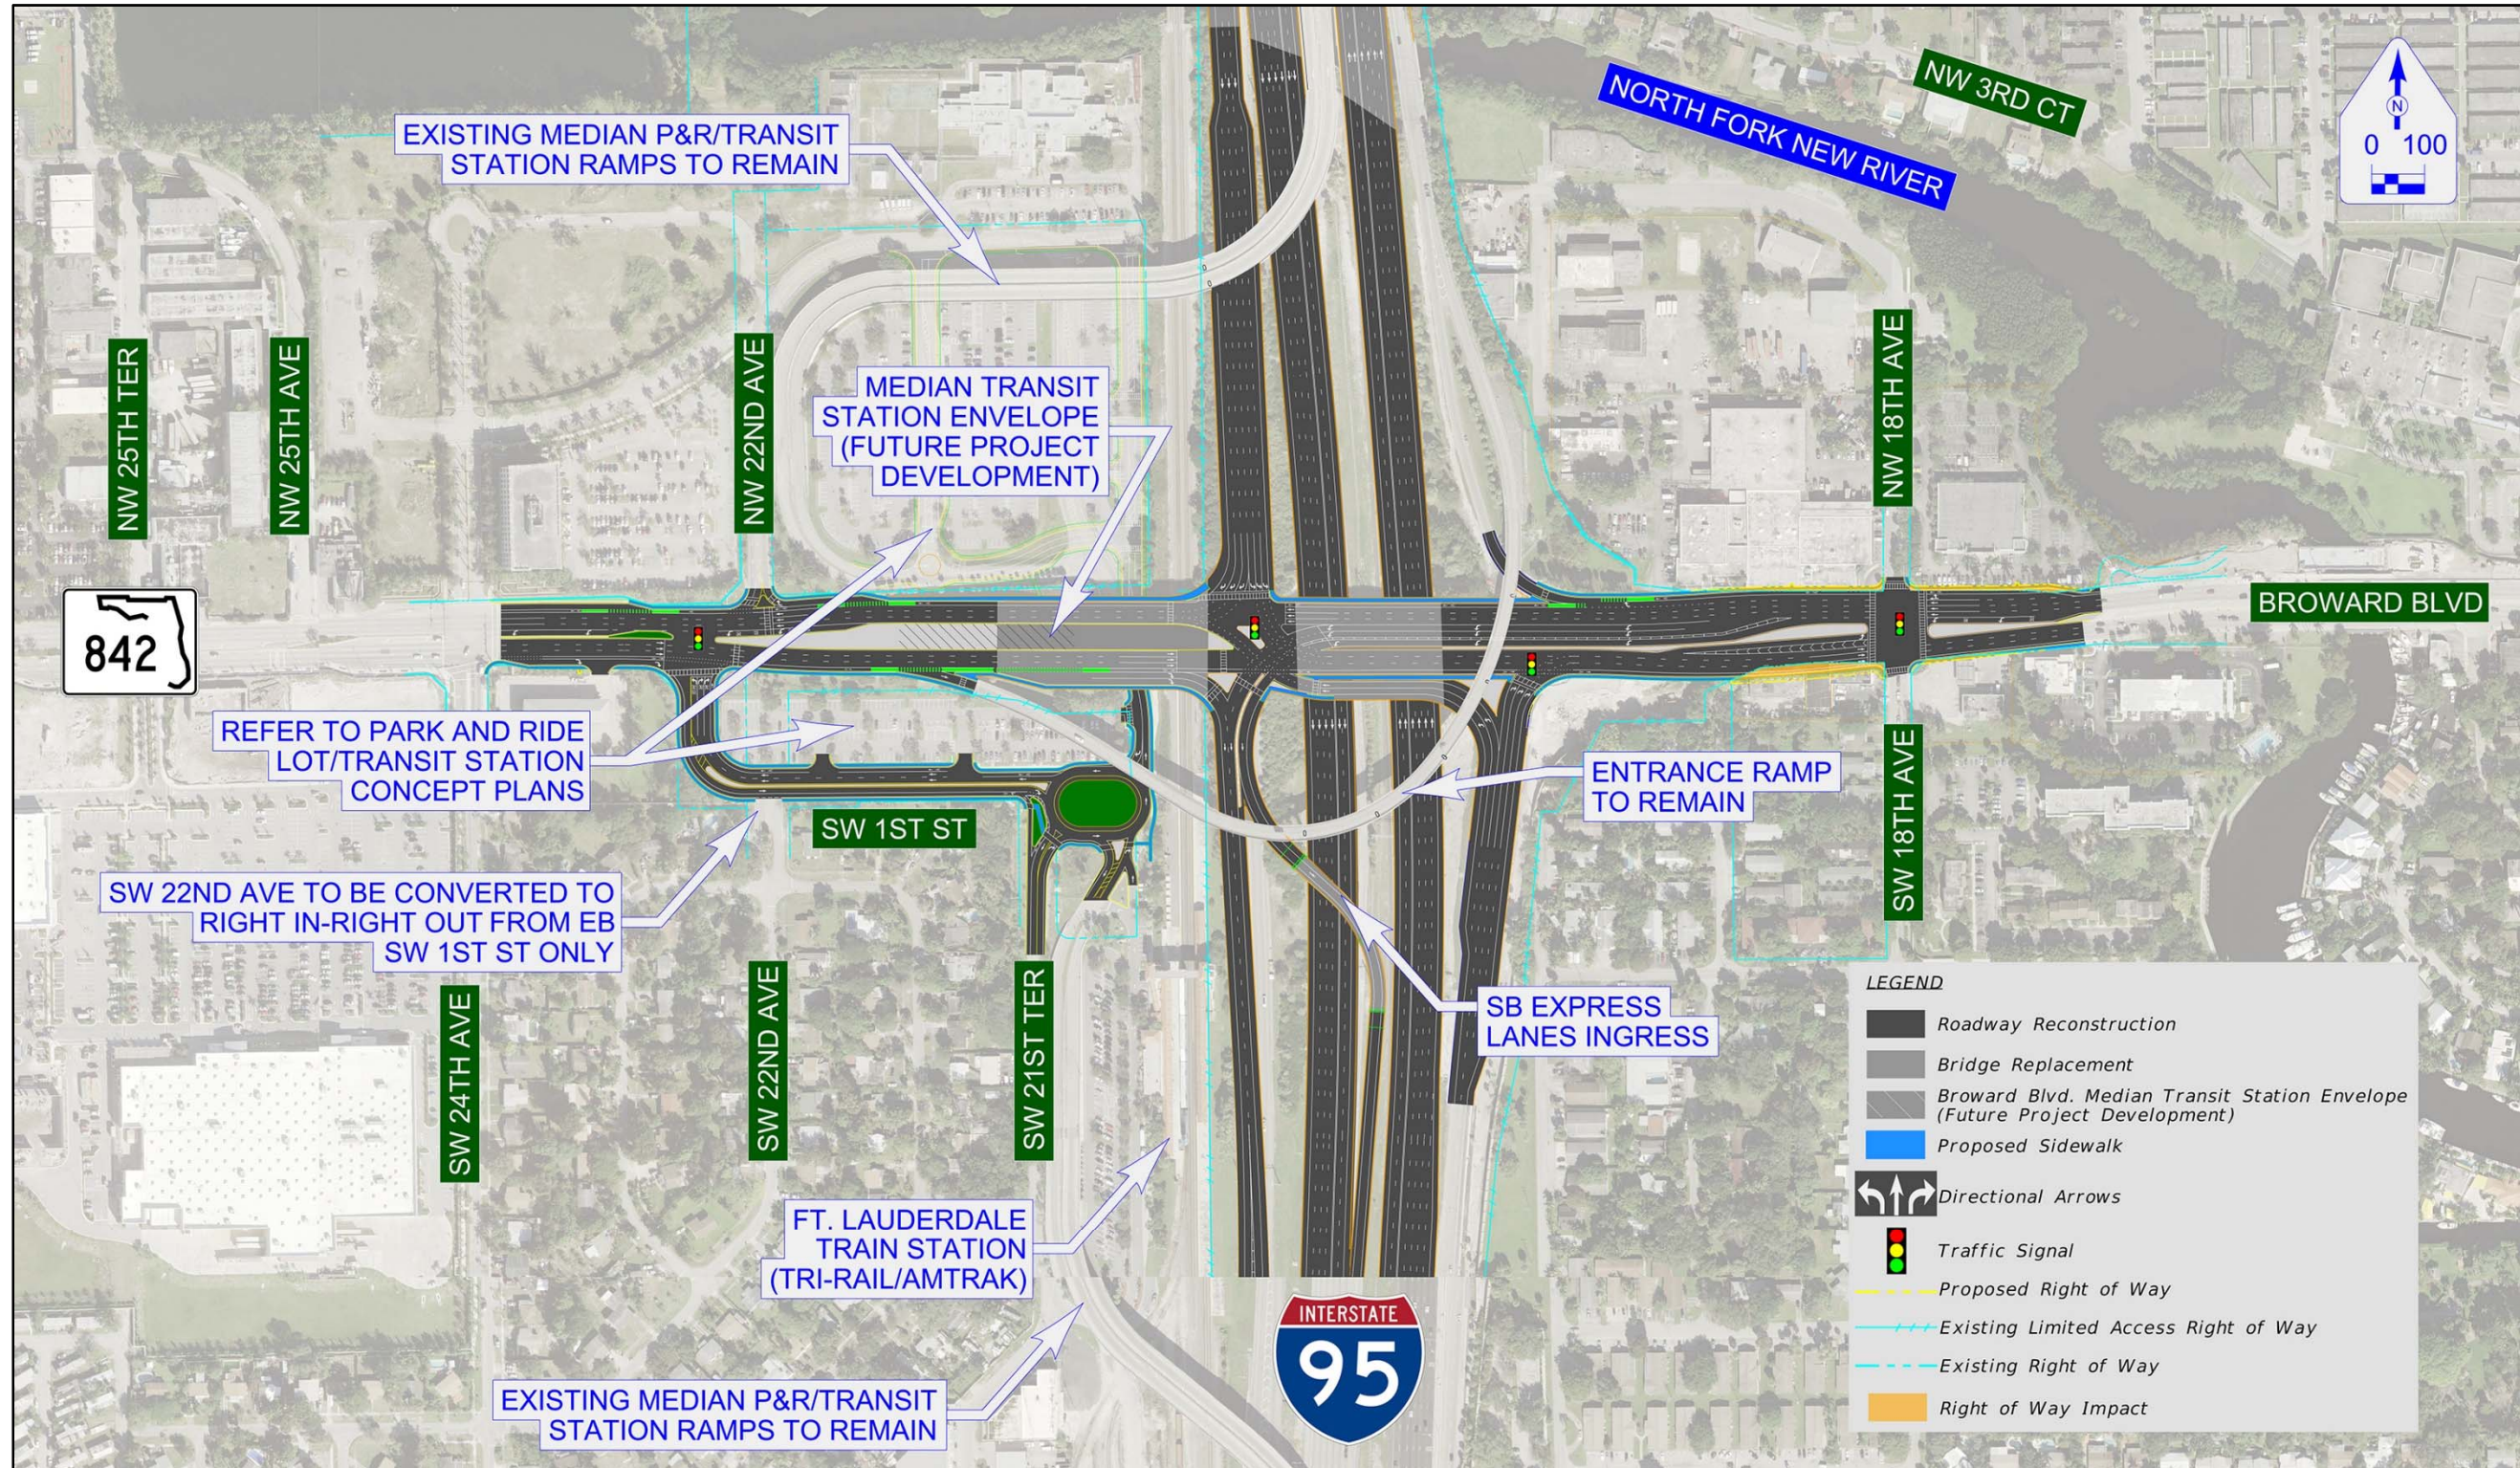
Figure 2 | Preferred Alternative 2B – Modified Displaced Left with Combined Roundabout

The mainline, interchange and park-and-ride lot alternatives are discussed in the original CRAS. The Interchange Build Alternative 2B – Modified Displaced Left was selected as the preferred alternative and is shown in **Figure 2**. The eastbound Broward Boulevard to southbound 95 Express options had not been developed at the time of the original CRAS. The purpose of this addendum is to provide a cultural resources assessment for those options.

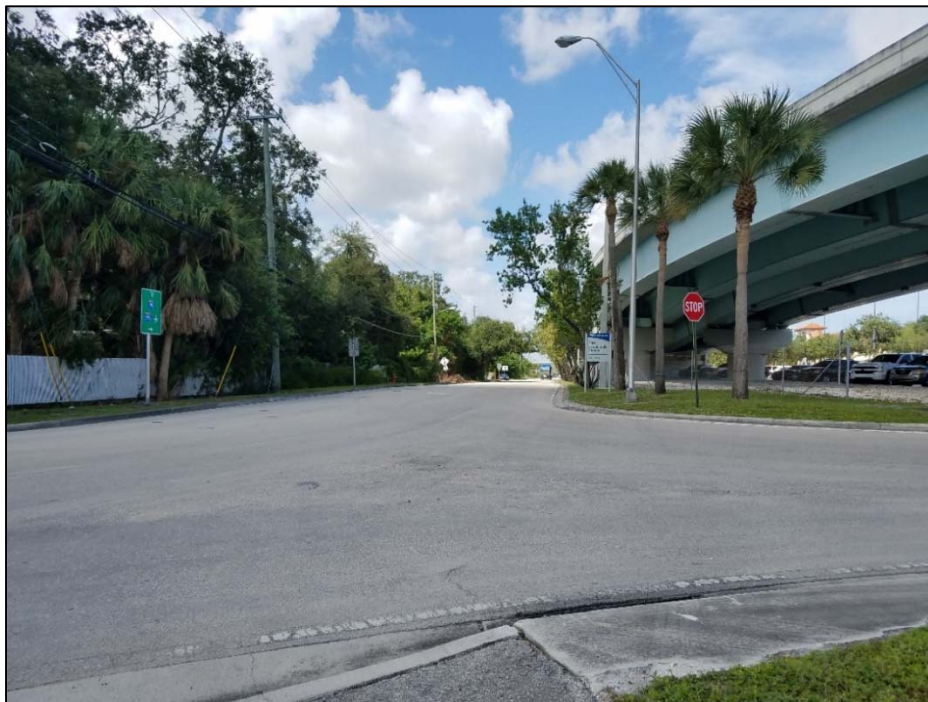
No previously recorded or newly recorded archaeological sites were identified within the archaeological APE. Background research and a pedestrian survey indicated that there is a low probability of finding intact archaeological sites within the archaeological APE. Subsurface archaeological testing was not feasible within the previously unsurveyed portion of the archaeological APE due to the existence of pavement, sidewalks, berms, buried utilities, landscaping, and residential and commercial frontage (**Appendix B**). A representative photograph of the archaeological APE is included below (**Figure 8**).

Figure 8 | Landscaped Berm with Buried Utilities East Side of I-95 Ramp Along NW 21st Terrace, Facing North

Although unlikely, should construction activities uncover any archaeological remains, it is recommended that activity in the immediate area of the remains be stopped while a professional archaeologist evaluates the remains. In the event that human remains are found during construction or maintenance activities, Chapter 872.05 of the Florida Statutes will apply and FDOT's Standard Specifications for Road and Bridge Construction require that all construction cease. Chapter 872.05 states that, when human remains are encountered, all activity that might disturb the remains shall cease and may not resume until authorized by the District Medical Examiner or the State Archaeologist. The District Medical Examiner has jurisdiction if the remains are less than 75 years old or if the remains are involved in a criminal investigation. The State Archaeologist has jurisdiction if the remains are 75 years of age or more.

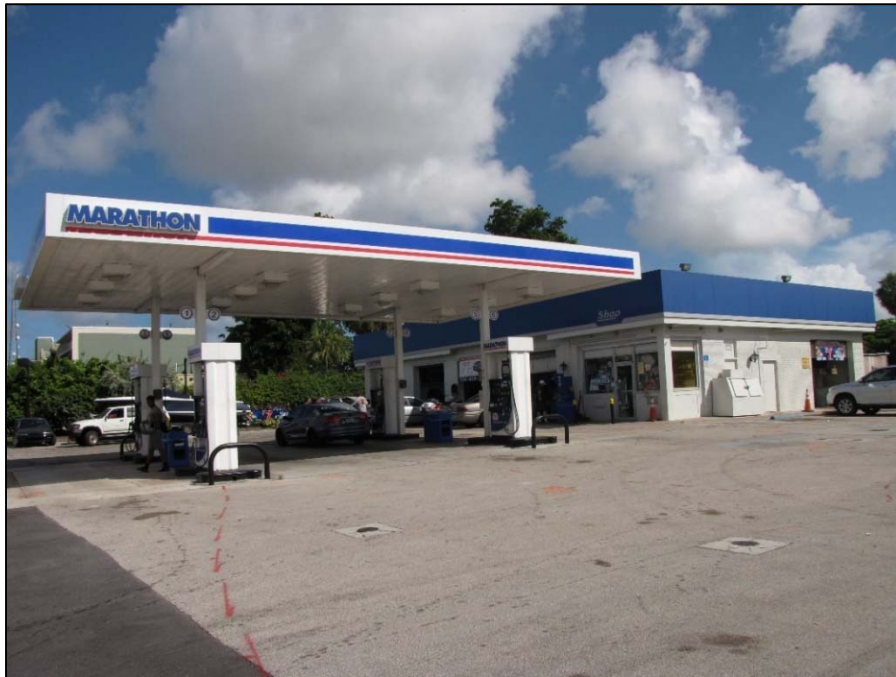
Figure 10 | Marathon Gas Station/1776 W Broward Boulevard (8BD6748), c. 1970, facing Southeast

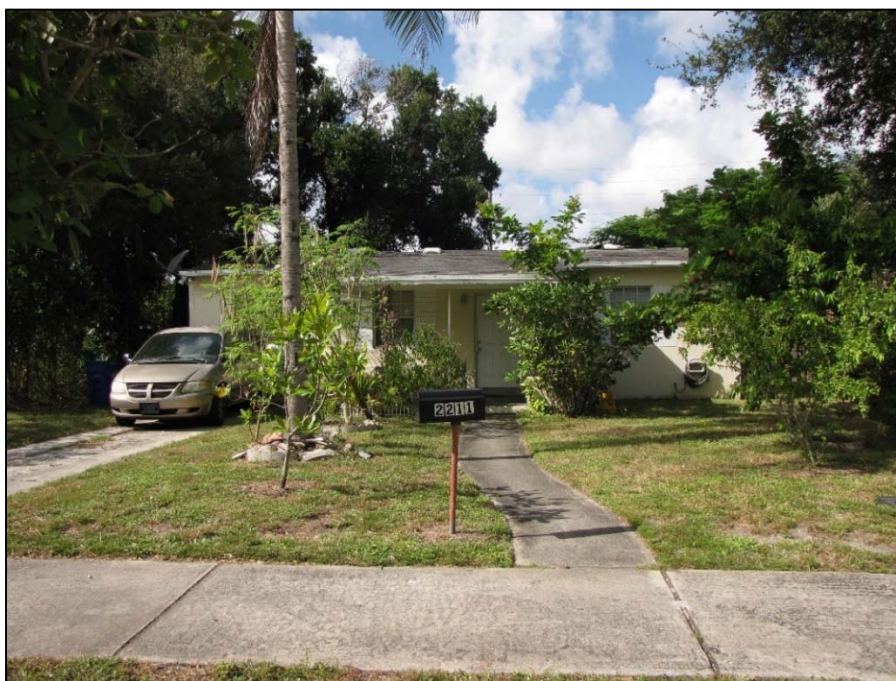
Figure 11 | 2211 SW 1st Court (8BD6749), c. 1953, facing North, exhibits enclosed carport, replaced windows and doors, and a north side addition

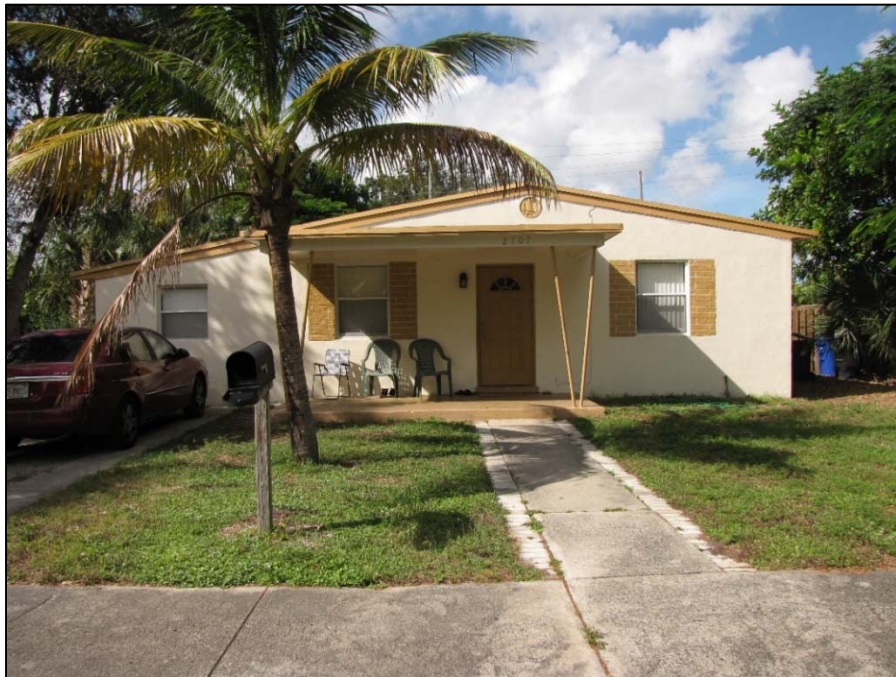
Figure 12 | 2207 SW 1st Court (8BD66750), c. 1953, facing North, exhibits enclosed carport, replaced windows and doors, and northwest corner addition

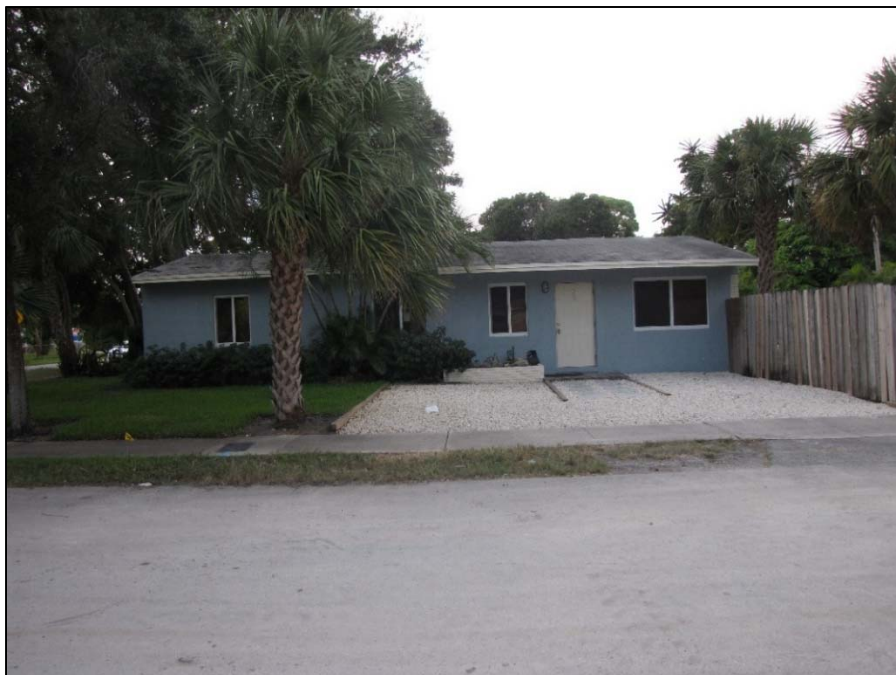
Figure 13 | 23 SW 22nd Avenue (8BD6751), c. 1952, facing West exhibits enclosed carport, replaced windows and doors, and northwest corner addition

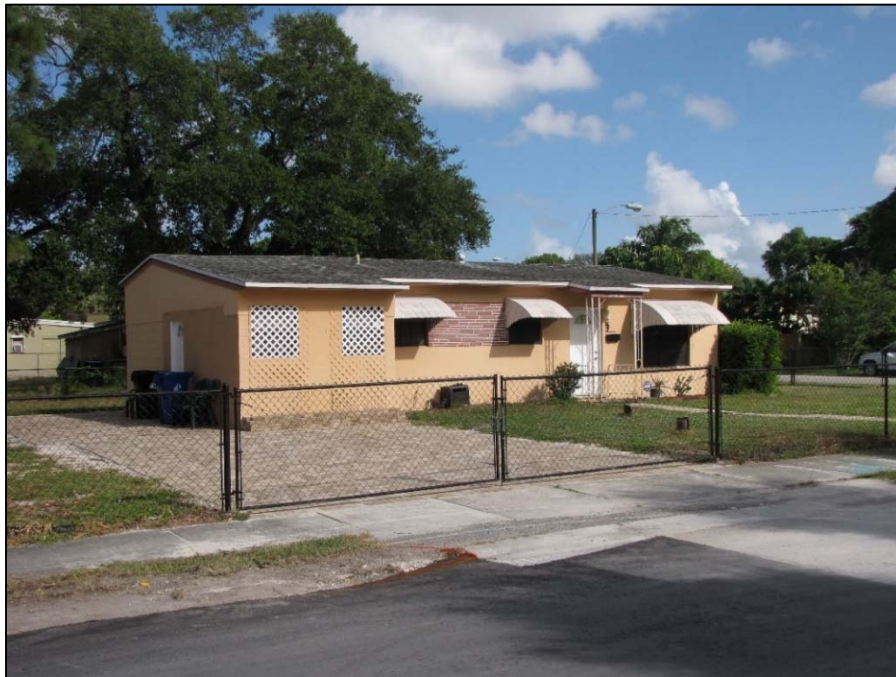
Figure 14 | 22 SW 22nd Avenue (8BD6752), c. 1954, facing Southeast, exhibits enclosed carport, replaced windows and doors

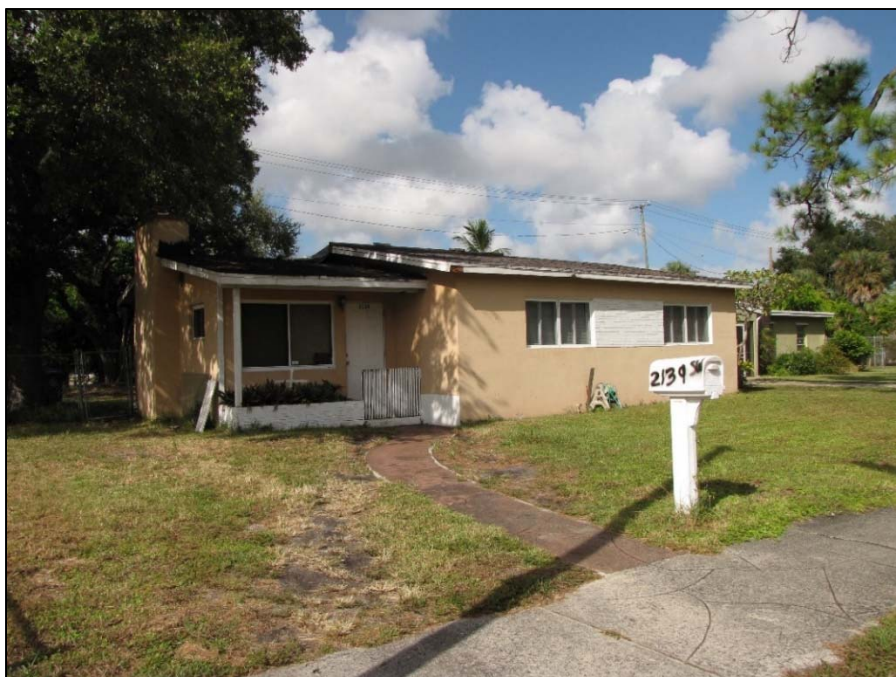
Figure 15 | 2139 SW 1st Court (8BD6753), c. 1952, facing Northeast, exhibits replaced windows and doors

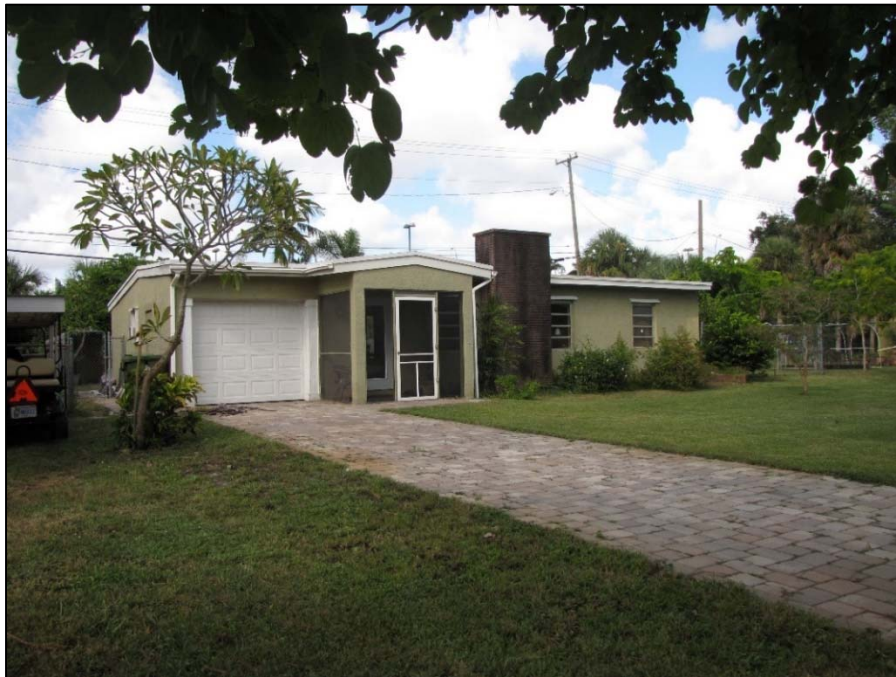
Figure 16 | 2133 SW 1st Court (8BD6754), c. 1952, facing Northeast, exhibits screened in porch, replaced windows and doors

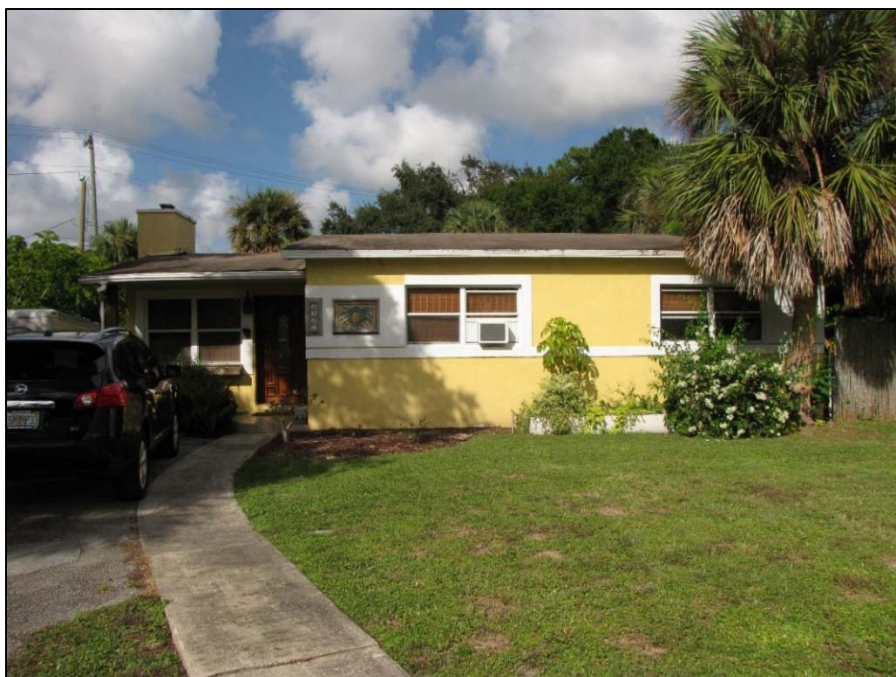
Figure 17 | 2127 SW 1st Court (8BD6755), c. 1958, facing Northeast, exhibits replaced windows and doors, northeast addition

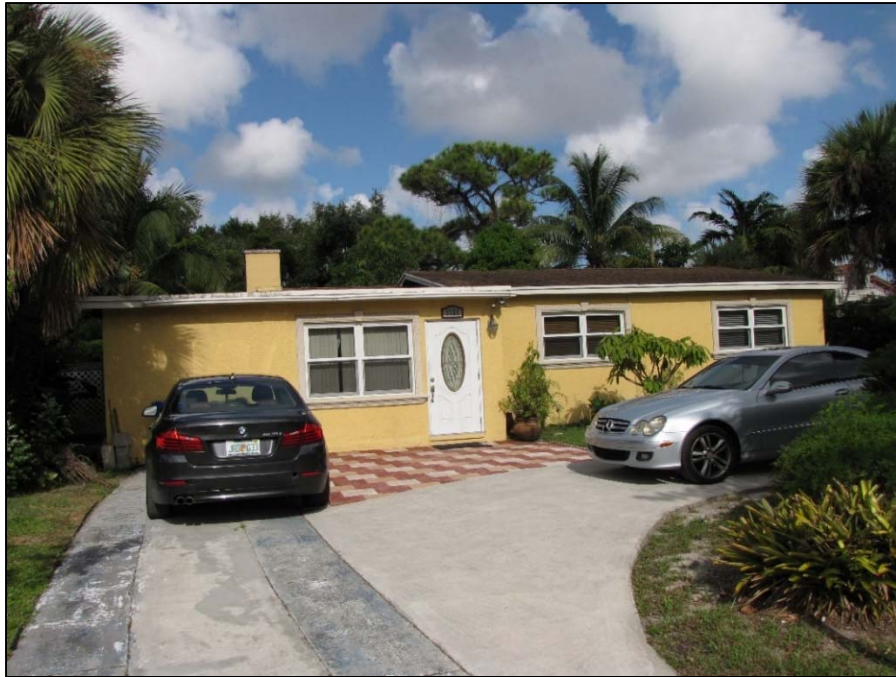
Figure 18 | 2121 SW 1st Court (8BD6756), c. 1953, facing East, exhibits replaced windows and doors, northwest corner addition

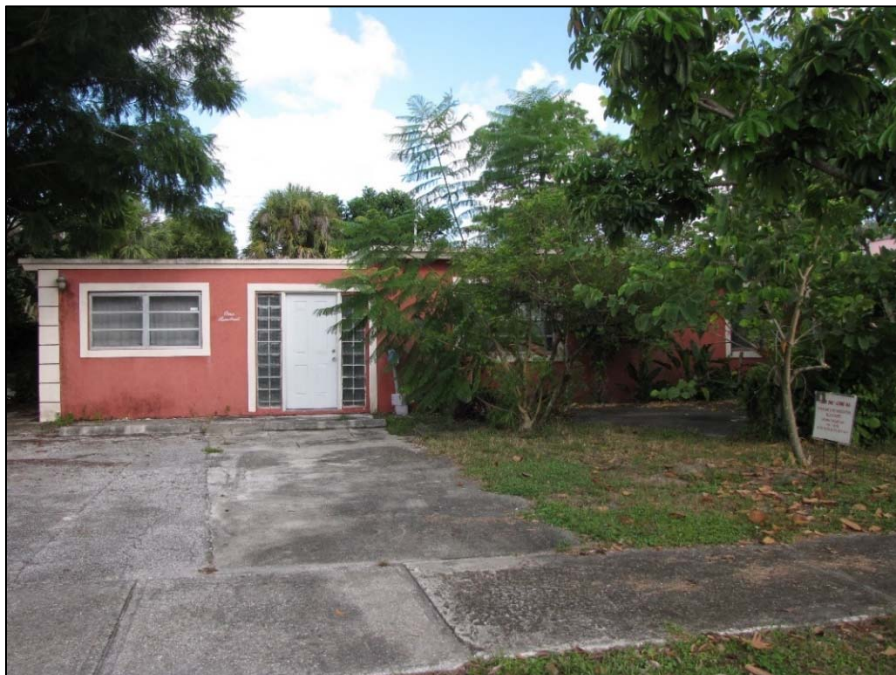
Figure 19 | 100 SW 21st Way (8BD6757), c. 1953, facing East, exhibits enclosed carport, replaced windows and doors, and southeast corner addition

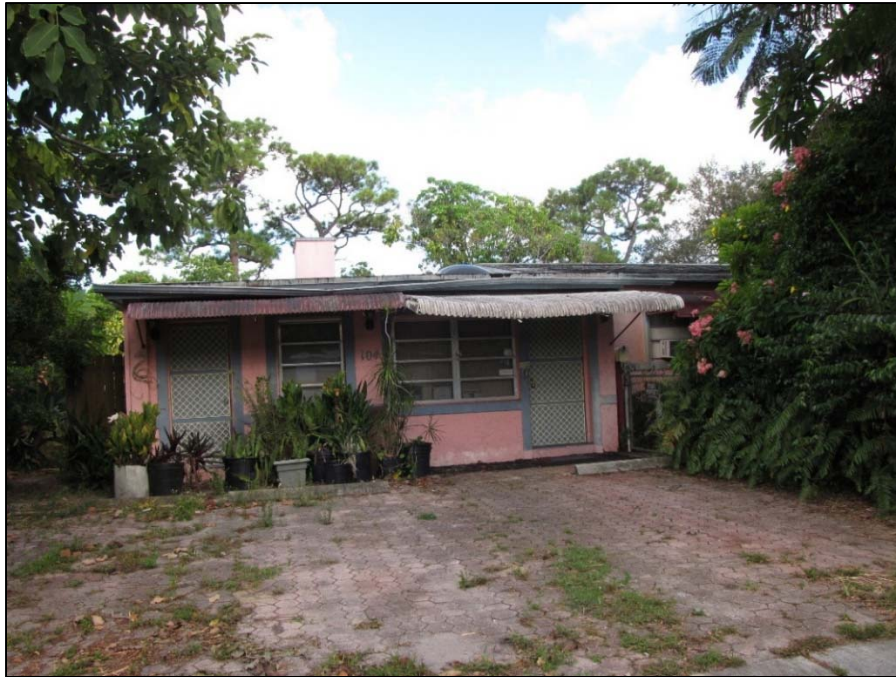
Figure 20 | 104 SW 21st Way (8BD6758), c. 1957, facing East, exhibits enclosed carport, replaced windows and doors, northwest corner addition, and east side addition

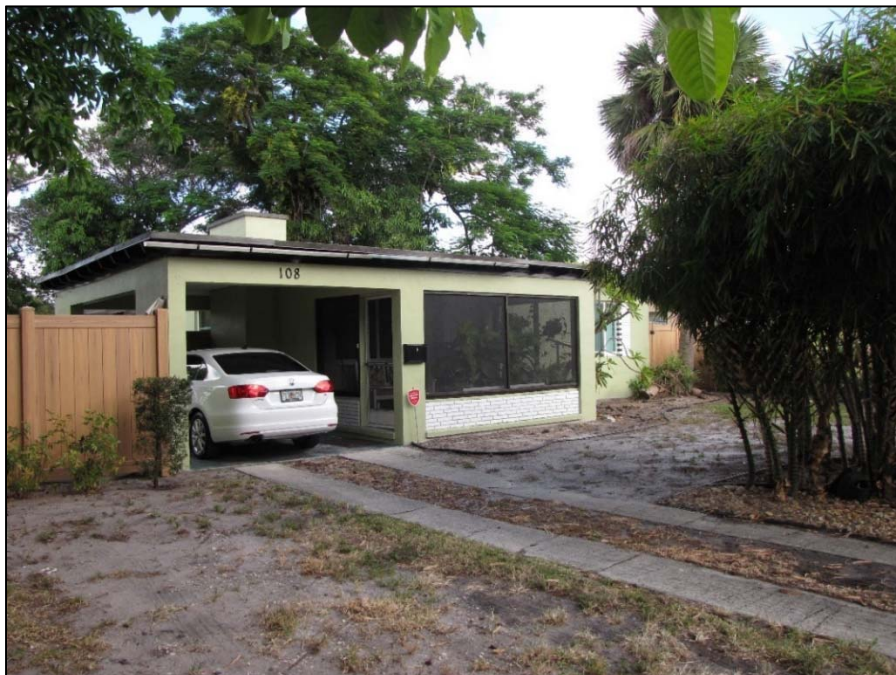
Figure 21 | 108 SW 21st Way (8BD6759), c. 1953, facing Southeast, exhibits enclosed carport, replaced windows and doors, northeast corner addition

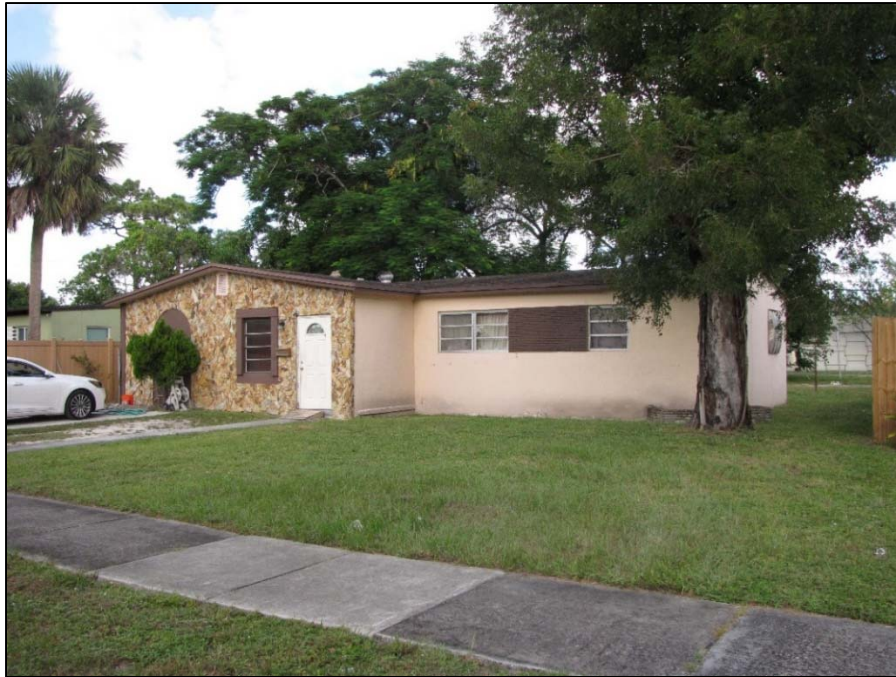
Figure 22 | 112 SW 21st Way (8BD6760), c. 1953, facing Northeast, exhibits enclosed carport, replaced windows and doors

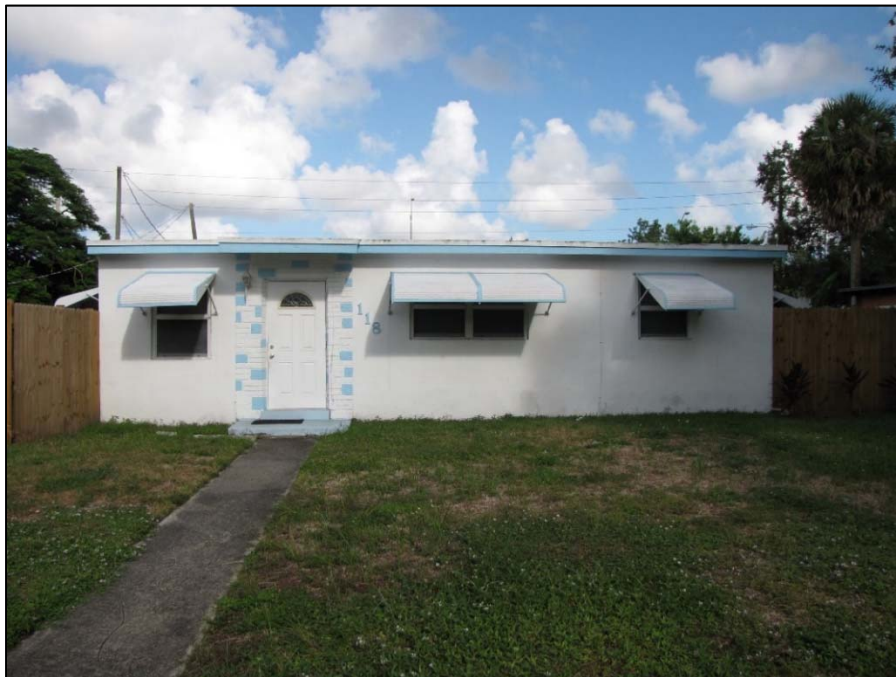
Figure 23 | 118 SW 21st Way (8BD6761), c. 1953, facing East, exhibits replaced windows and doors

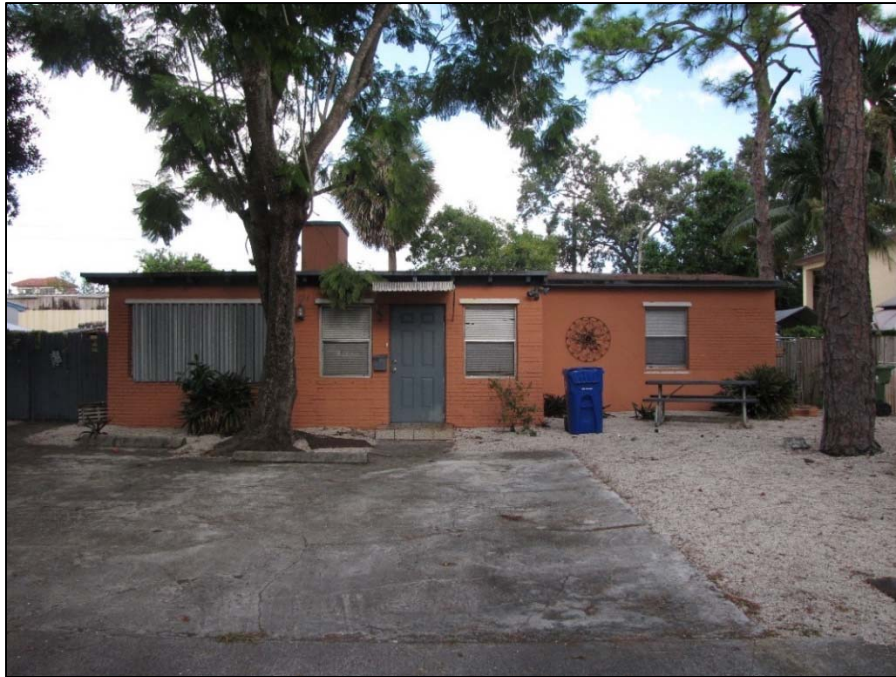
Figure 24 | 124 SW 21st Way (8BD6762), c. 1953, facing East, exhibits enclosed carport, replaced windows and doors

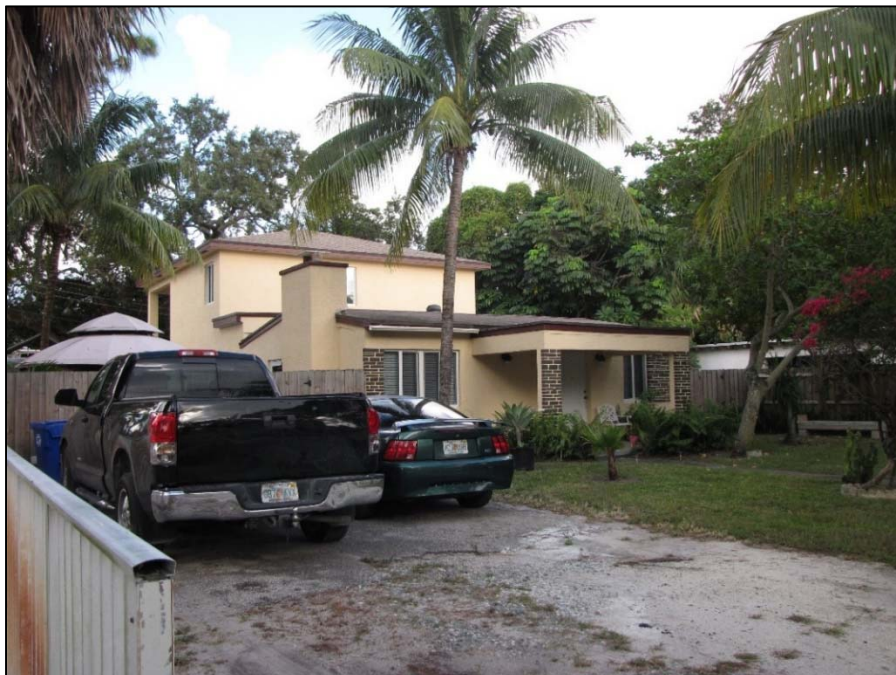
Figure 25 | 128 SW 21st Way (8BD6763), c. 1953, facing Southeast, exhibits replaced windows and doors, large two-story east side addition

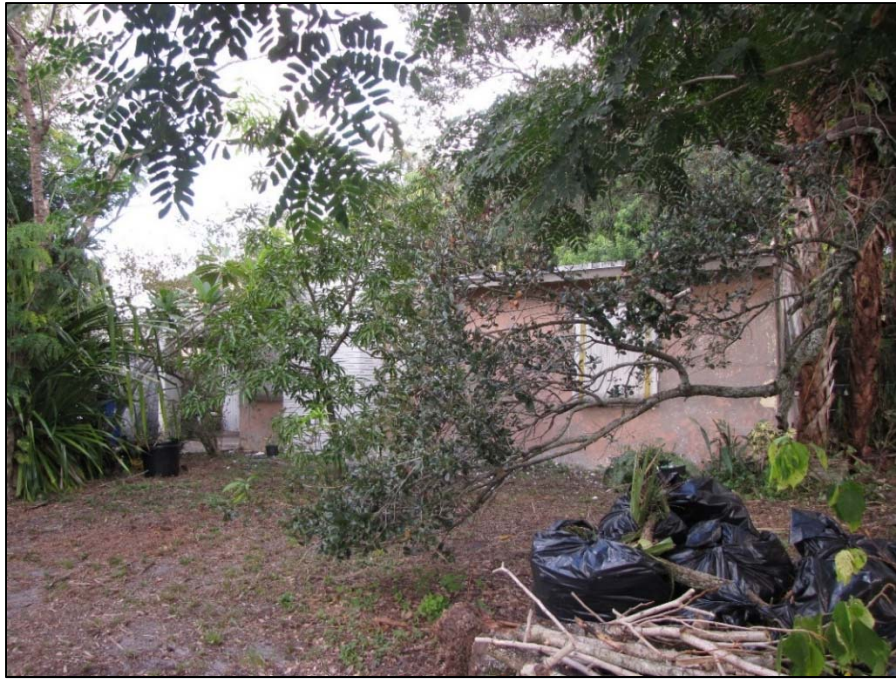
Figure 26 | 132 SW 21st Way (8BD6764), c. 1953, facing Northeast, exhibits replaced doors, added shutters

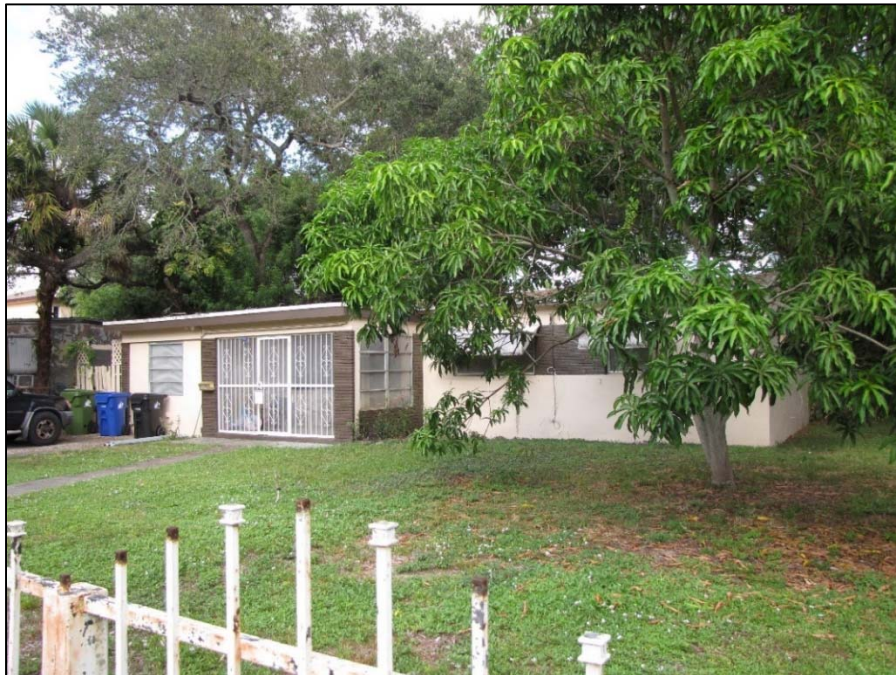
Figure 27 | 138 SW 21st Way (8BD6765), c. 1953, facing Northeast, exhibits enclosed porch, replaced windows and doors, northwest corner addition

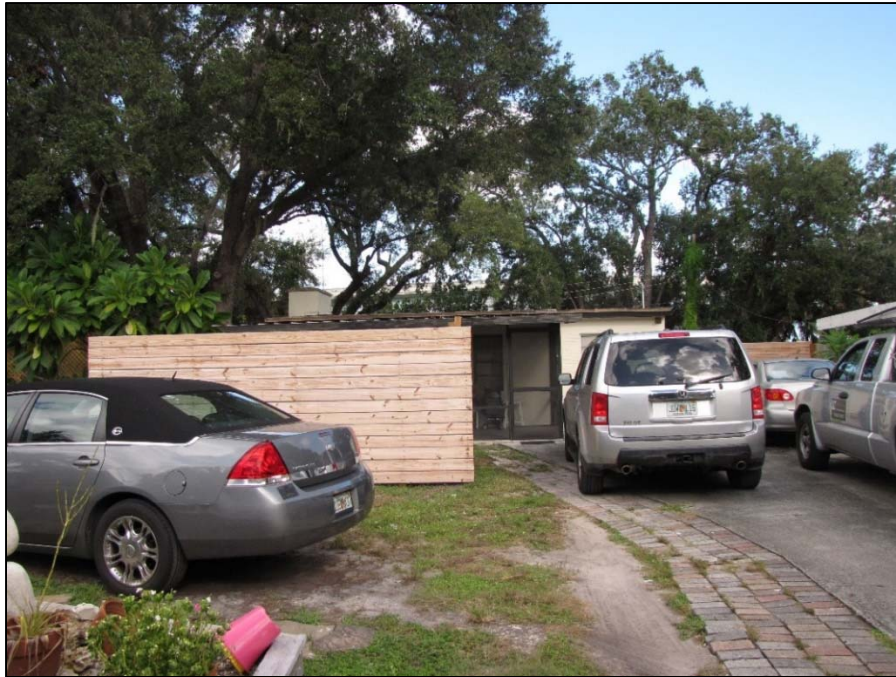
Figure 28 | 142 SW 21st Way (8BD6766), c. 1953, facing East, exhibits enclosed carport and porch, replaced windows and doors, west side screened porch addition

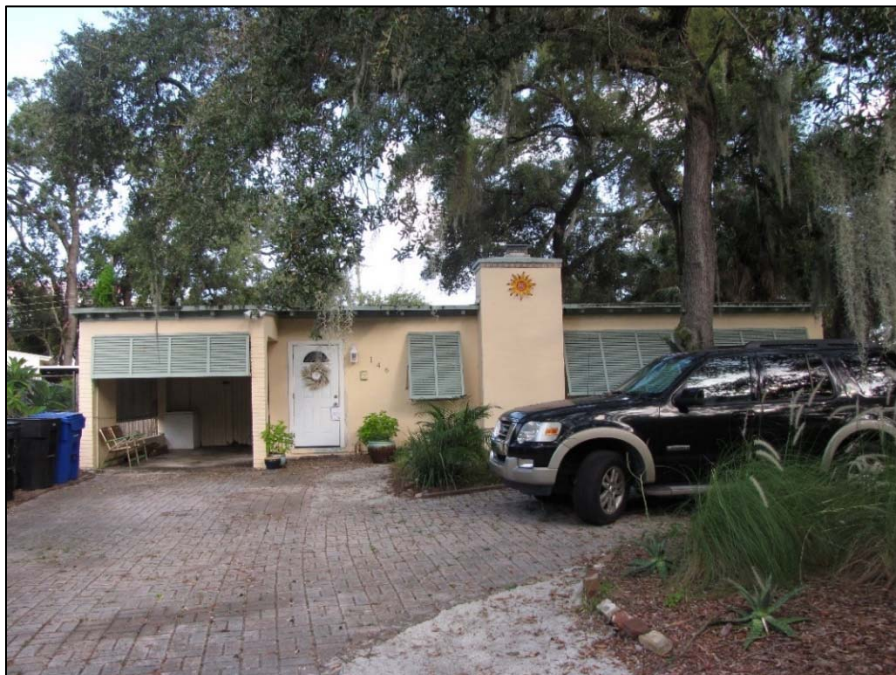
Figure 29 | 146 SW 21st Way (8BD6767), c. 1953, facing Southeast, exhibits replaced windows and doors

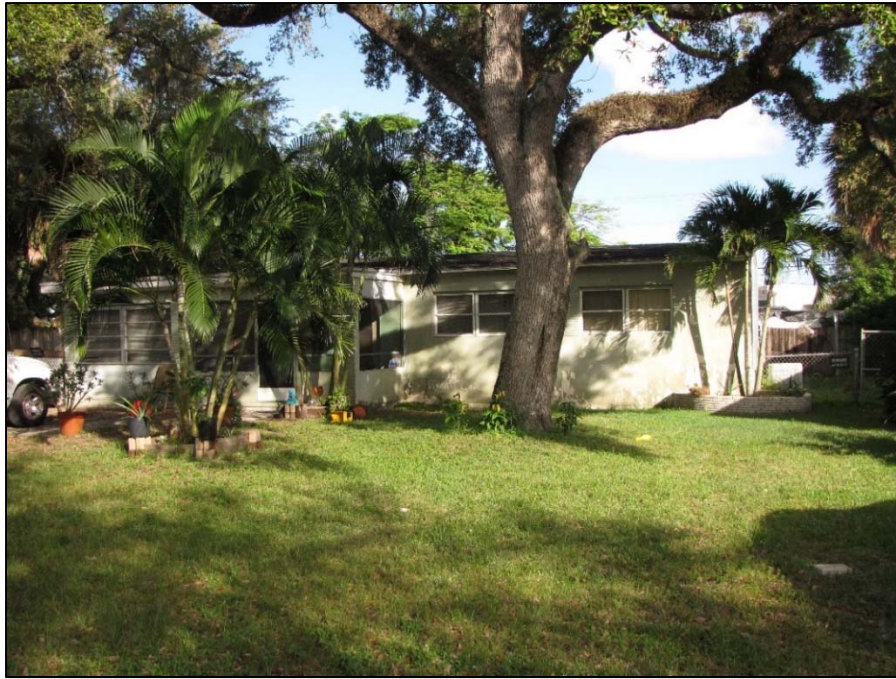
Figure 30 | 200 SW 21st Way (8BD6768), c. 1953, facing Northeast, exhibits enclosed carport, screened in porch, replaced windows and doors, northeast corner addition

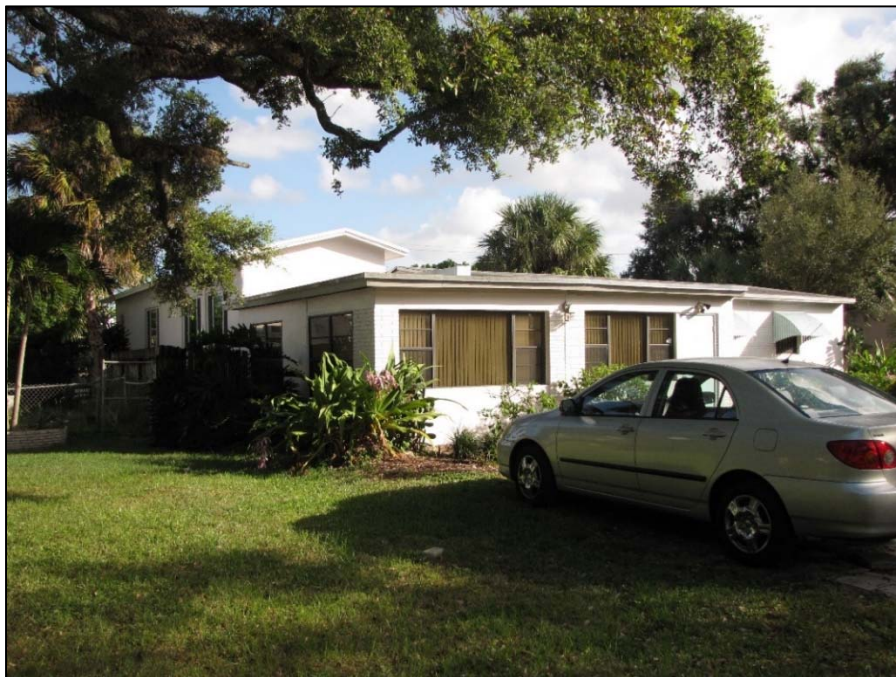
Figure 31 | 204 SW 21st Way (8BD6769), c. 1953, facing South, exhibits enclosed porch, replaced windows and doors, northwest and southwest corner additions

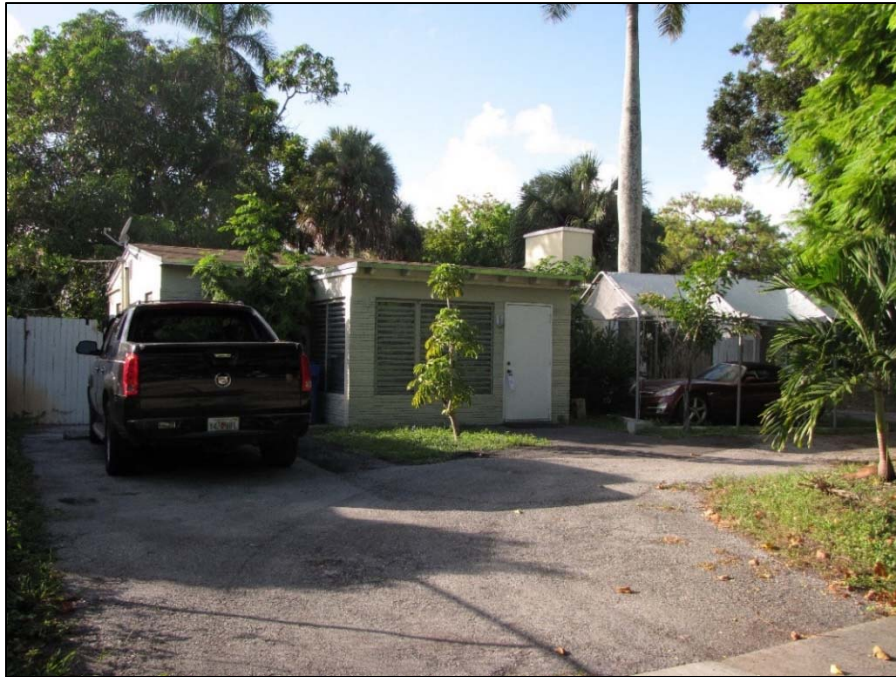
Figure 32 | 143 SW 21st Way (8BD6770), c. 1953, facing Northwest, exhibits enclosed porch, replaced windows and doors

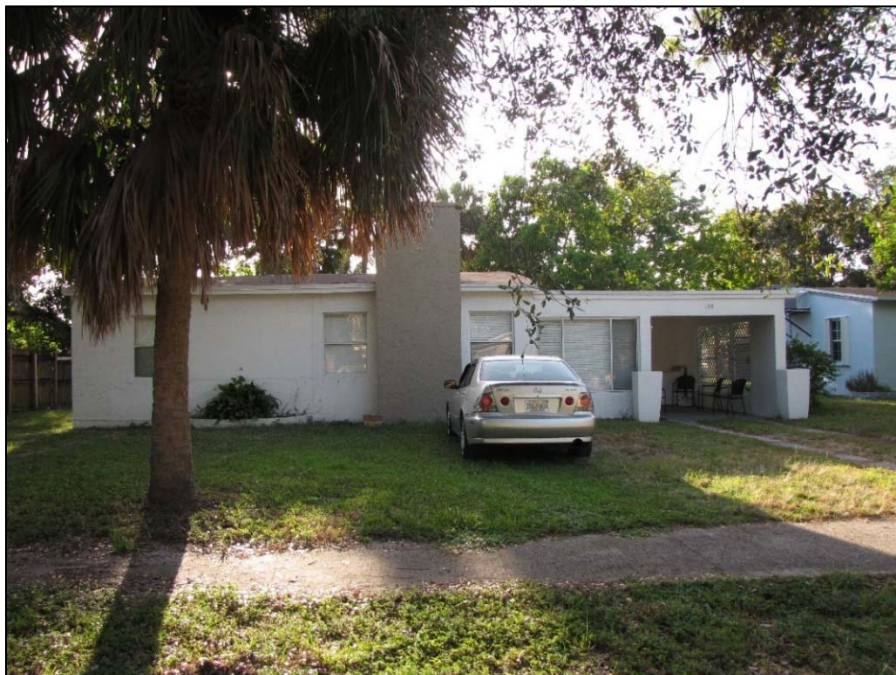
Figure 33 | 139 SW 21st Way (8BD6771), c. 1953, facing West, exhibits enclosed portion of carport, replaced windows and doors

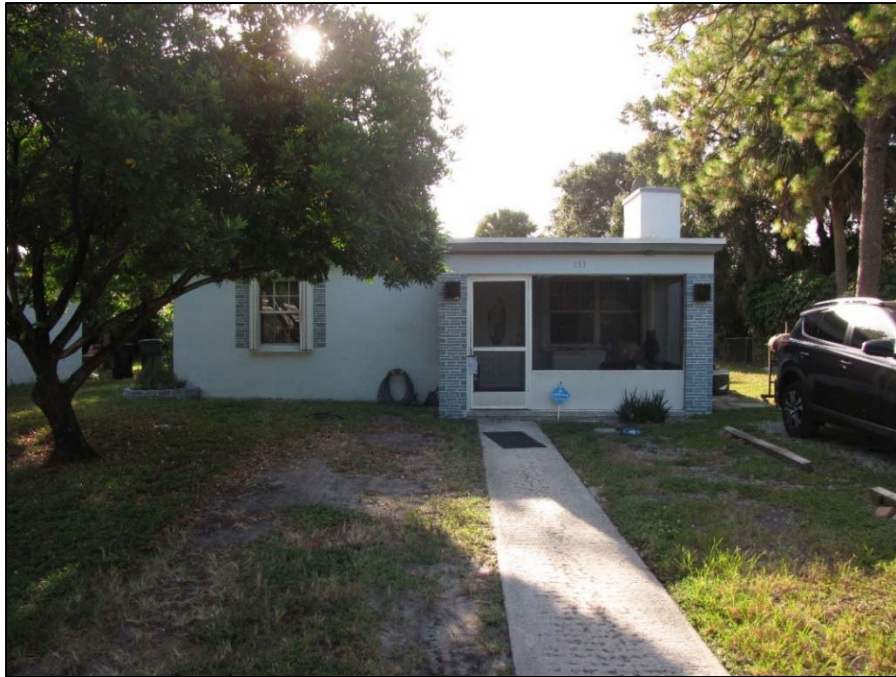
Figure 34 | 133 SW 21st Way (8BD6772), c. 1953, facing West, exhibits screened in porch, replaced windows and doors

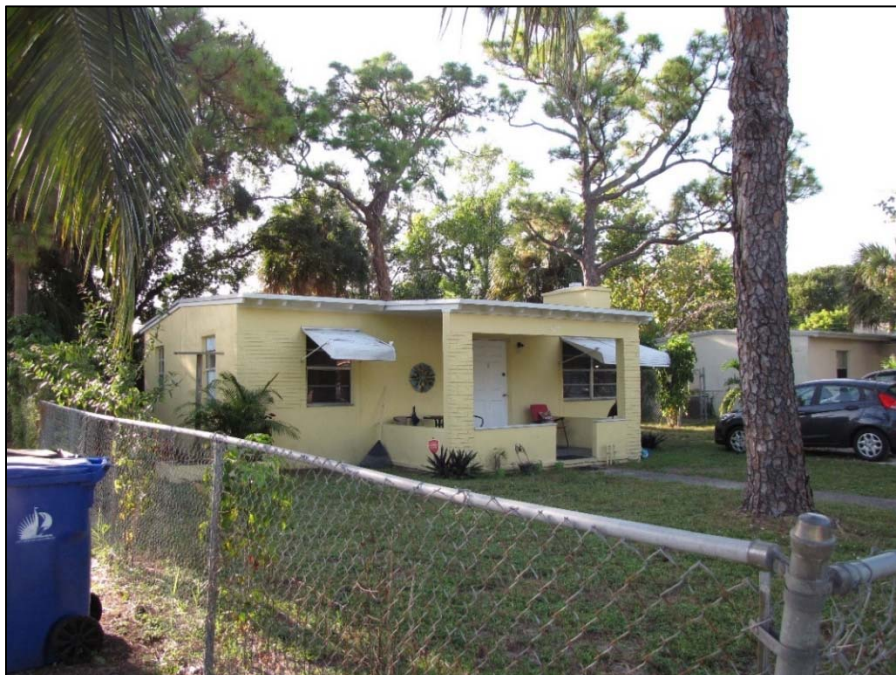
Figure 35 | 129 SW 21st Way (8BD6773), c. 1953, facing Northwest, exhibits replaced windows and doors

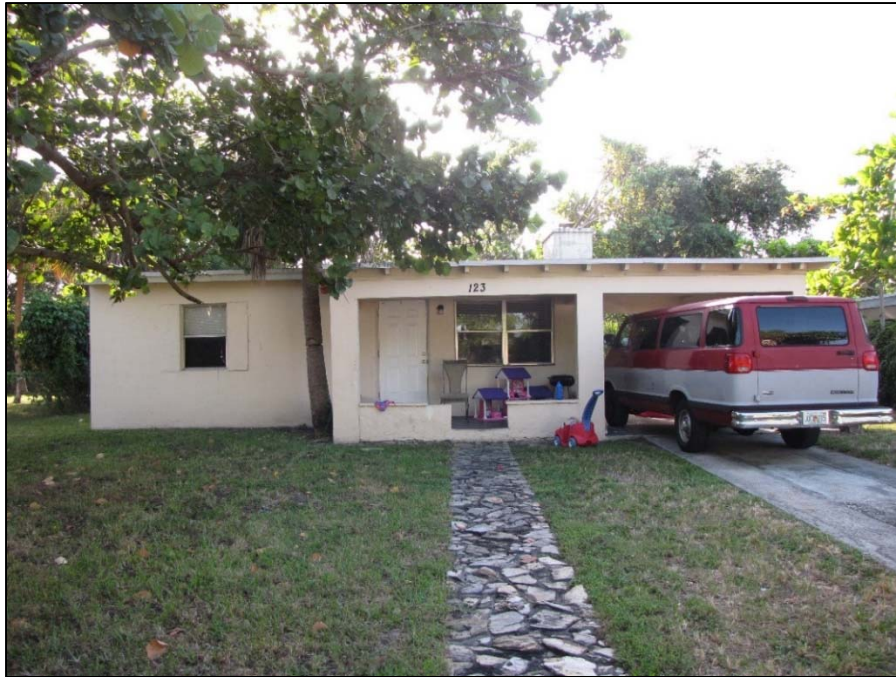
Figure 36 | 123 SW 21st Way (8BD6774), c. 1953, facing West, exhibits replaced windows and doors

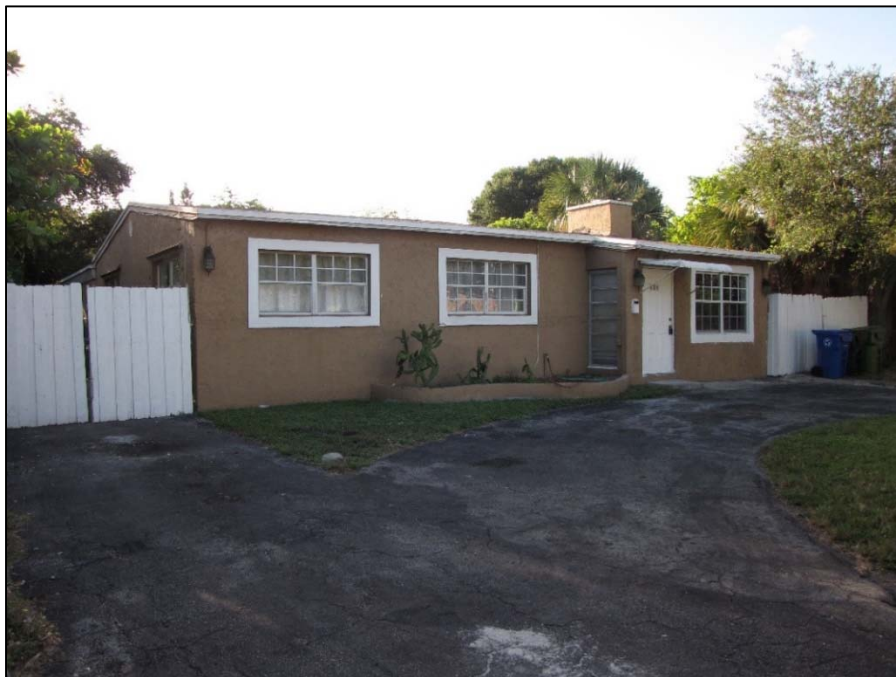
Figure 37 | 119 SW 21st Way (8BD6775), c. 1953, facing Northwest, exhibits enclosed porch, replaced windows and doors
