Cultural Resource Assessment Survey Addendum

**SR-9/I-95 @ SR 842/Broward Boulevard (Broward
Boulevard from West of SW 24th Avenue to East of
NW/SW 18th Avenue)
Project Development & Environment (PD&E) Study**

**Broward County, Florida
Financial Project ID Number: 435513-1-22-02**

April 2019

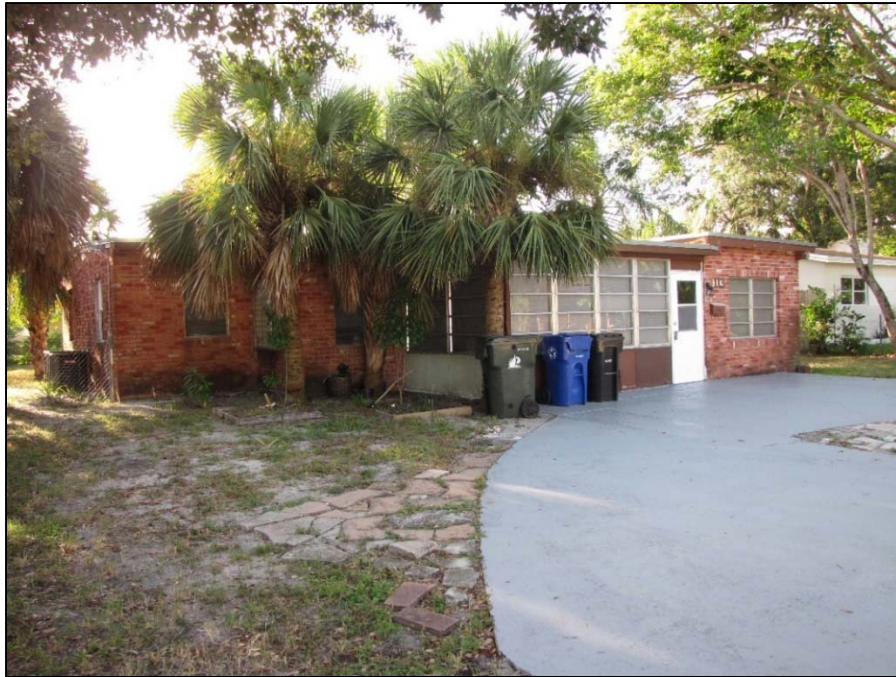
Figure 38 | 113 SW 21st Way (8BD6776), c. 1953, facing Northwest, exhibits enclosed carport and porch, replaced windows and doors

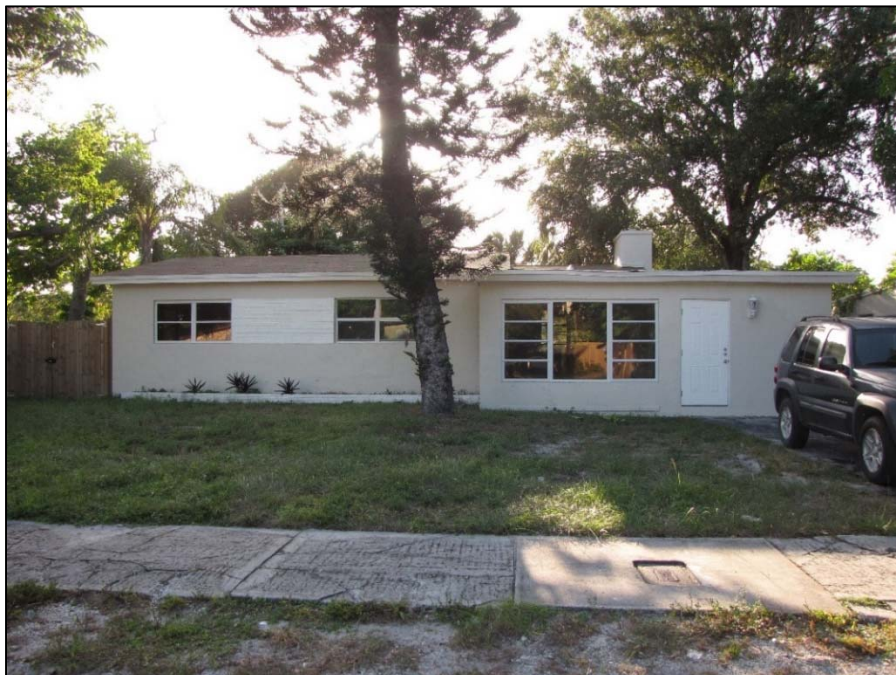
Figure 39 | 109 SW 21st Way (8BD6777), c. 1953, facing West, exhibits enclosed carport and porch, replaced windows and doors, northeast corner addition

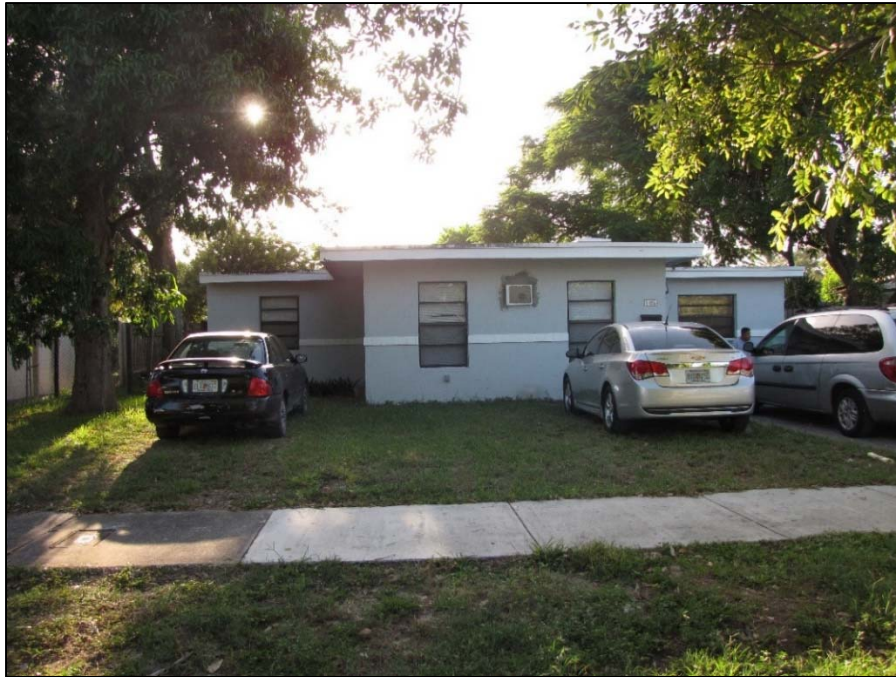
Figure 40 | 105 SW 21st Way (8BD6778), c. 1953, facing West, exhibits enclosed porch, replaced windows and doors

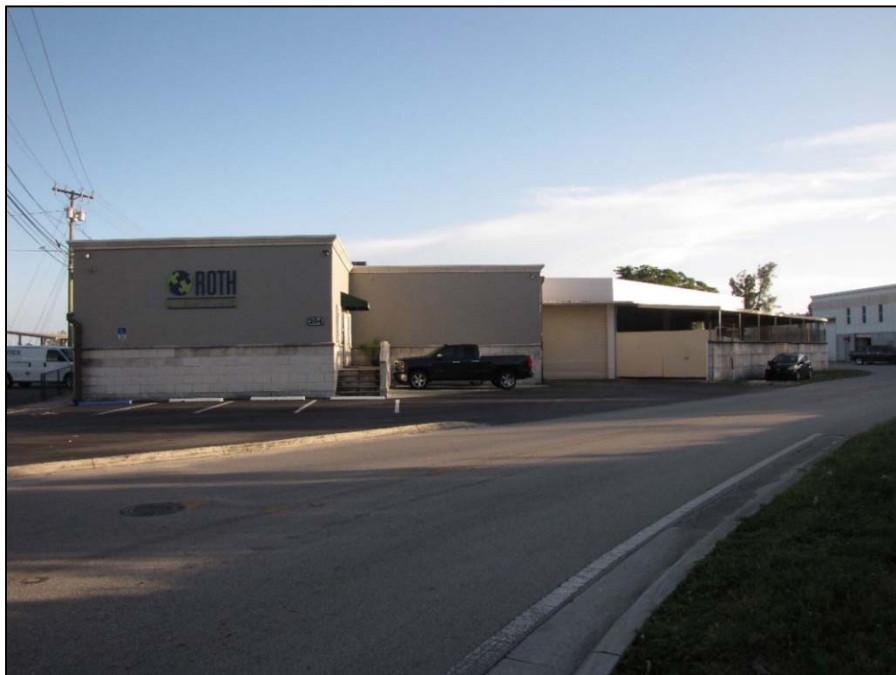
Figure 41 | Roth Lighting/204 SW 21st Terrace (8BD6779), c. 1959, facing South, exhibits replaced windows and doors, added decorative railing and stone at entrance

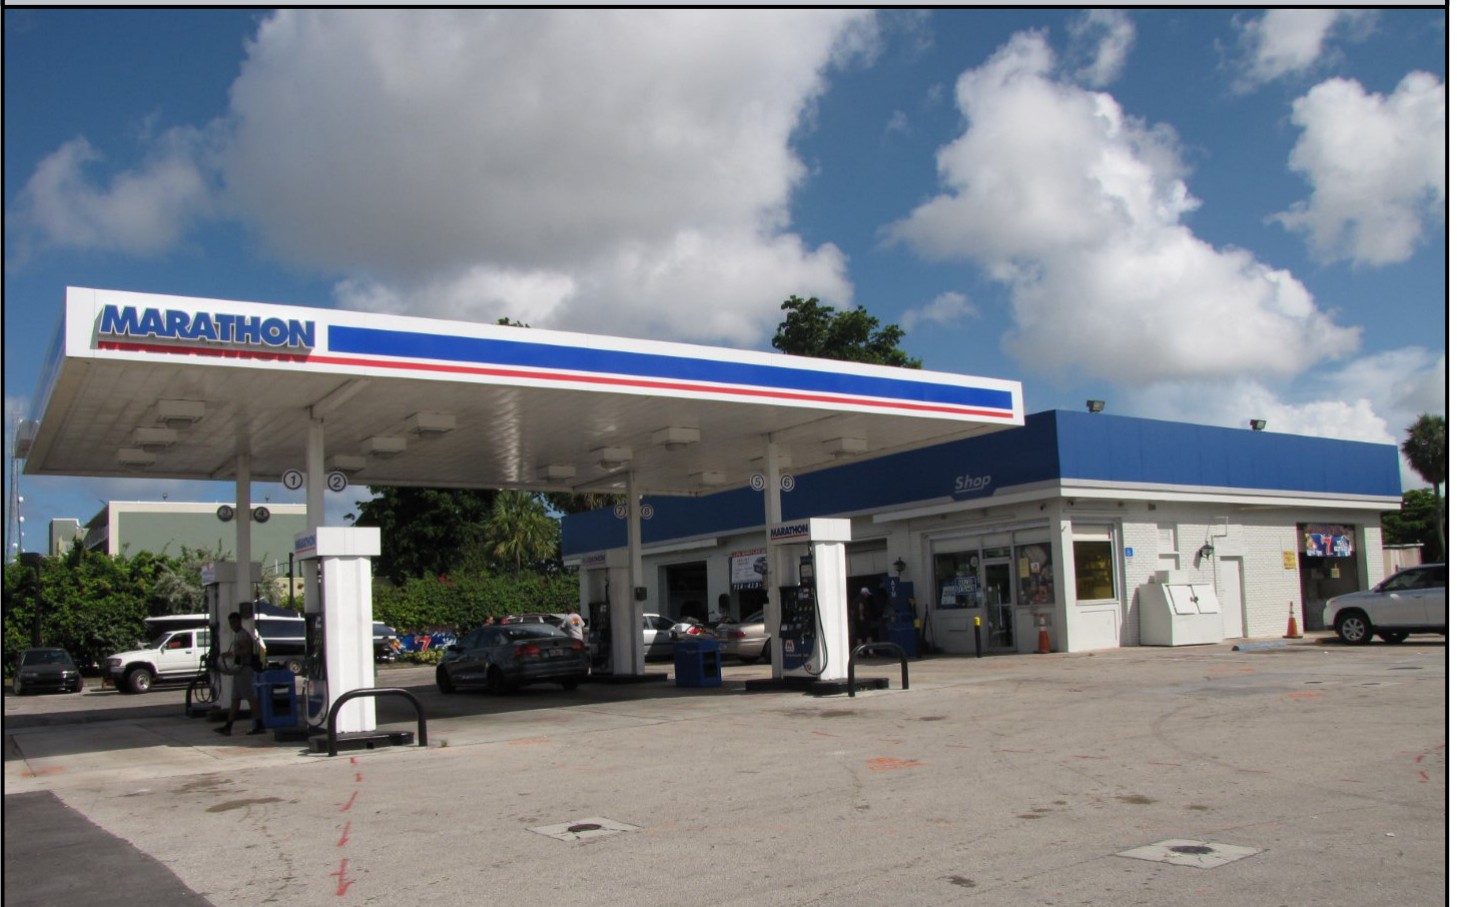
PHOTOGRAPH

Narrative Description of Resource This Masonry Vernacular commercial building has a simple form with few alterations. The pent-roof overhang was replaced, as well as the canopy over the gas pumps. The area around the building is commercial in nature.

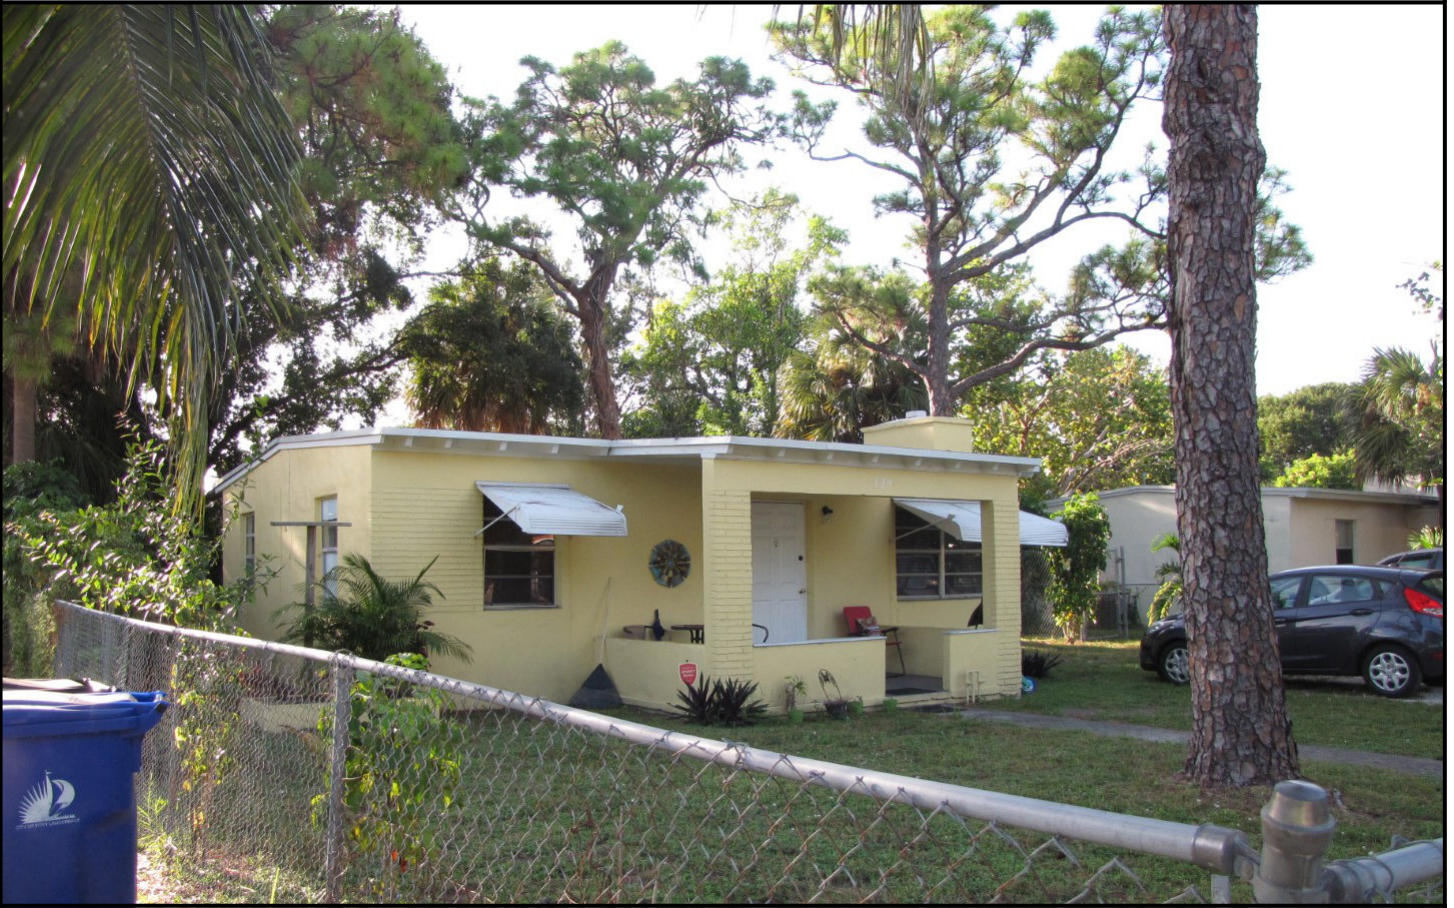
PHOTOGRAPH

Chimney: No. 1 Chimney Material(s): 1. Stucco 2. _____
Structural System(s): 1. Concrete block 2. _____ 3. _____
Foundation Type(s): 1. Continuous 2. _____
Foundation Material(s): 1. Concrete Block 2. _____
Main Entrance (stylistic details) East-facing panel door

Narrative Description of Resource This Masonry Vernacular residence has a simple form with few alterations. The windows and door have been replaced. The area around the building is residential in nature.

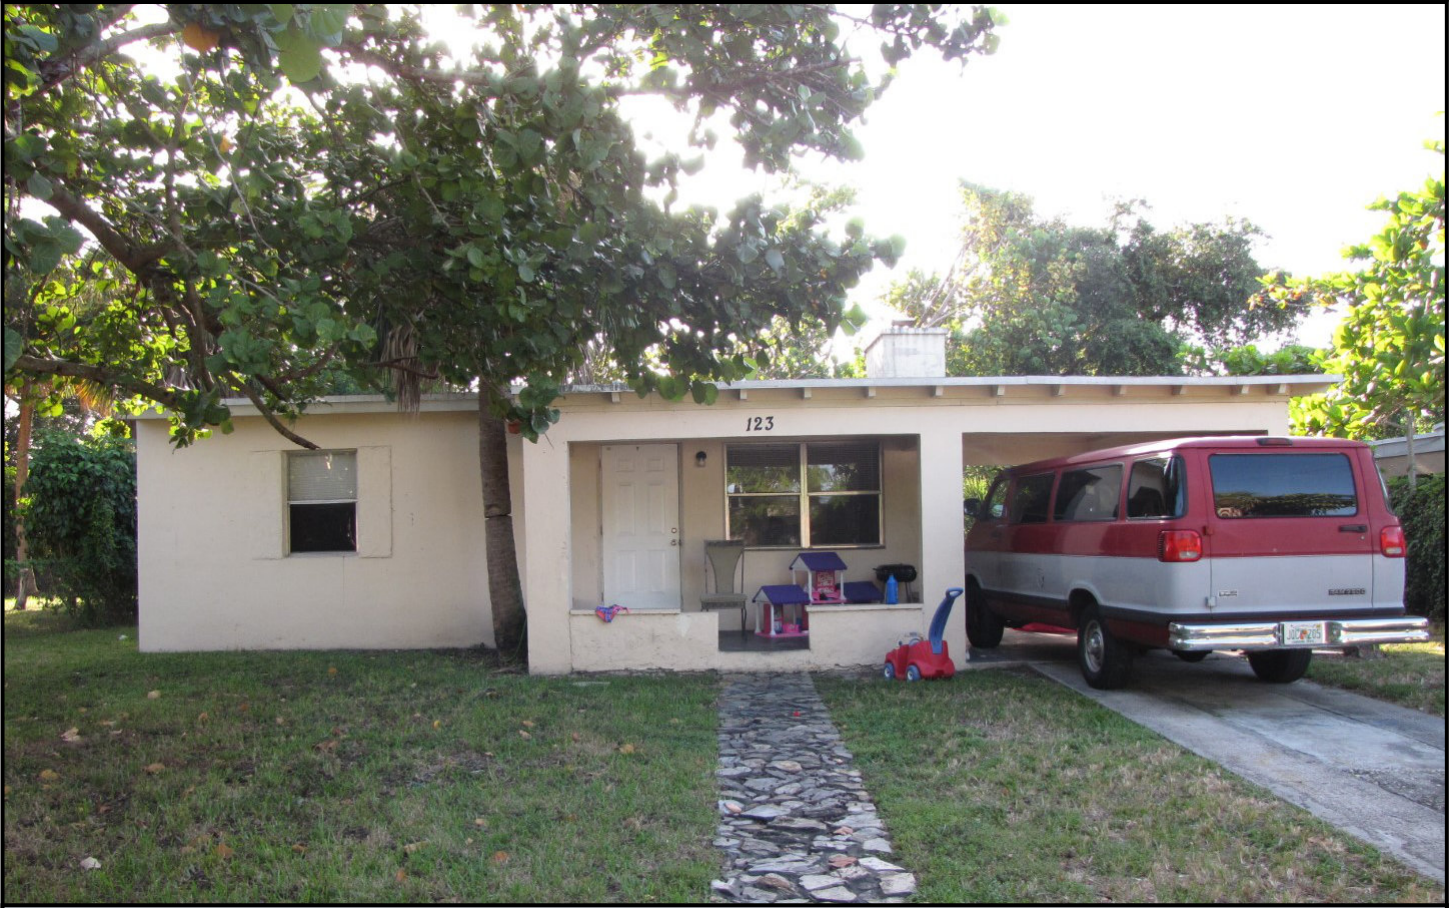
PHOTOGRAPH

Chimney: No. 1 Chimney Material(s): 1. Stucco 2. _____
Structural System(s): 1. Concrete block 2. _____ 3. _____
Foundation Type(s): 1. Continuous 2. _____
Foundation Material(s): 1. Concrete Block 2. _____
Main Entrance (stylistic details) East-facing panel door

Narrative Description of Resource This Masonry Vernacular residence has a simple form with few alterations. The windows and door were replaced and the porch was enclosed. The area around the building is residential in nature.

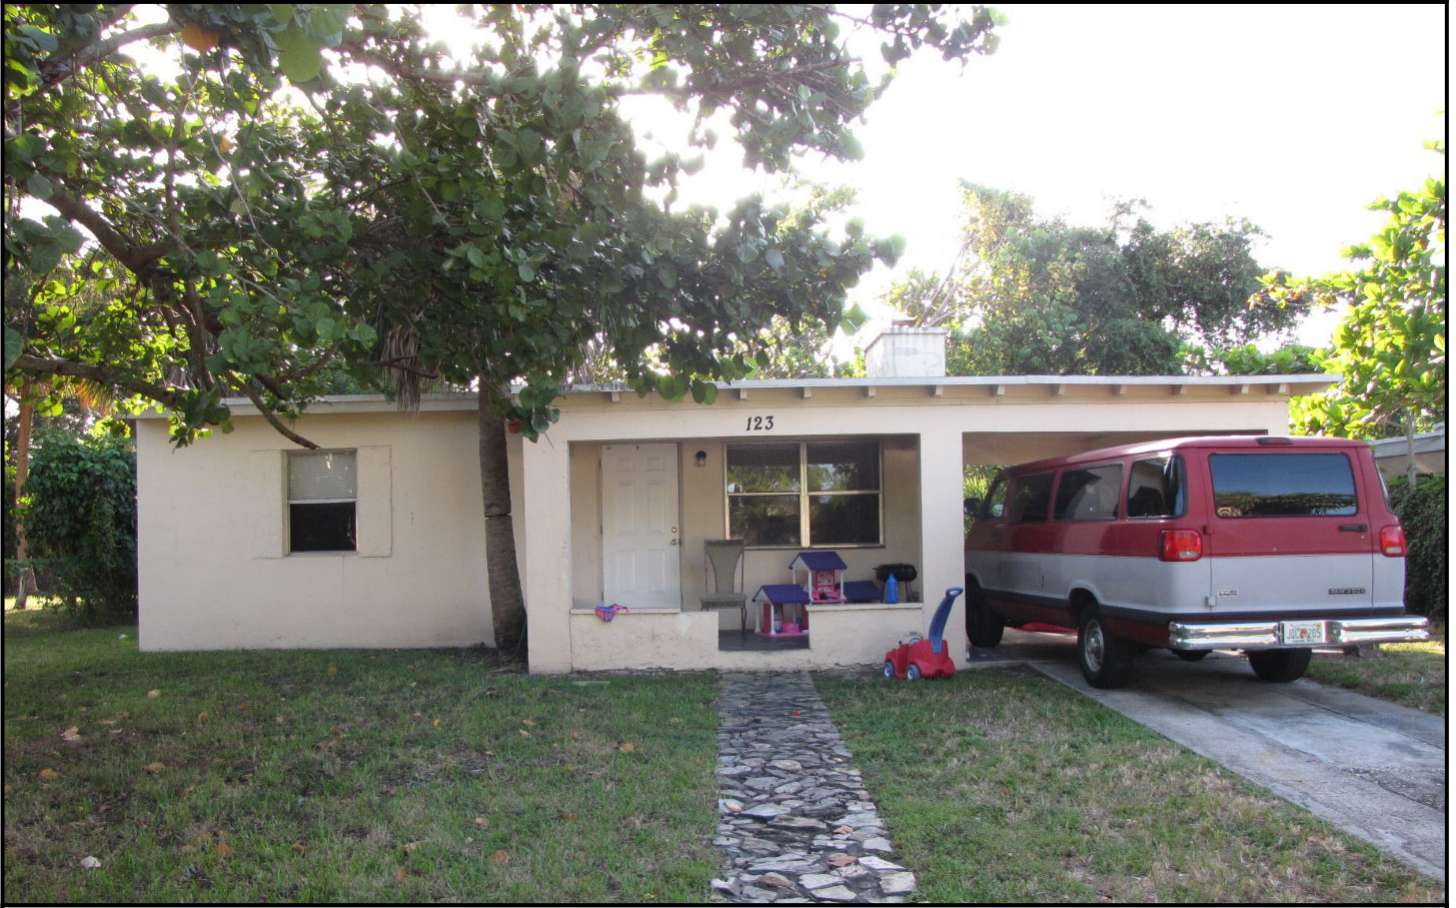
PHOTOGRAPH

Chimney: No. 1 Chimney Material(s): 1. Stucco 2. _____
Structural System(s): 1. Brick 2. _____ 3. _____
Foundation Type(s): 1. Slab 2. _____
Foundation Material(s): 1. Concrete, Generic 2. _____
Main Entrance (stylistic details) East-facing panel door with rectangular light
Porch Descriptions (types, locations, roof types, etc.) None observed

Condition (overall resource condition): excellent good fair deteriorated ruinous
Narrative Description of Resource This Masonry Vernacular residence has a simple form with few alterations. The windows and door were replaced and the porch ass enclosed. The area around the building is residential in nature.
Archaeological Remains _____ Check if Archaeological Form Completed

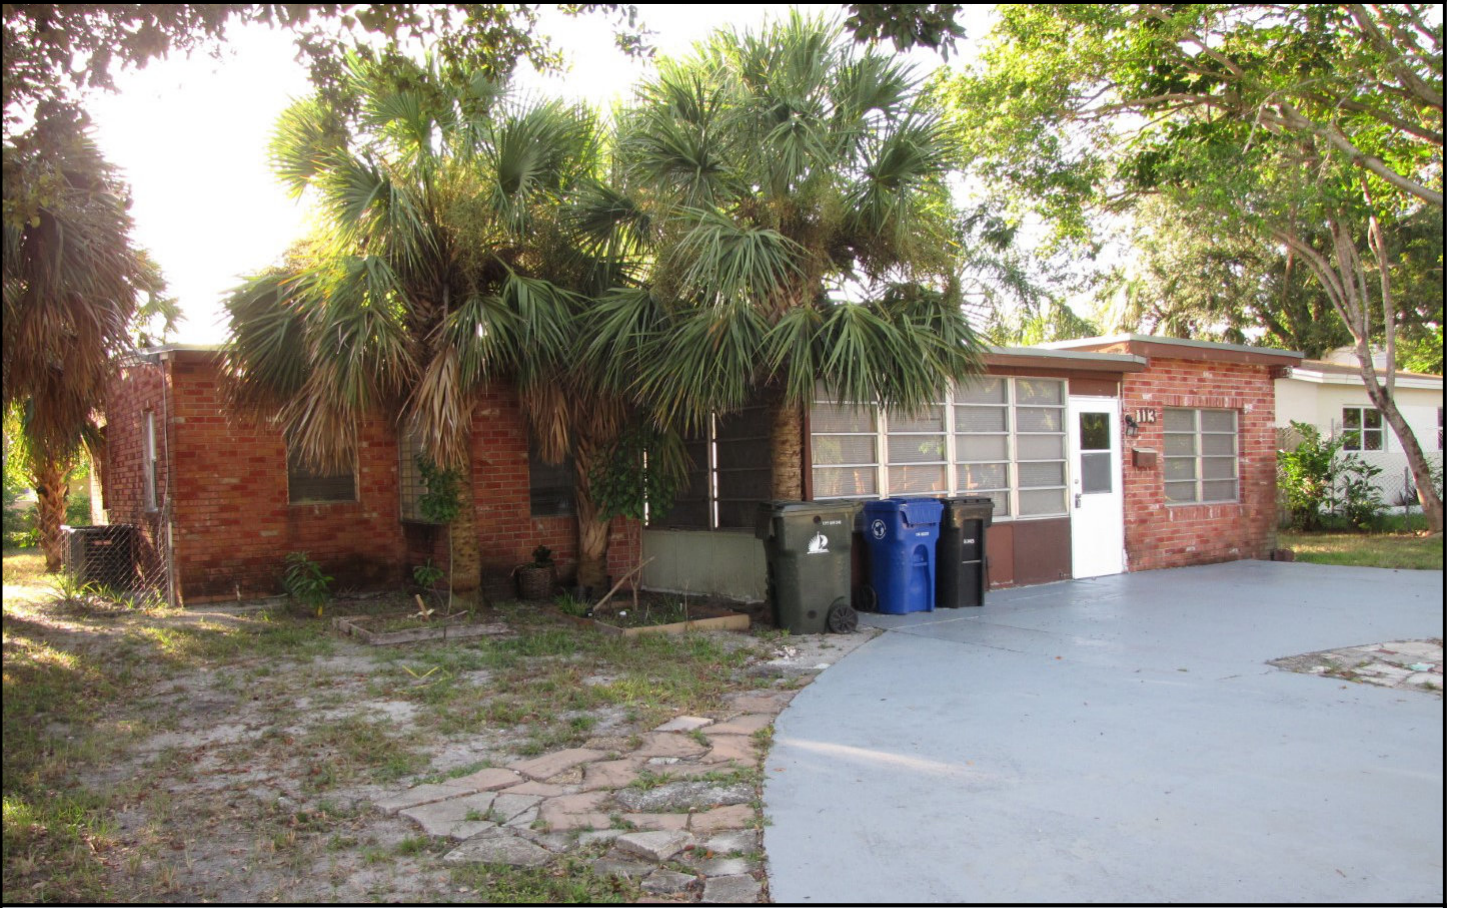
PHOTOGRAPH

Chimney: No. 1 Chimney Material(s): 1. Stucco 2. _____
Structural System(s): 1. Concrete block 2. _____ 3. _____
Foundation Type(s): 1. Continuous 2. _____
Foundation Material(s): 1. Concrete Block 2. _____
Main Entrance (stylistic details) East-facing metal panel door

Narrative Description of Resource This Masonry Vernacular residence has a simple form with several alterations. The windows and door were replaced, and the porch and carport were enclosed. The area around the building is residential in nature.

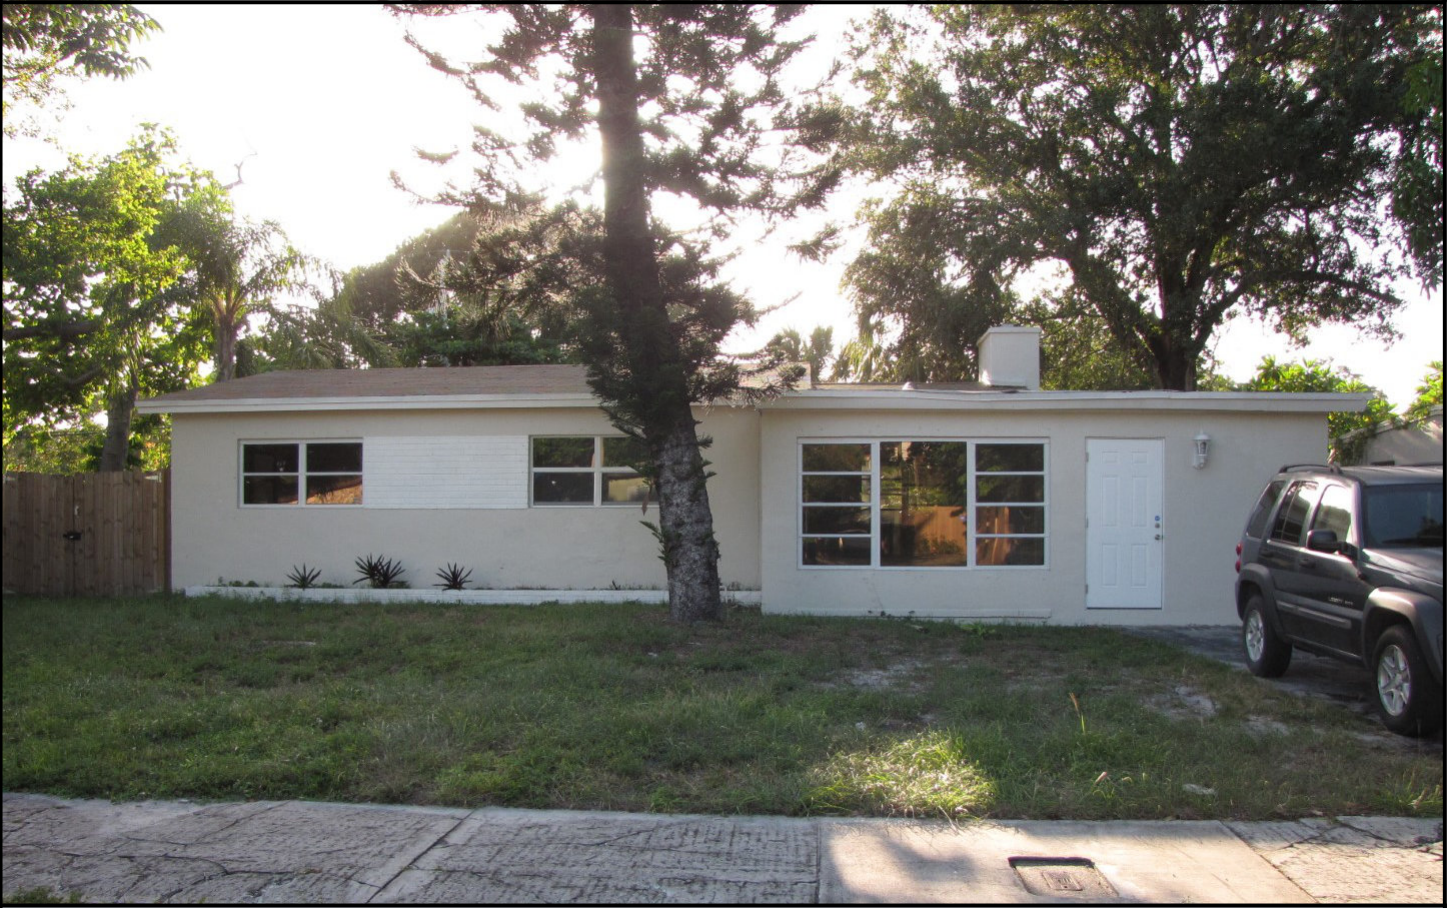
PHOTOGRAPH

Chimney: No. 1 Chimney Material(s): 1. Stucco 2. _____
Structural System(s): 1. Concrete block 2. _____ 3. _____
Foundation Type(s): 1. Continuous 2. _____
Foundation Material(s): 1. Concrete Block 2. _____
Main Entrance (stylistic details) North-facing panel door on enclosed porch.

Narrative Description of Resource This Masonry Vernacular residence has a simple form with several alterations. The windows and door were replaced and the porch was enclosed. The area around the building is residential in nature.
