Cultural Resource Assessment Survey

SR-9/I-95 @ SR 842/Broward Boulevard (Broward Boulevard from West of SW 24th Avenue to East of NW/SW 18th Avenue)

Project Development & Environment (PD&E) Study

Broward County, Florida Financial Project ID Number: 435513-1-22-02

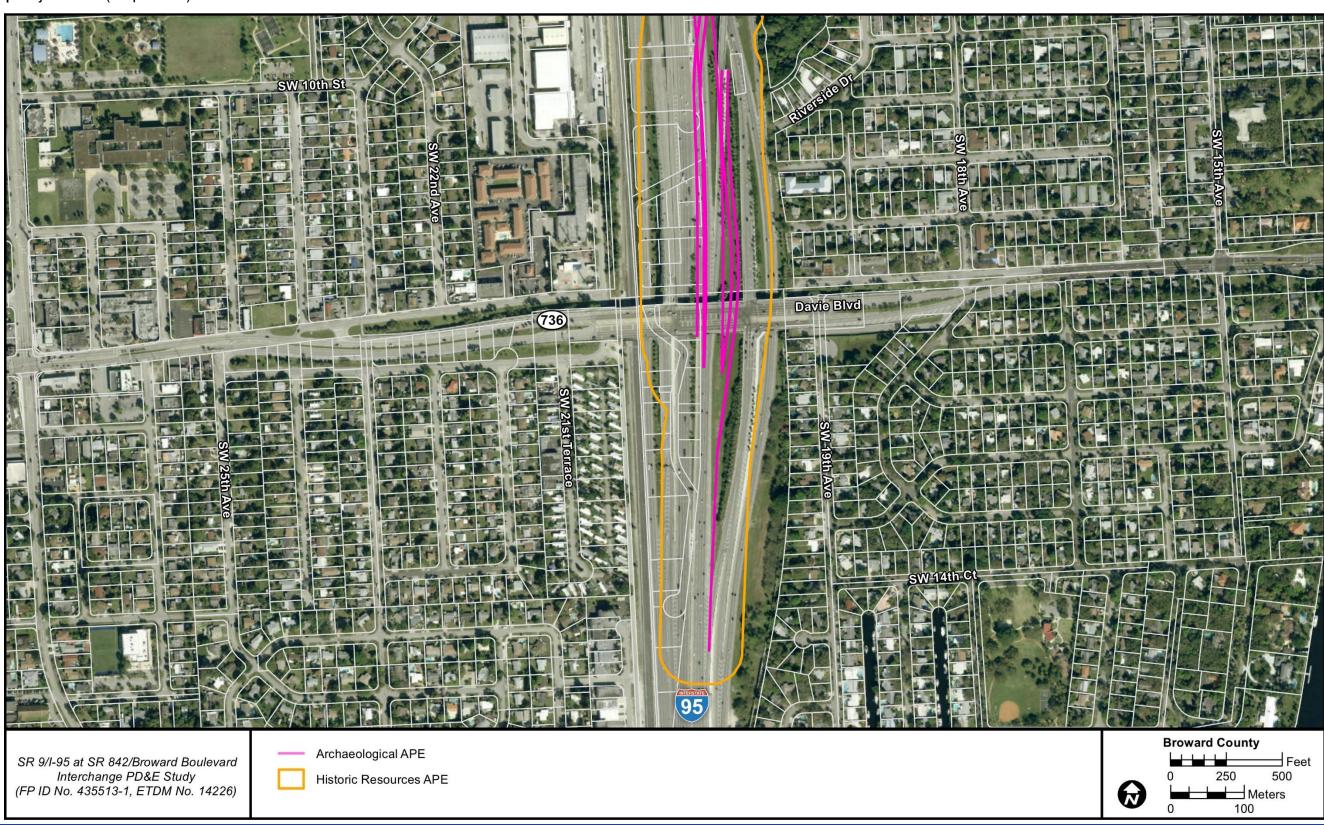
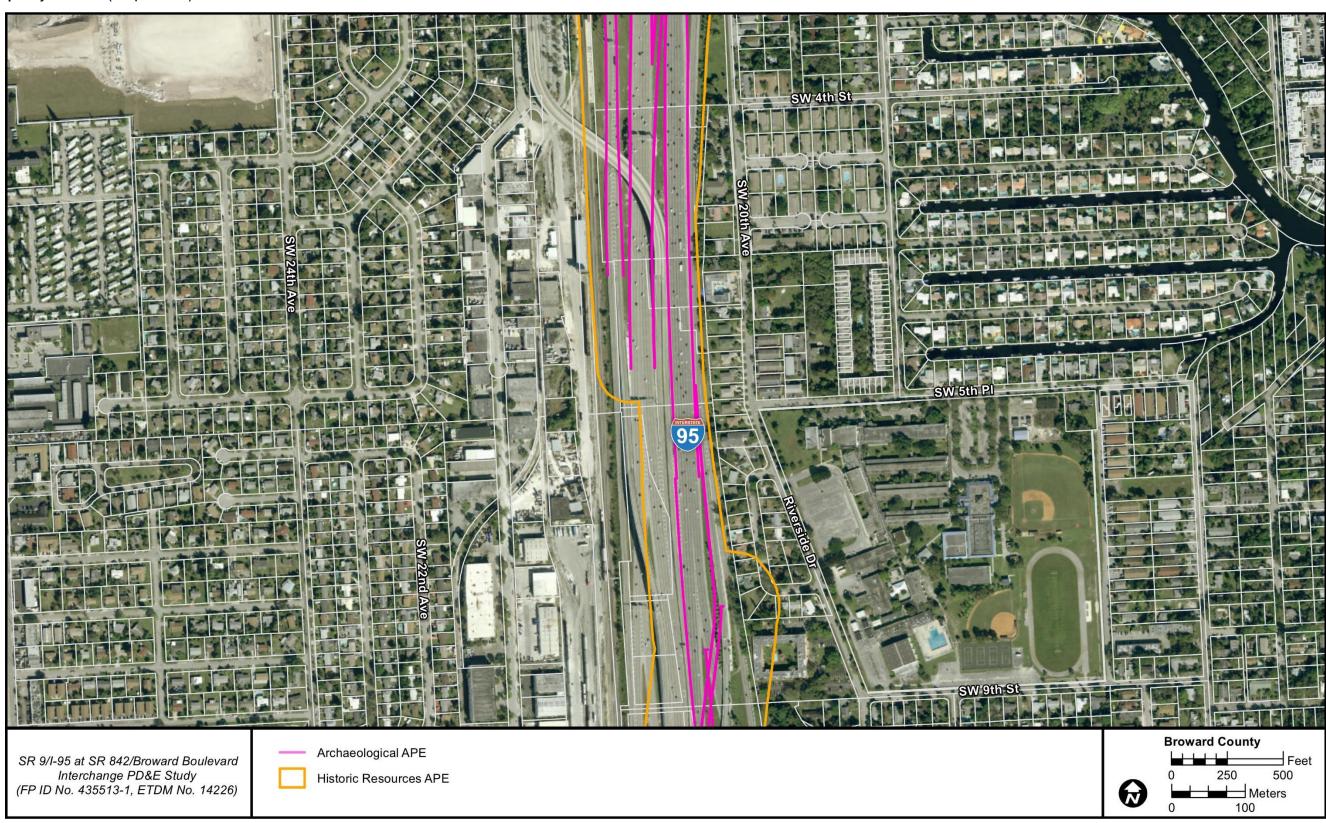
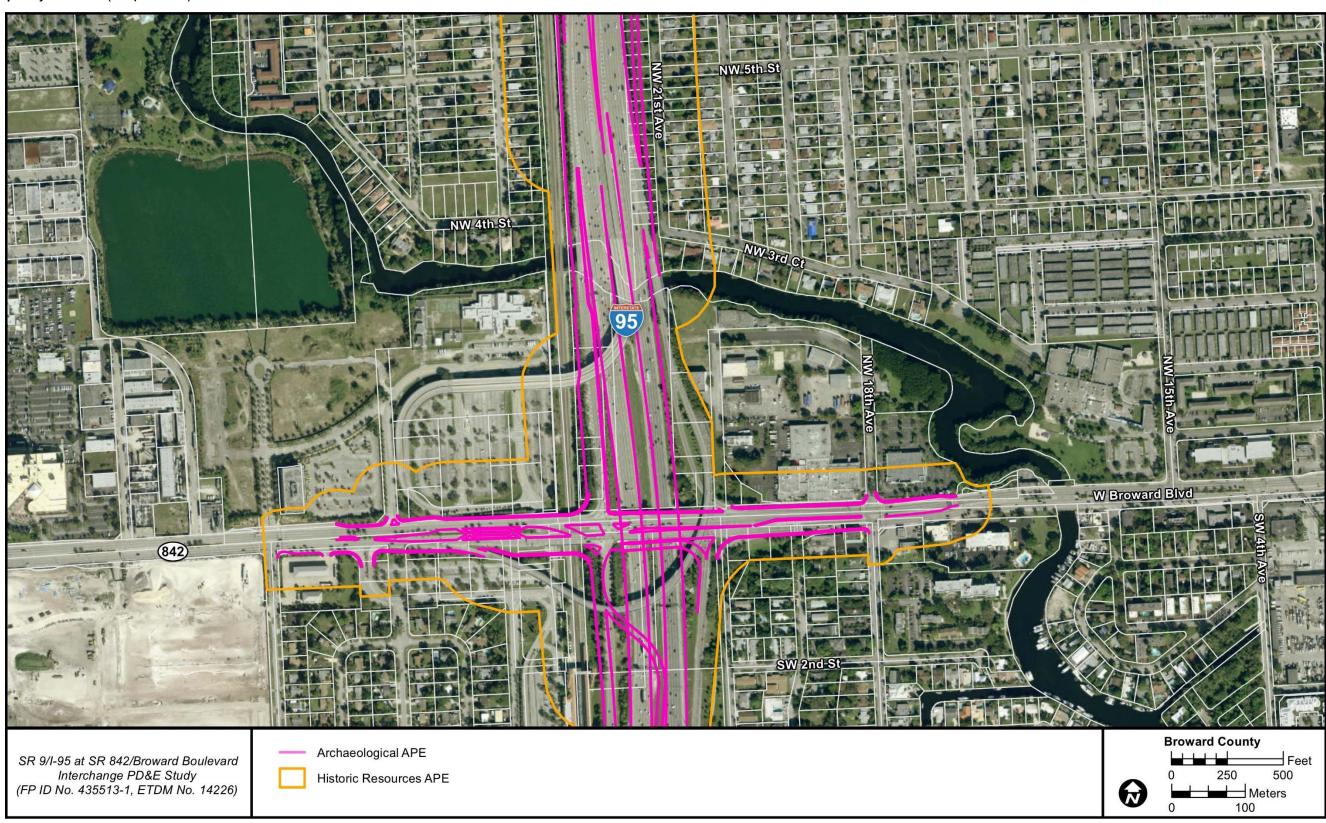
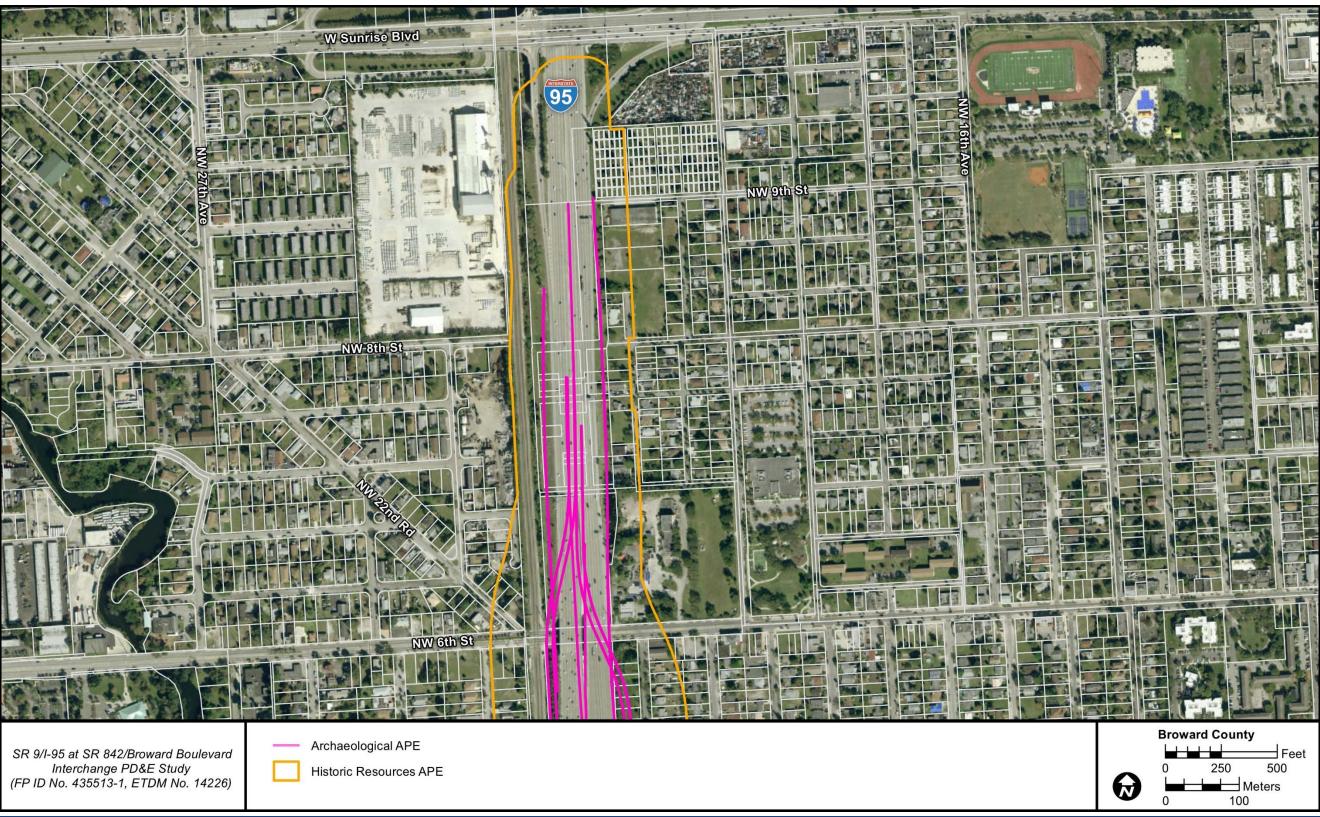
The historic resources APE is defined as the area within which potential effects for the improvements could be observed. The APE for historic resources where the improvements are within existing sound walls is limited to the existing ROW. The historic resources APE for improvements at grade is the footprint of the improvements and adjacent parcels within 150 feet. The historic resources APE is 250 feet from the footprint of improvements that include proposed elevated ramps. (**Figure 10a–d**).

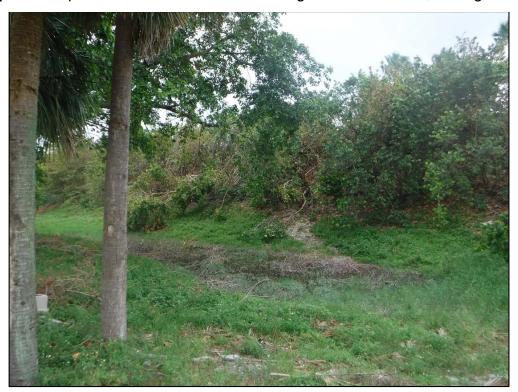
Figure 17 | Landscaped Berm East Side of I-95 Along NW 21st Avenue, Facing Southwest

No previously recorded or newly recorded archaeological sites were identified within the archaeological APE. Background research and a pedestrian survey indicated that there is a low probability of finding intact archaeological sites within the archaeological APE. The majority of the project area has been previously surveyed during FMSF Survey Nos. 19752 and 20623 (Janus Research 2012, 2013) that have received SHPO concurrence (**Appendix B**). Subsurface archaeological testing was not feasible within the previously unsurveyed portion of the archaeological APE due to the existence of pavement, sidewalks, berms, buried utilities, landscaping, and residential and commercial frontage (**Appendix C**). Representative photographs of the archaeological APE are included below (**Figures 17–19**).

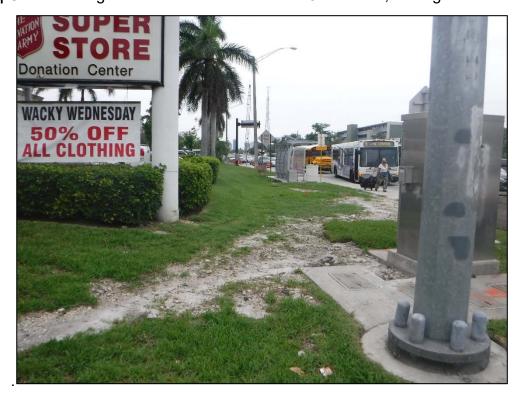
Figure 18 | Utilities Along Broward Boulevard at NW 18th Avenue, Facing East

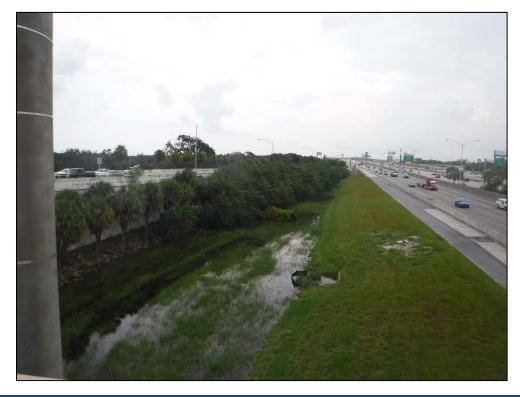
Figure 19 | Standing Water within I-95 ROW at Davie Boulevard, Facing South

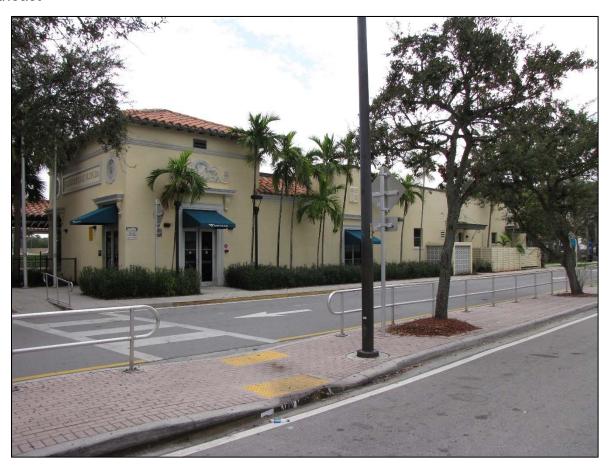
Figure 21 | Seaboard Airline Railroad Station, located at 200 SW 21st Terrace (8BD1452), facing Southeast

The circa-1926/1927 Seaboard Airline Railroad Station (8BD1452) (**Figure 21**) is located at 200 SW 21st Terrace and still serves its original purpose as a railroad station. It was designed by architect Gustav A. Maass in the Mediterranean Revival style, and is representative of the transportation boom that took place in Fort Lauderdale and across southeast Florida during the Boom Times of the 1920s. For significance under Criteria A and C in the areas of Transportation and Architecture, the SHPO determined on December 20, 1999 that the Seaboard Airline Railroad Station was eligible for listing in the National Register. This building is also locally-designated within the City of Fort Lauderdale.

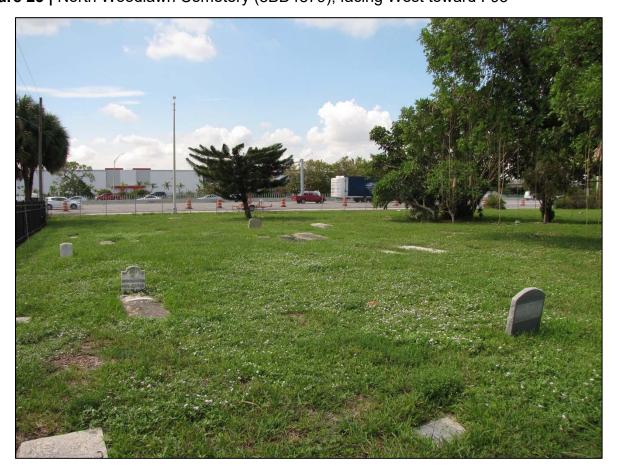
Figure 23 | North Woodlawn Cemetery (8BD4879), facing West toward I-95

North Woodlawn Cemetery (8BD4879) (**Figure 23**) was established in 1926, and is located on the west side of NW 19th Avenue, between NW 9th Street and Sunrise Boulevard. The cemetery serves as the final resting place for many of the areas pioneering African American residents. It was the only cemetery in Fort Lauderdale where African Americans could be buried until 1962 (Janus Research 2012). North Woodlawn Cemetery possesses local significance under Criterion A in the area of ethnic heritage, for its connection to the early African American community in the northwest quadrant Fort Lauderdale. The cemetery also meets National Register Criteria Consideration D for its connection to historical events, as it is one of the few remaining resources associated with Fort Lauderdale's African American community during the period of racial segregation. North Woodlawn Cemetery was determined eligible for the National Register by the SHPO on March 27, 2013. The cemetery has already passed the state review board and is currently being reviewed for listing in the National Register by the national review board as of

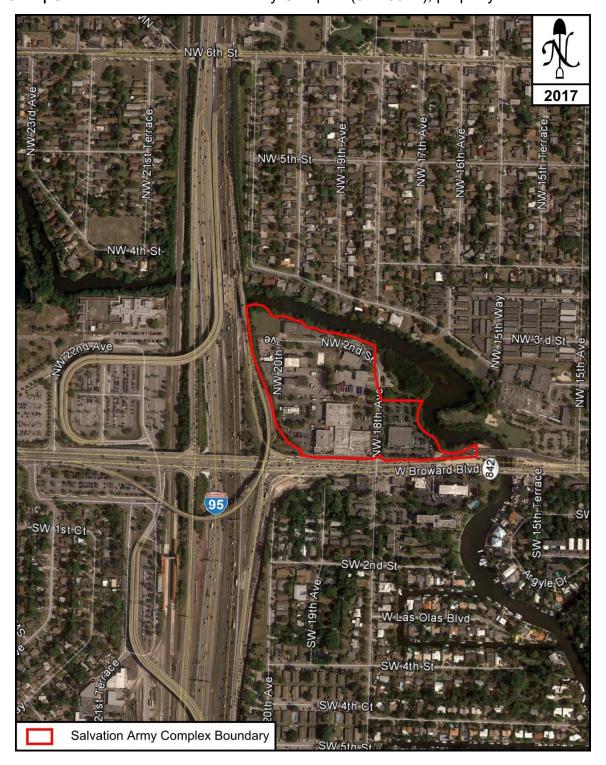
Figure 27 | Current aerial of Salvation Army Complex (8BD6347), property boundaries in red

The development of the Salvation Army Complex and the area around it has been gradual. The original use of the property is unknown, but the Salvation Army obtained the property in 1980 (Broward County 1980). A review of historic aerials shows that four of the Masonry Vernacular buildings are historic. The oldest building on the complex, Warehouse 1, can be seen in the 1958 aerial (**Figure 24**). By 1968, five more buildings were constructed: Warehouse 2, Warehouse 3, the Adult Rehabilitation Center, and two smaller buildings in the northwest and southeast corners of the property that were demolished in the 1990s (**Figure 25**). The 1958 and 1968 aerials also show a building next to the railroad that may have been a train station, but this building and three others that may have been associate with the Salvation Army Complex were demolished in the 1970s when I-95 was built. By 1988, Warehouses 4 and 5 and Offices 1 and 2 were constructed (**Figure 26**). A current aerial shows the addition to the Adult Rehabilitation Center, c. 1990, and the Super Store, c. 2000 (**Figure 27**).

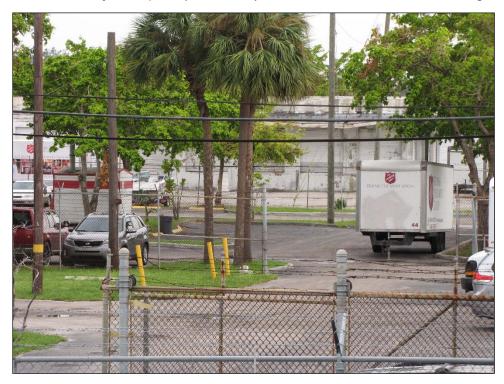
Figure 28 | Salvation Army Complex (8BD6347), Warehouse 1, c. 1957, looking North

Warehouse 1 is the oldest building on the complex having been constructed c. 1957 (**Figure 28**). This one and a half story Masonry Vernacular warehouse was built in two phases. The west half of the building was completed c. 1957, and shortly after in 1958 the east half of the building was completed. The building is constructed of concrete block painted white. There are nine bays with rolling garage doors on each of the north and south sides. The windows on the west end of the building have iron security bars, which make it impossible to see what style the windows are. There is a set of stairs with a small platform leading to a metal door on the west side. That is the only known entrance, because the east side of the building is not visible. There are flat roof overhangs on the north, east, and south sides of the east half of the building. The building has a flat built-up roof.

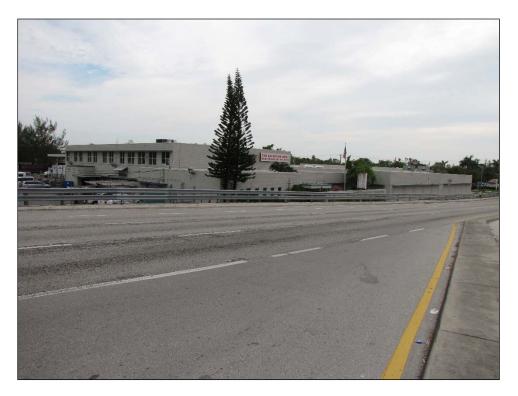
Figure 30 | Salvation Army Complex (8BD6347), Adult Rehabilitation Center, c. 1967, looking Northeast

This Masonry Vernacular building sits southeast of Warehouses 1 and 2, at the northwest corner of W Broward Boulevard and NW 18th Avenue. It was once a warehouse, but is currently used as the Salvation Army Adult Rehabilitation Center (**Figure 30**). This building was constructed c. 1967 of concrete block and is covered in brick painted grey. It has always been irregularly shaped, originally having four large connected massings. The two-story portion of the building in the northwest corner was likely the original office. It has evenly spaced one-over-one single-hung-sash windows on the east side of the second story. The west side has several single door entrances on the first floor and double windows on the second floor. There are only two windows on the south side of the second story. All the windows sit under flat roof overhangs.

All portions and additions of the building have flat, built-up roofs Most of the area around the Adult Rehabilitation Center has been paved for parking and loading. There have been several alterations and additions to this building. Most of the windows appear to have been replaced in the 1980s. The main south-facing entrance was likely altered to accommodate the 1980s commercial glass double doors and window wall. Many other doors also appear to be 1980s replacements.

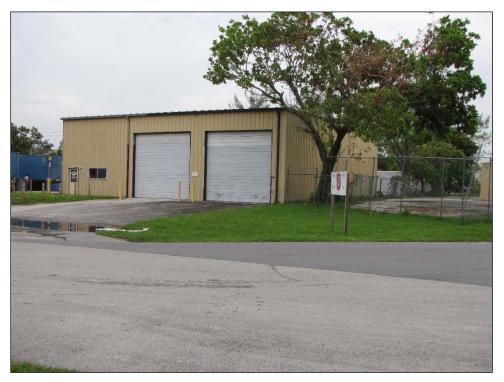
Figure 31 | Salvation Army Complex (8BD6347), Warehouse 4, c. 1985, looking West

This Industrial Vernacular building sits just north of the Adult Rehabilitation Center. It has a simple form and was constructed c. 1985 with a metal steel frame covered in metal siding (**Figure 31**). The north and south sides are blank with no window or door openings. The west side of the building is not visible. The east side has a simple metal door in the southeast corner with a two-light sliding window to its right. There are also two large bays with rolling garage doors on the east side. The roof is side-gabled and covered in standing seam metal sheets.

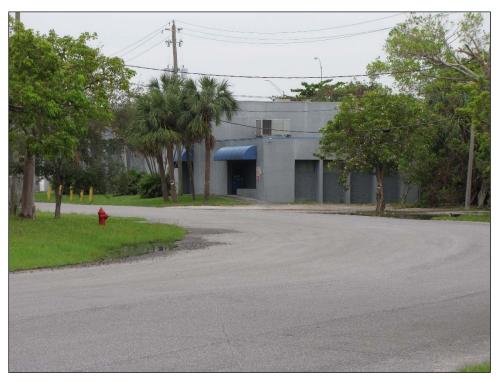
Office 2

This two-story Masonry Vernacular building sits in the northwest corner of the property along the North Fork of the New River (**Figure 33**). It was constructed c. 1985 of concrete block and is covered in grey stucco. The building has an irregular form, and the west portion of the building was formerly a warehouse. The north and west sides of the building are not visible. The east portion of the building is only one-story tall, and contains both the main and secondary entrances recessed along its south side. The east side has four recessed bays with metal, one-light fixed windows at the top. The east-facing main entrance is a metal door with a square light recessed in the southeast corner under a canvas awning. There are four south-facing thin vertical windows recessed in the same space. The south-facing secondary entrance is a simple metal door to the left of the main entrance. It is also recessed and has a canvas awning. There were originally seven bays along the south side of the two-story portion of the building. Only the bay in the southwest corner has remained altered. The one directly to the right of it was completely enclosed with plain stucco. Each of the remaining five bays to the right were enclosed with scored stucco and a row of five four-light awning windows at the top. Both portions of the building have a flat, built-up roof.

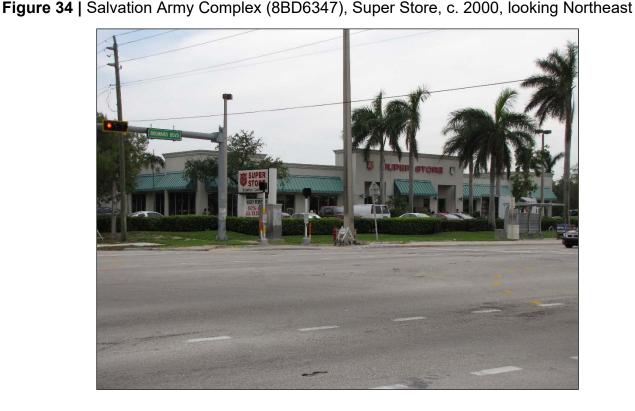
This Masonry Vernacular building sits just east of the Adult Rehabilitation Center, at the northeast corner of W Broward Boulevard and NW 18th Avenue. The Super Store was constructed c. 2000 of concrete blocked and covered in stucco (**Figure 34**). The building is generally rectangular; however, the southwest and southeast corners extend out slightly. There are storefront windows that run from just north of and around the southwest corner, along the south side, around the southeast corner, and ending just north of the southeast corner. There are metal awnings over the windows. The south-facing commercial glass double doors with transom and side lights sits amongst the storefront windows under a portico. A two-story entry portico is located centrally along the south side, and is taller than the rest of the building. Other than the storefront windows, the east and west sides are blank with no other openings. The north side has a simple metal door and a loading bay with rolling garage door in the northeast corner. There are stucco walls around the AC units on the north side. Most of the area around the Super Store is paved for parking. The building has a flat, built-up roof.

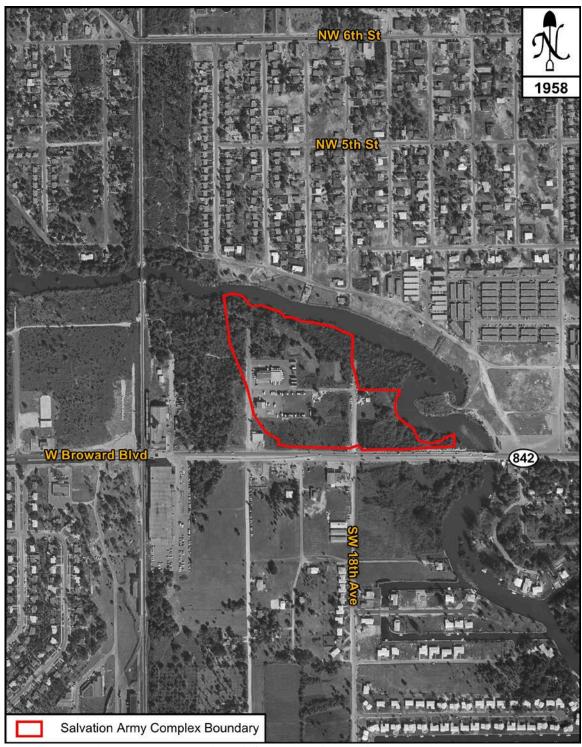
Figure 1: 1958 aerial of Salvation Army Complex (8BD6347)

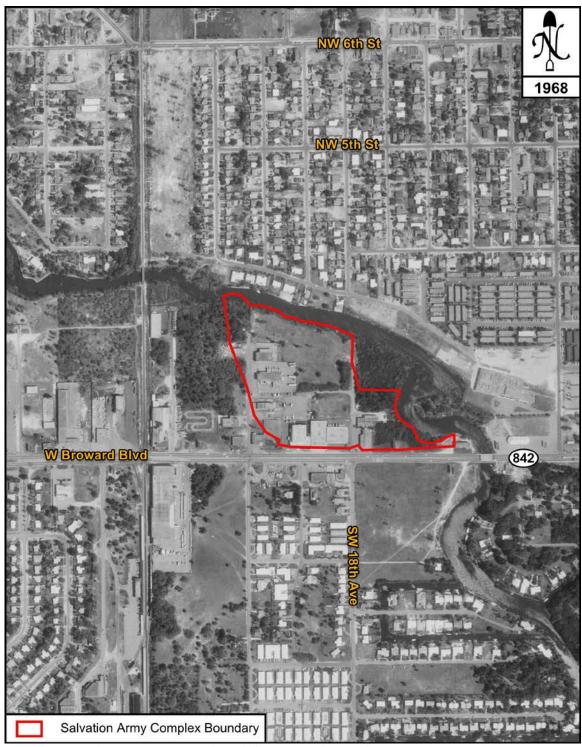
Figure 2: 1968 aerial of Salvation Army Complex (8BD6347)

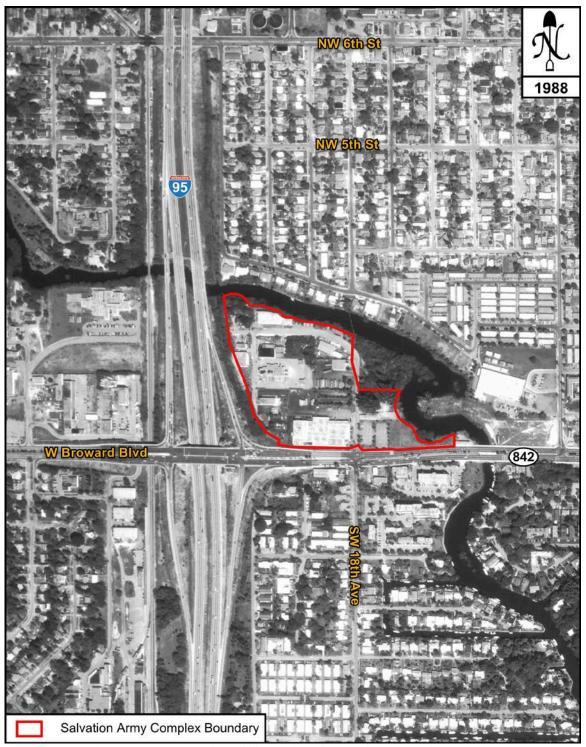
Figure 3: 1988 aerial of Salvation Army Complex (8BD6347)

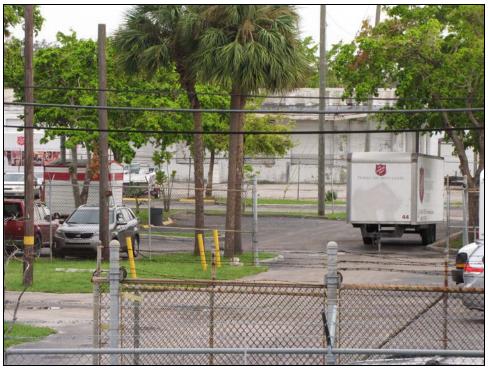
Figure 5: Salvation Army Complex (8BD6347), Warehouse 1, c. 1957, looking North

Warehouse 1 is the oldest building on the complex having been constructed c. 1957 (Figure 5). This one and a half story Masonry Vernacular warehouse was built in two phases. The west half of the building was completed c. 1957, and shortly after in 1958 the east half of the building was completed. The building is constructed of concrete block painted white. There are nine bays with rolling garage doors on each of the north and south sides. The windows on the west end of the building have iron security bars, which make it impossible to see what style the windows are. There is a set of stairs with a small platform leading to a metal door on the west side. That is the only known entrance, because the east side of the building is not visible. There are flat roof overhangs on the north, east, and south sides of the east half of the building. The building has a flat built-up roof.

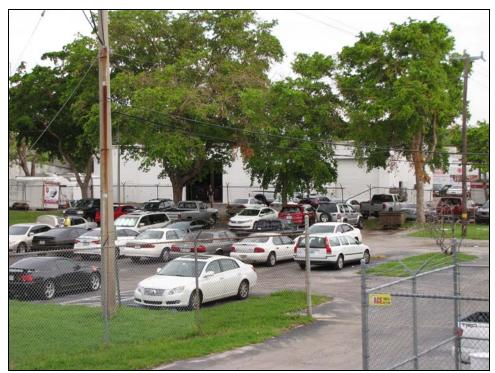
Figure 6: Salvation Army Complex (8BD6347), Warehouse 2, c. 1967, looking Northwest

This one and a half story Masonry Vernacular building sits just south of Warehouse 1. It was constructed c. 1967 of concrete block covered in white stucco (Figure 6). There are two bays with rolling garage doors on each of the north and south sides. The building has no windows, and there is no other visible entrance. The west end of the building is only one story tall with no windows or doors, and its purpose is unclear. The building has a flat, built-up roof.

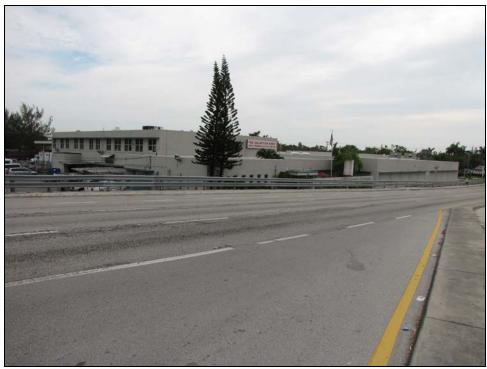
Figure 7: Salvation Army Complex (8BD6347), Adult Rehabilitation Center, c. 1967, looking Northeast

This Masonry Vernacular building sits southeast of Warehouses 1 and 2, at the northwest corner of W Broward Boulevard and NW 18th Avenue. It was once a warehouse, but is currently used as the Salvation Army Adult Rehabilitation Center (Figure 7). This building was constructed c. 1967 of concrete block and is covered in brick painted grey. It has always been irregularly shaped, originally having four large connected massings. The two-story portion of the building in the northwest corner was likely the original office. It has evenly spaced one-over-one single-hung-sash windows on the east side of the second story. The west side has several single door entrances on the first floor and double windows on the second floor. There are only two windows on the south side of the second story. All the windows sit under flat roof overhangs.

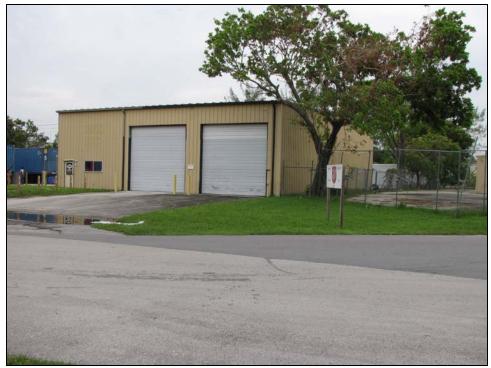
Figure 8: Salvation Army Complex (8BD6347), Warehouse 4, c. 1985, looking West

The original east portion of the building was extended south c. 1980, so that its south side was in line with the south side of the central portion of the building. The extension is five bays wide like the central portion. On the east side of the extension, which is not in line with the original east side, has a metal double door entrance. The original east side is blank except for three one-light fixed windows. There are flat roof overhands along the south and east sides of the east portion. The north side continues to be used as a loading dock, as this is currently the donation drop off location. The raised loading dock is L-shaped along the north side of the east portion and the east side of the original central portion of the building. Due to low visibility it's unclear exactly how many bays are recessed in the raised loading dock, but there are at least two bays. One bay is east-facing, and the other is north-facing. The loading dock has a flat roof extension with four supports along the north side, and a ramp at the northeast corner.

All portions and additions of the building have flat, built-up roofs Most of the area around the Adult Rehabilitation Center has been paved for parking and loading. There have been several alterations and addition to this building. Most of the windows appear to have been replaced in the 1980s. The main south-facing entrance was likely altered to accommodate the 1980s commercial glass double doors and window wall. Many other doors also appear to be 1980s replacements. Despite substantial additions and surrounding development, the south front of the building retains much of its historic feel.

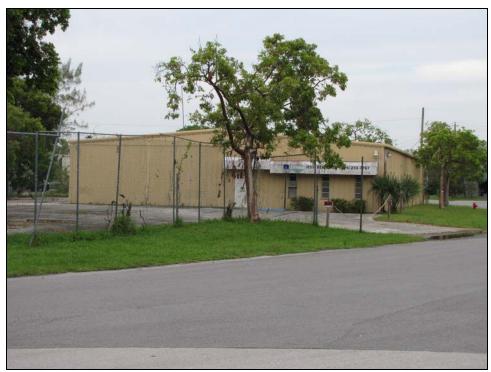
Figure 9: Salvation Army Complex (8BD6347), Office 1, c. 1978, looking Northwest

This Industrial Vernacular building sits just northwest of Warehouse 4 (Figure 9). It has a simple form and was constructed c. 1978 with a metal steel frame covered in metal siding. The northwest side is blank with no window or door openings. The northeast side has six five-light awning windows, three in the center and three on the left side. The southwest side is not visible. The entrance is a simple metal door on the southeast side, which sits under a canvas awning. There is a similar awning over the three windows. The three windows are five-light awning similar to those on the northeast side. The front-gabled roof is covered in 5V crimped metal sheets.

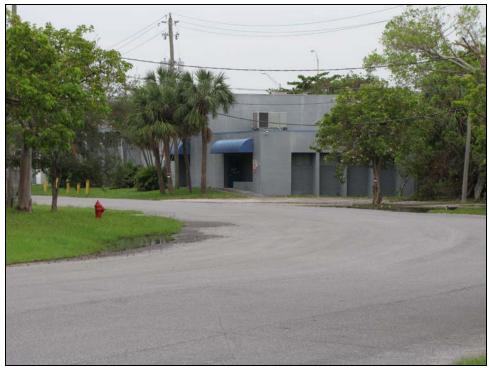
Figure 10: Salvation Army Complex (8BD6347), Office 2, c. 1985, looking West

This two-story Masonry Vernacular building sits in the northwest corner of the property along the North Fork of the New River (Figure 10). It was constructed c. 1985 of concrete block and is covered in grey stucco. The building has an irregular form, and the west portion of the building was formerly a warehouse. The north and west sides of the building are not visible. The east portion of the building is only one-story tall, and contains both the main and secondary entrances recessed along its south side. The east side has four recessed bays with metal, one-light fixed windows at the top. The eastfacing main entrance is a metal door with a square light recessed in the southeast corner under a canvas awning. There are four south-facing thin vertical windows recessed in the same space. The south-facing secondary entrance is a simple metal door to the left of the main entrance. It is also recessed and has a canvas awning. There were originally seven bays along the south side of the two-story portion of the building. Only the bay in the southwest corner has remained altered. The one directly to the right of it was completely enclosed with plain stucco. Each of the remaining five bays to the right were enclosed with scored stucco and a row of five four-light awning windows at the top. Both portions of the building have a flat, built-up roof.

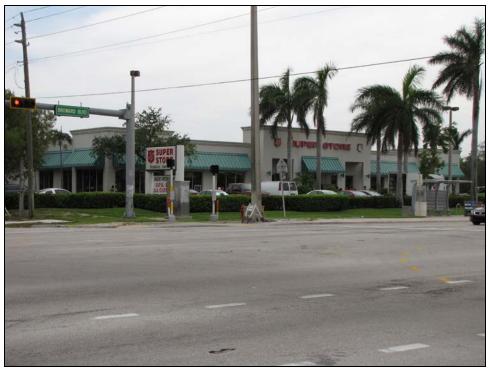
Figure 11: Salvation Army Complex (8BD6347), Super Store, c. 2000, looking Northeast
