Cultural Resource Assessment Survey Addendum

**SR 9/I-95 @ SR 842/Broward Boulevard (Broward
Boulevard from West of SW 24th Avenue to East of
NW/SW 18th Avenue)
Project Development & Environment (PD&E) Study**

Efficient Transportation Decision Making (ETDM) No.: 14226

**Broward County, Florida
Financial Project ID Number: 435513-1-22-02**

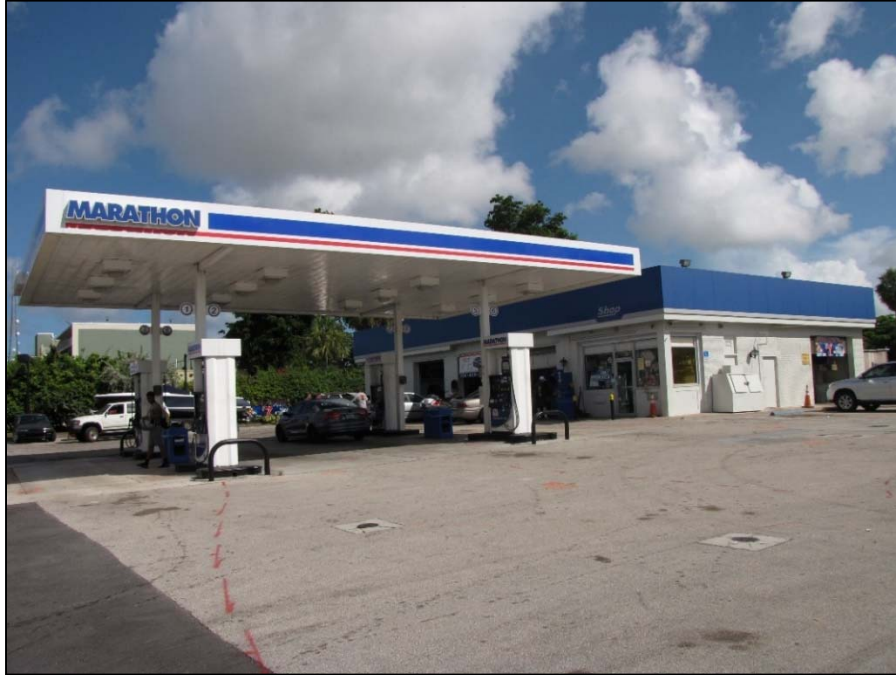
Figure 10 | Marathon Gas Station/1776 W Broward Boulevard (8BD6748), c. 1970, facing Southeast

Narrative Description of Resource This Masonry Vernacular commercial building has a simple form with few alterations. The pent-roof overhang was replaced, as well as the canopy over the gas pumps. The area around the building is commercial in nature.

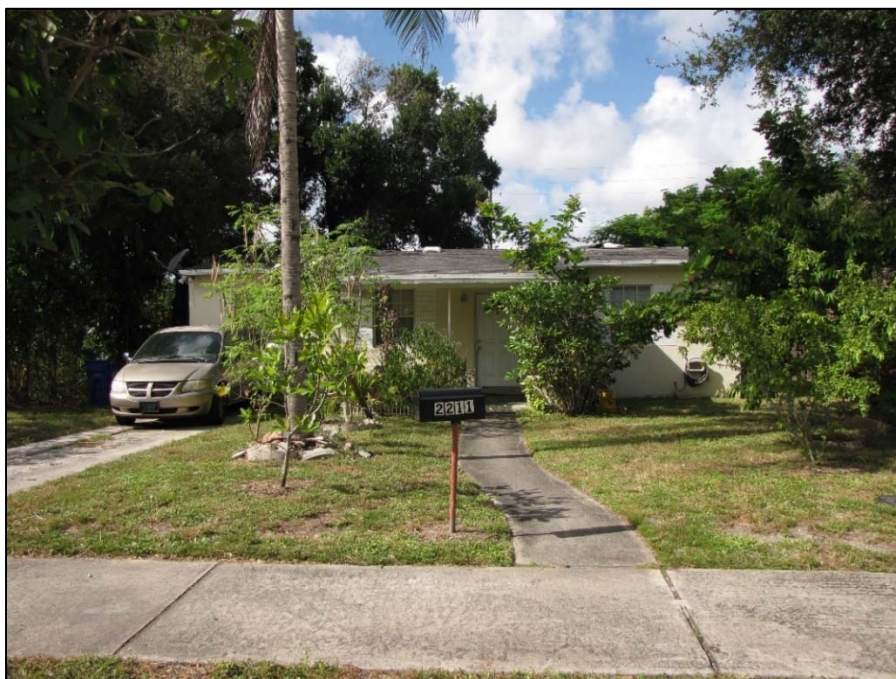
Figure 11 | 2211 SW 1st Court (8BD6749), c. 1953, facing North, exhibits enclosed carport, replaced windows and doors, and a north side addition

Narrative Description of Resource This Masonry Vernacular residence has a simple form with several alterations and one addition. In the 1990s the carport was enclosed, and the windows and doors were replaced. The area around the building is residential in nature.

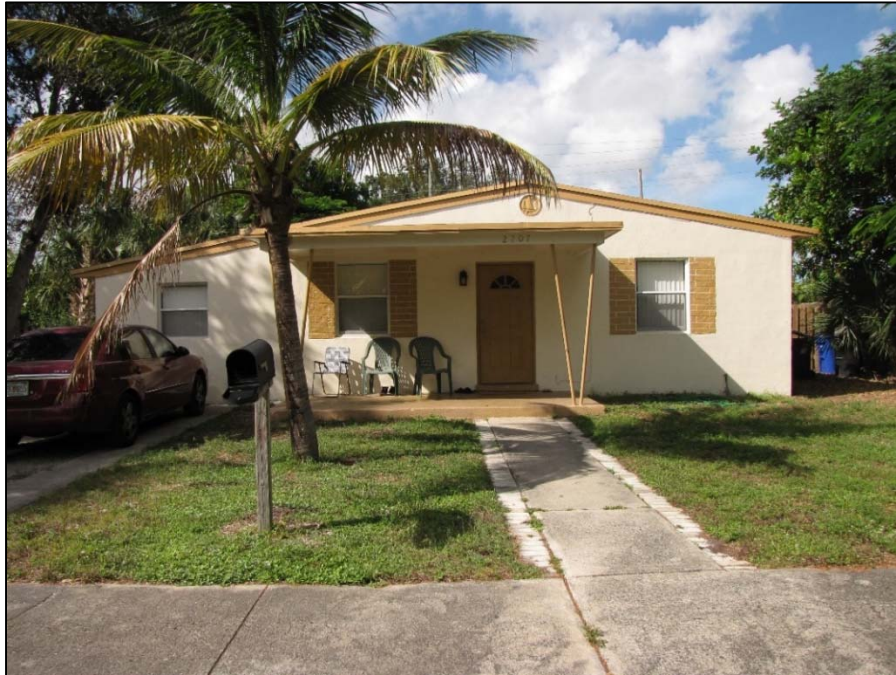
Figure 12 | 2207 SW 1st Court (8BD66750), c. 1953, facing North, exhibits enclosed carport, replaced windows and doors, and northwest corner addition

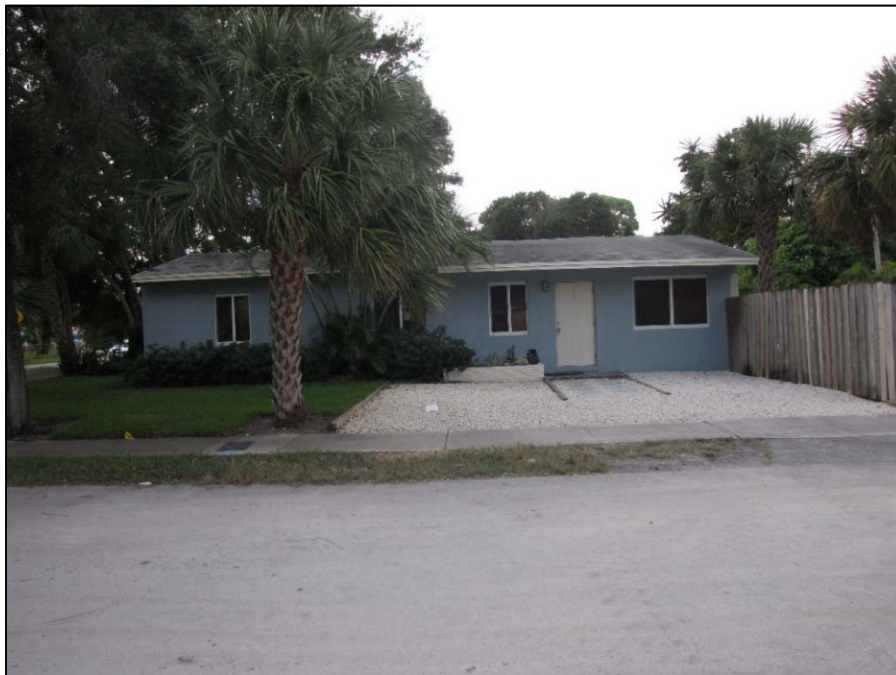
Figure 13 | 23 SW 22nd Avenue (8BD6751), c. 1952, facing West exhibits enclosed carport, replaced windows and doors, and northwest corner addition

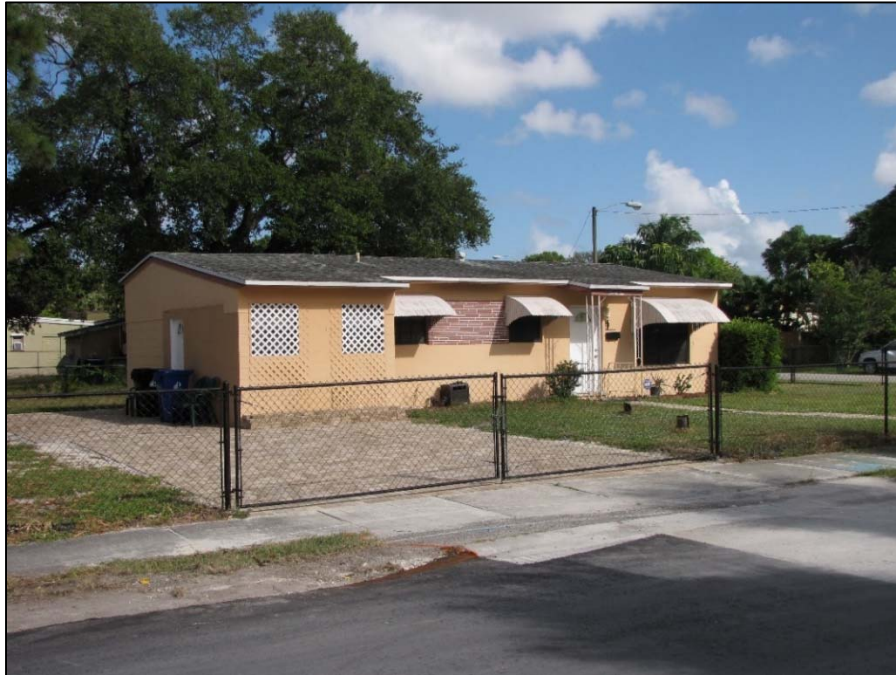
Figure 14 | 22 SW 22nd Avenue (8BD6752), c. 1954, facing Southeast, exhibits enclosed carport, replaced windows and doors

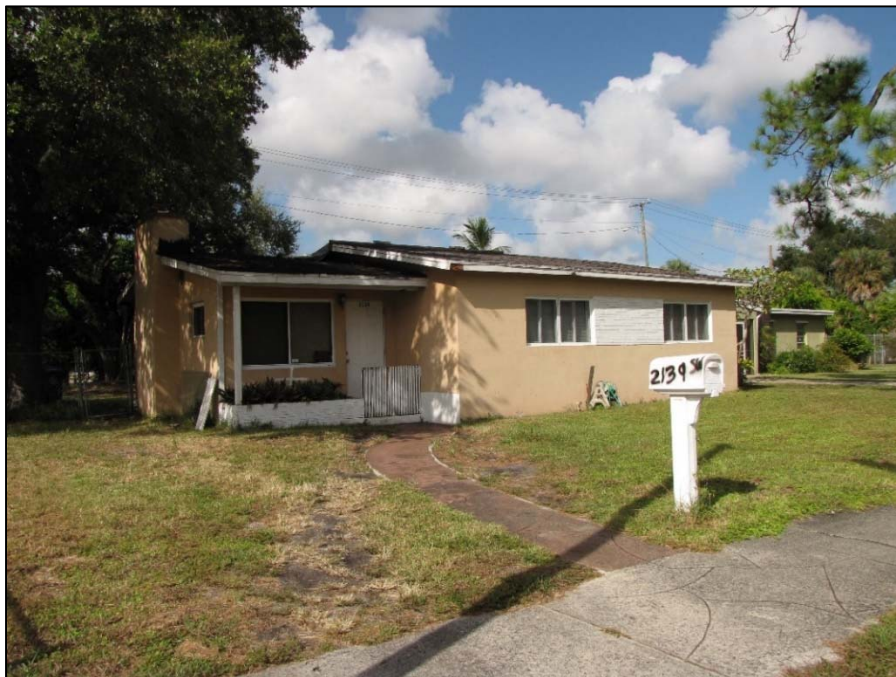
Figure 15 | 2139 SW 1st Court (8BD6753), c. 1952, facing Northeast, exhibits replaced windows and doors

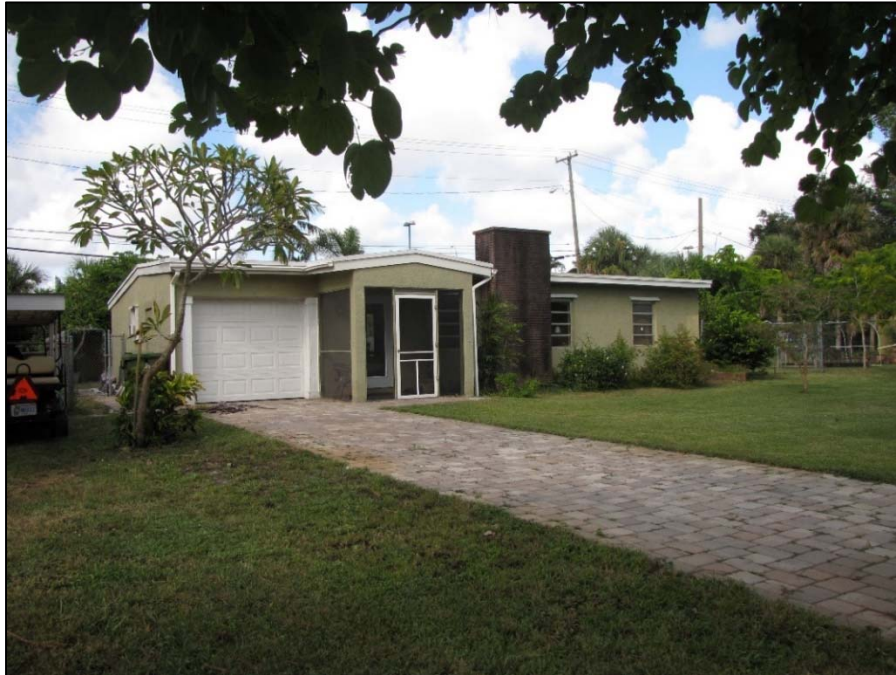
Figure 16 | 2133 SW 1st Court (8BD6754), c. 1952, facing Northeast, exhibits screened in porch, replaced windows and doors

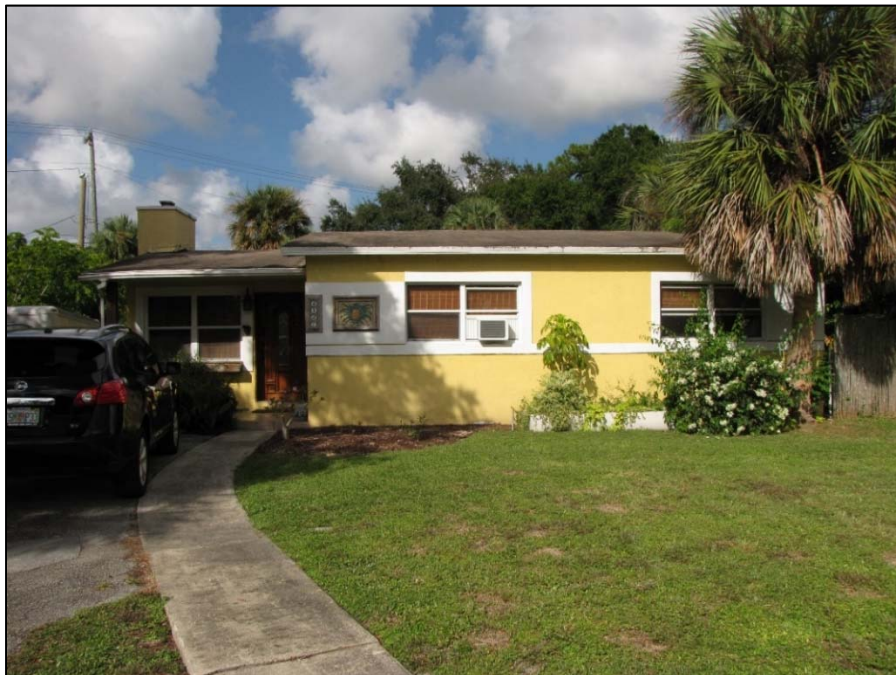
Figure 17 | 2127 SW 1st Court (8BD6755), c. 1958, facing Northeast, exhibits replaced windows and doors, northeast addition

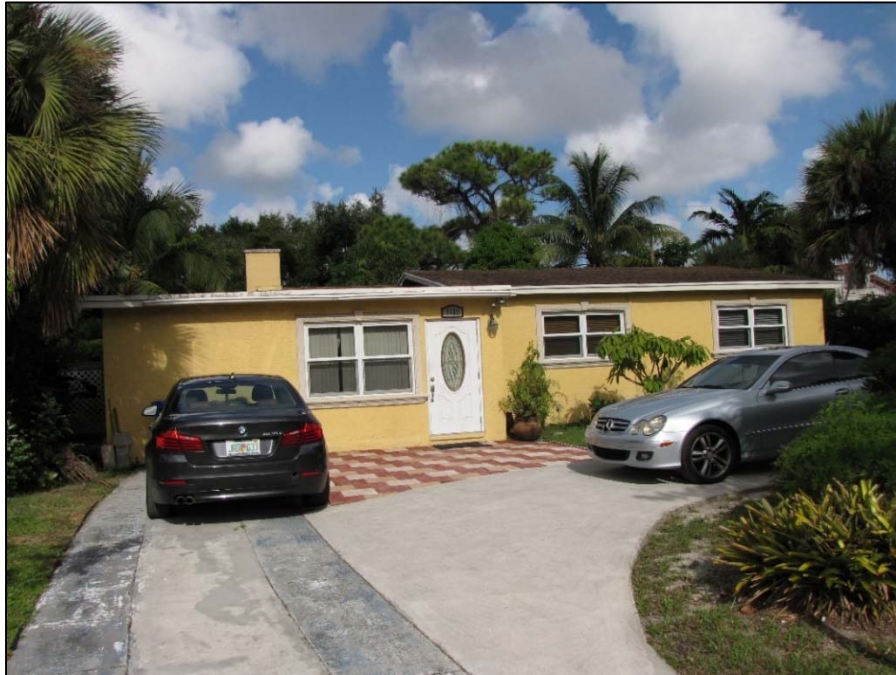
Figure 18 | 2121 SW 1st Court (8BD6756), c. 1953, facing East, exhibits replaced windows and doors, northwest corner addition

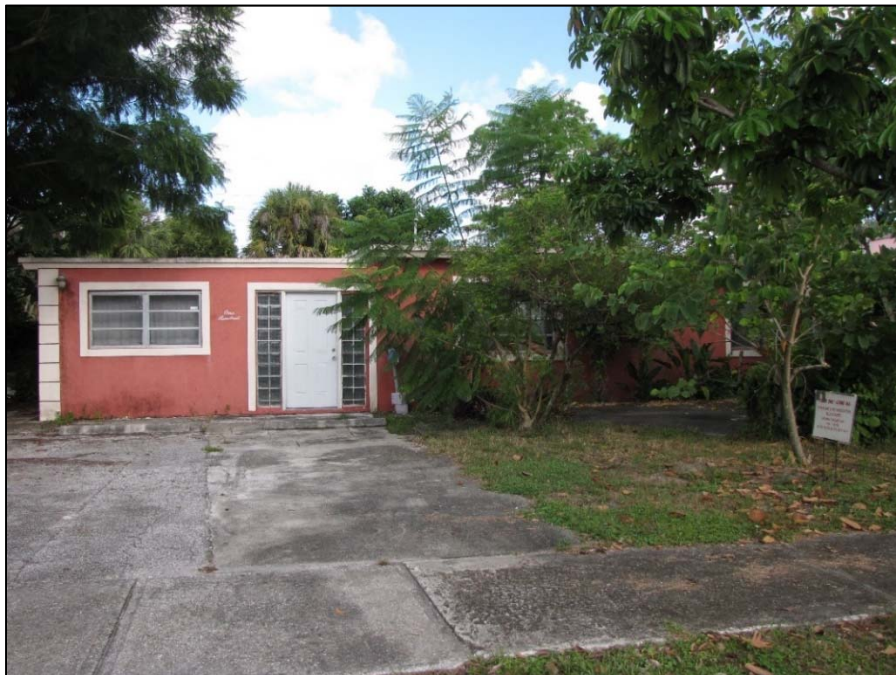
Figure 19 | 100 SW 21st Way (8BD6757), c. 1953, facing East, exhibits enclosed carport, replaced windows and doors, and southeast corner addition

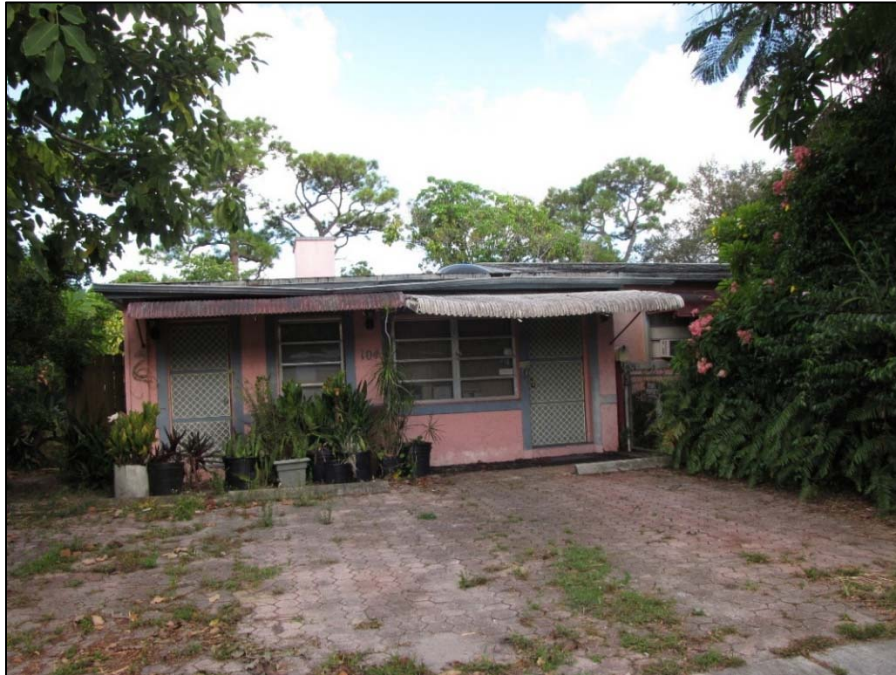
Figure 20 | 104 SW 21st Way (8BD6758), c. 1957, facing East, exhibits enclosed carport, replaced windows and doors, northwest corner addition, and east side addition

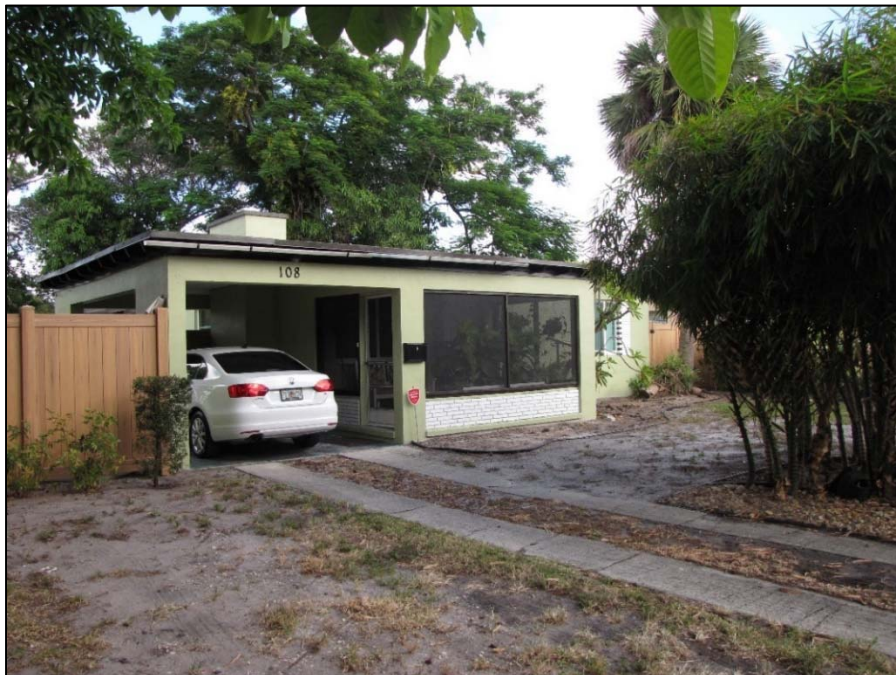
Figure 21 | 108 SW 21st Way (8BD6759), c. 1953, facing Southeast, exhibits enclosed carport, replaced windows and doors, northeast corner addition

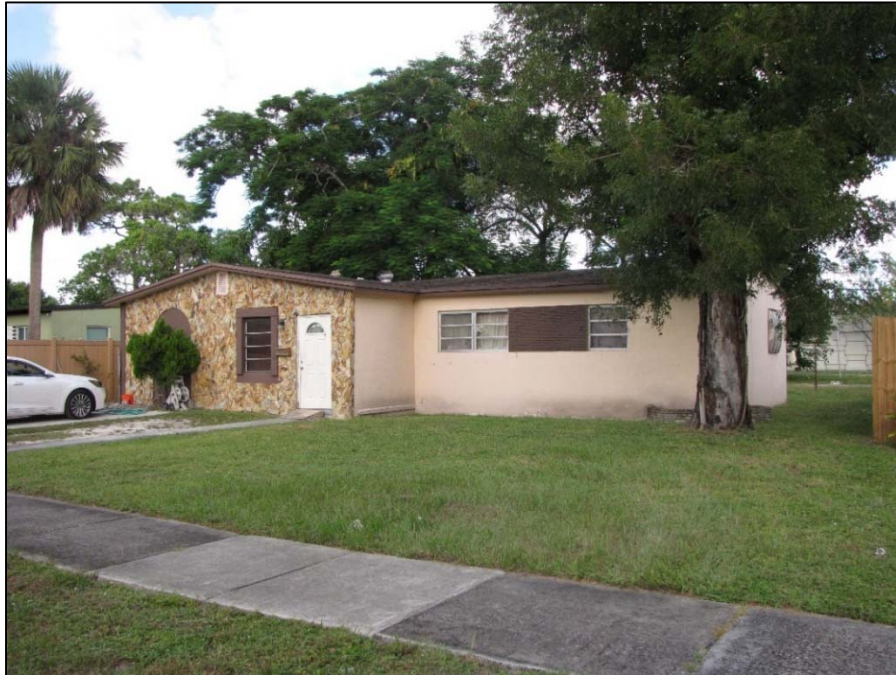
Figure 22 | 112 SW 21st Way (8BD6760), c. 1953, facing Northeast, exhibits enclosed carport, replaced windows and doors

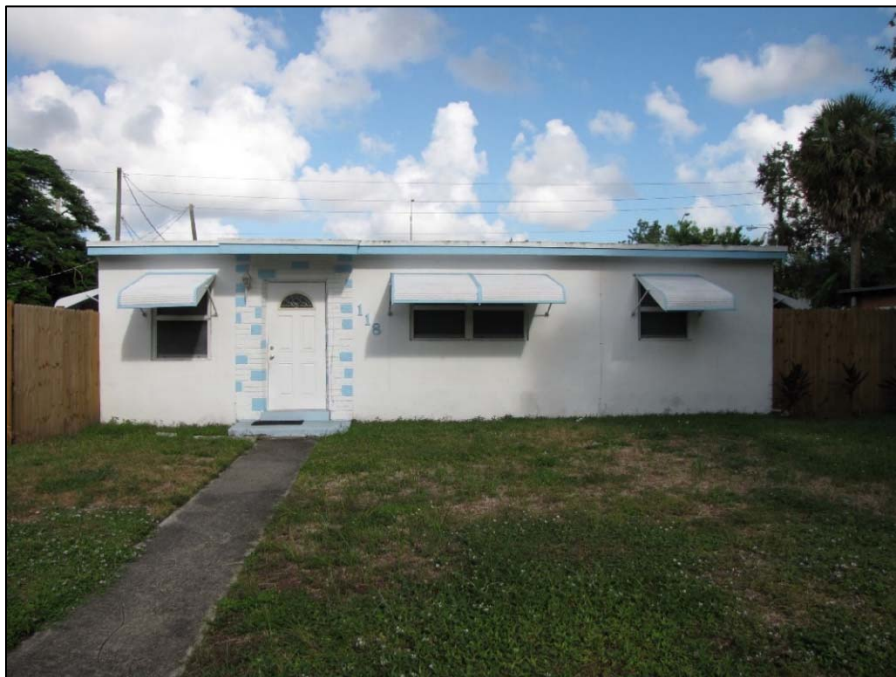
Figure 23 | 118 SW 21st Way (8BD6761), c. 1953, facing East, exhibits replaced windows and doors

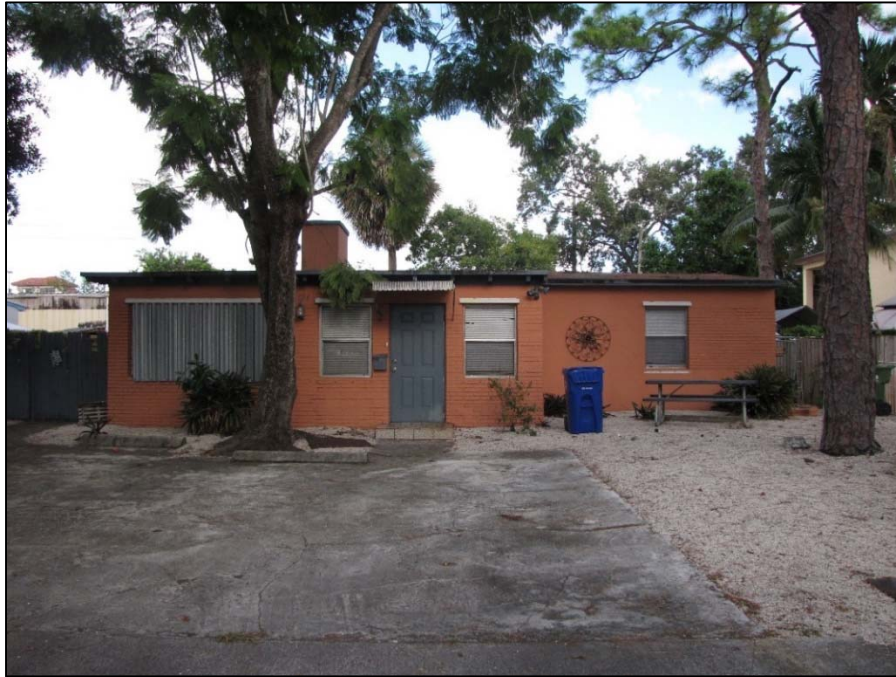
Figure 24 | 124 SW 21st Way (8BD6762), c. 1953, facing East, exhibits enclosed carport, replaced windows and doors

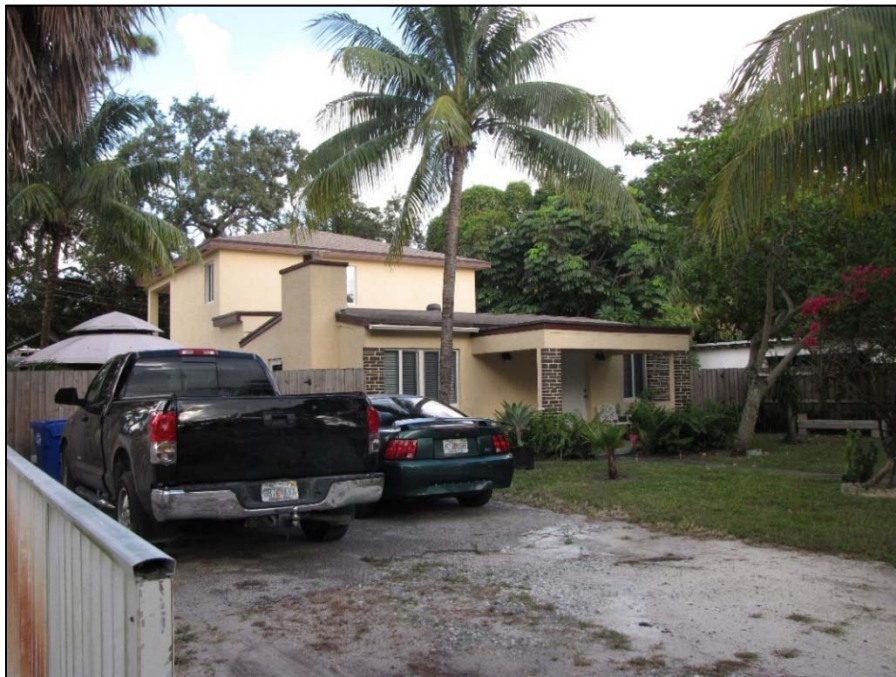
Figure 25 | 128 SW 21st Way (8BD6763), c. 1953, facing Southeast, exhibits replaced windows and doors, large two-story east side addition

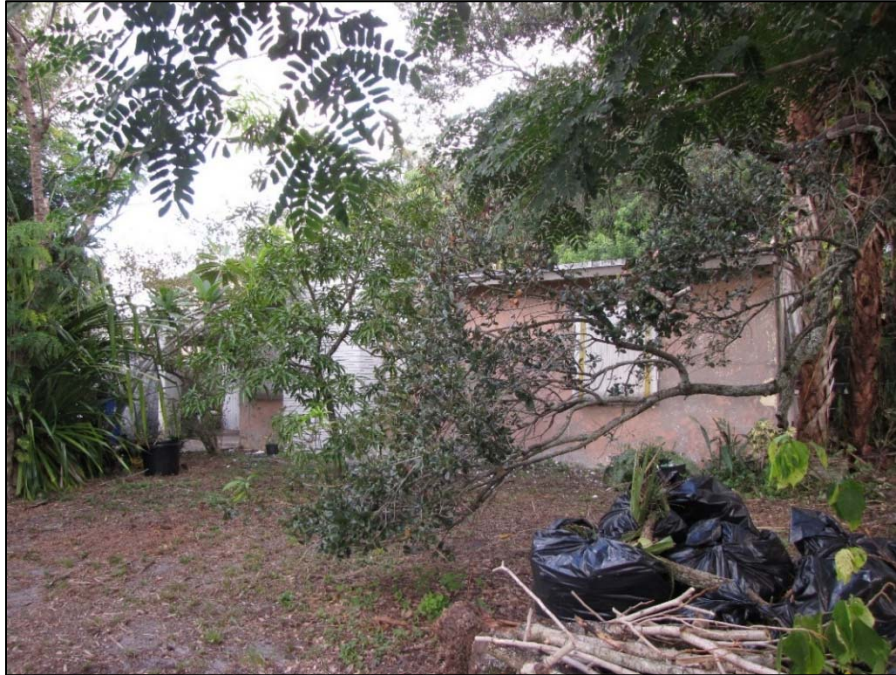
Figure 26 | 132 SW 21st Way (8BD6764), c. 1953, facing Northeast, exhibits replaced doors, added shutters

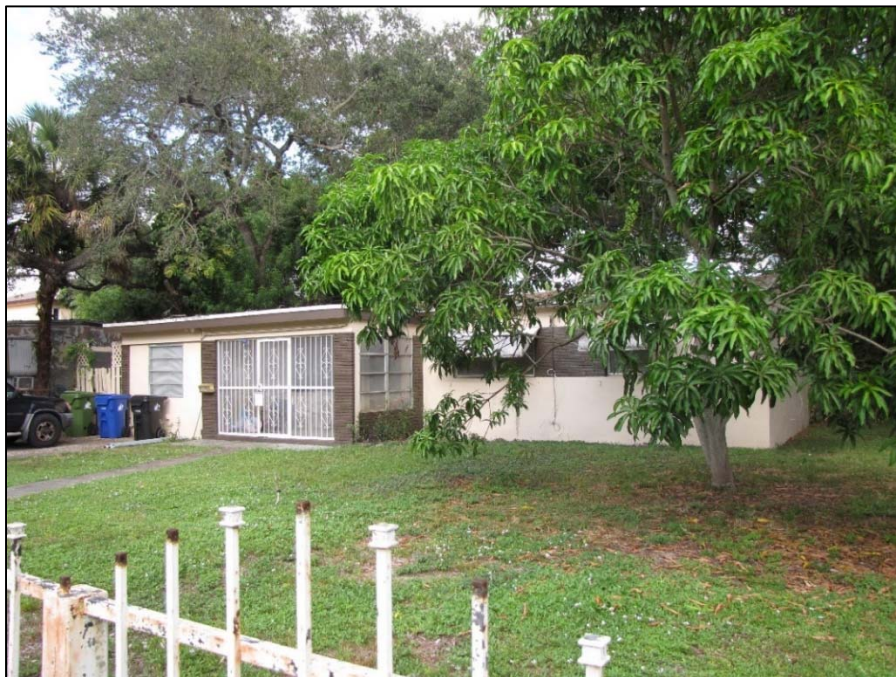
Figure 27 | 138 SW 21st Way (8BD6765), c. 1953, facing Northeast, exhibits enclosed porch, replaced windows and doors, northwest corner addition

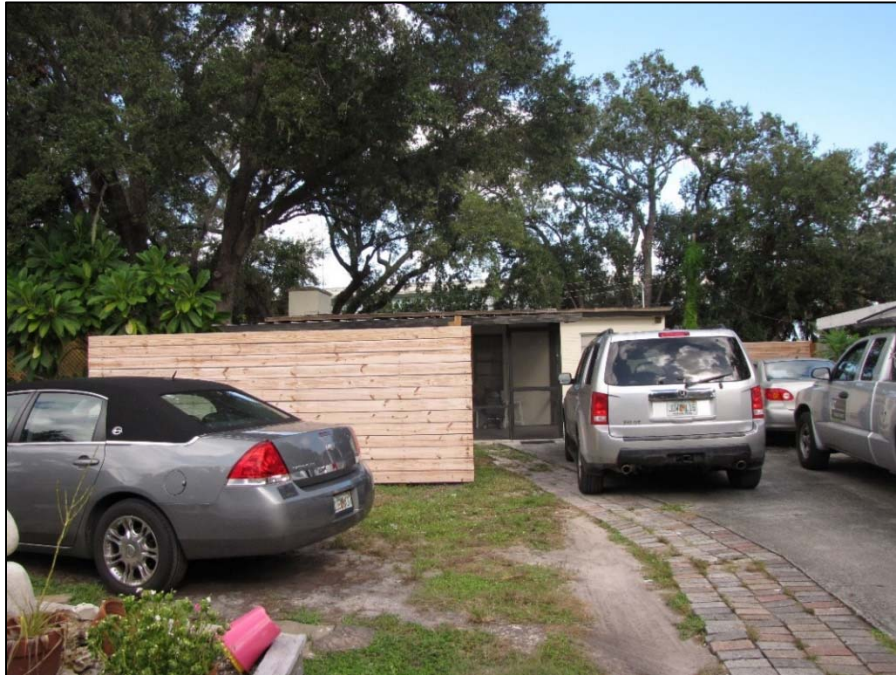
Figure 28 | 142 SW 21st Way (8BD6766), c. 1953, facing East, exhibits enclosed carport and porch, replaced windows and doors, west side screened porch addition

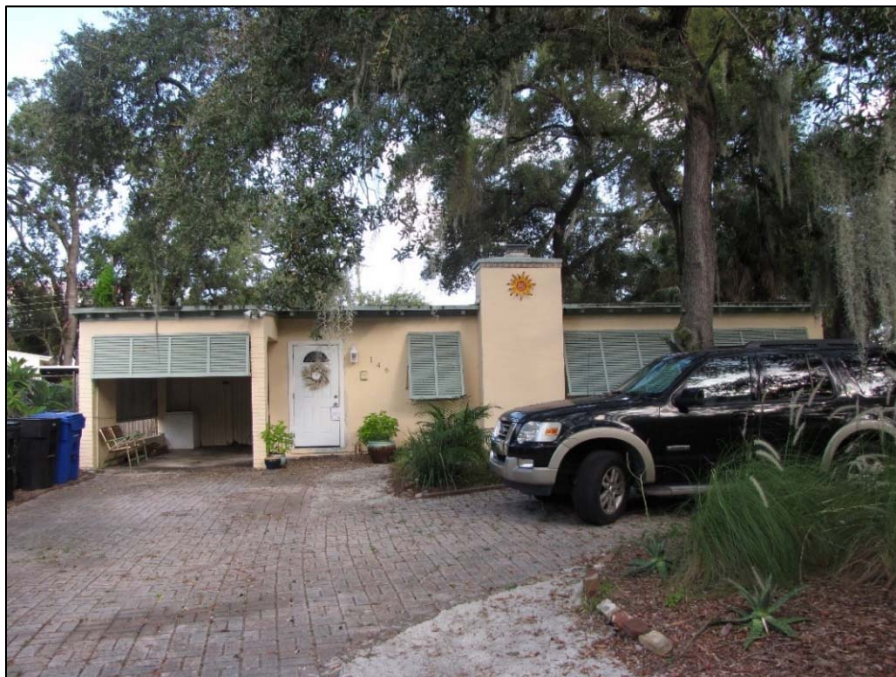
Figure 29 | 146 SW 21st Way (8BD6767), c. 1953, facing Southeast, exhibits replaced windows and doors

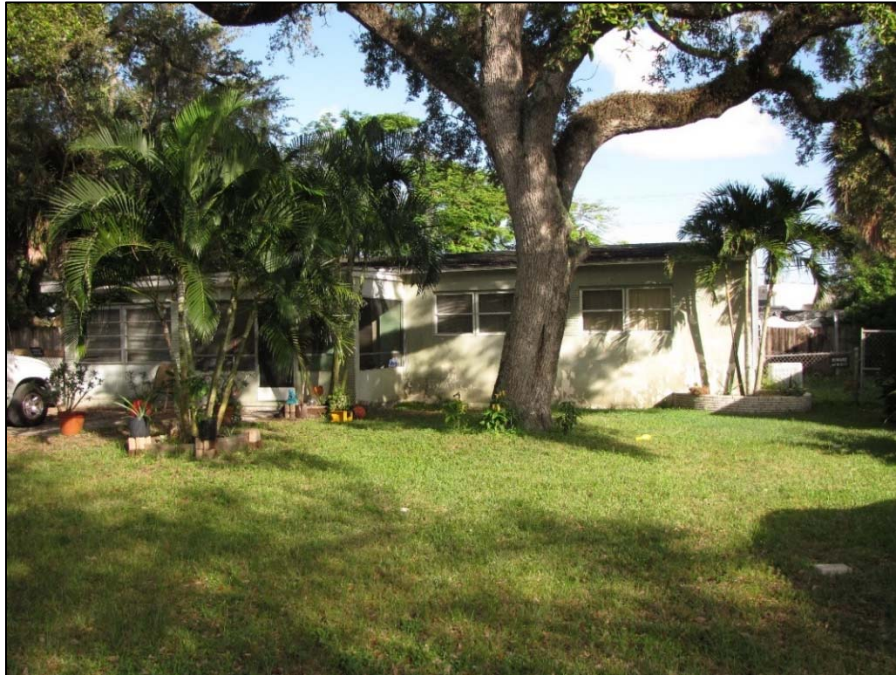
Figure 30 | 200 SW 21st Way (8BD6768), c. 1953, facing Northeast, exhibits enclosed carport, screened in porch, replaced windows and doors, northeast corner addition

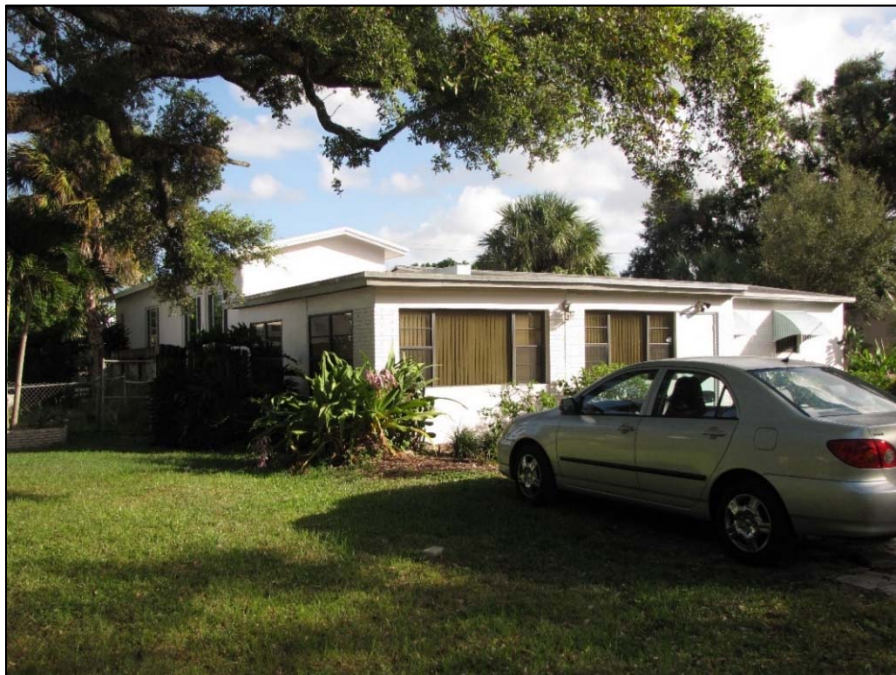
Figure 31 | 204 SW 21st Way (8BD6769), c. 1953, facing South, exhibits enclosed porch, replaced windows and doors, northwest and southwest corner additions

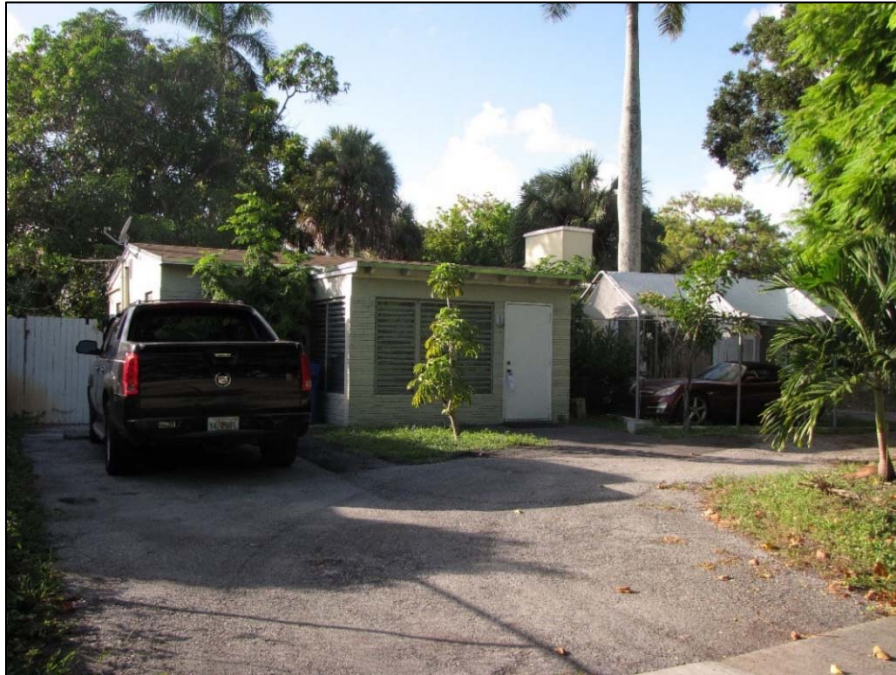
Figure 32 | 143 SW 21st Way (8BD6770), c. 1953, facing Northwest, exhibits enclosed porch, replaced windows and doors

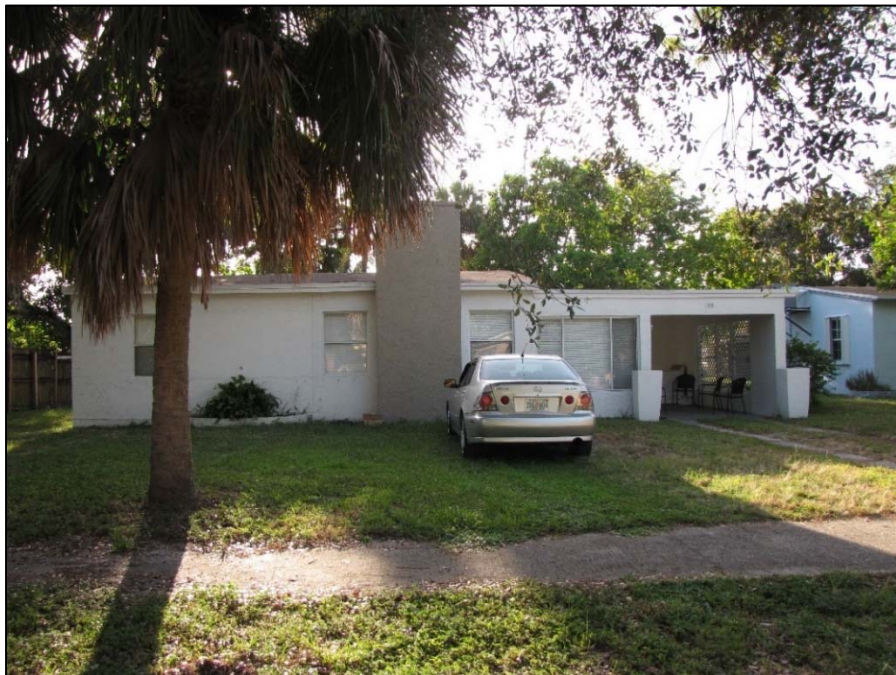
Figure 33 | 139 SW 21st Way (8BD6771), c. 1953, facing West, exhibits enclosed portion of carport, replaced windows and doors

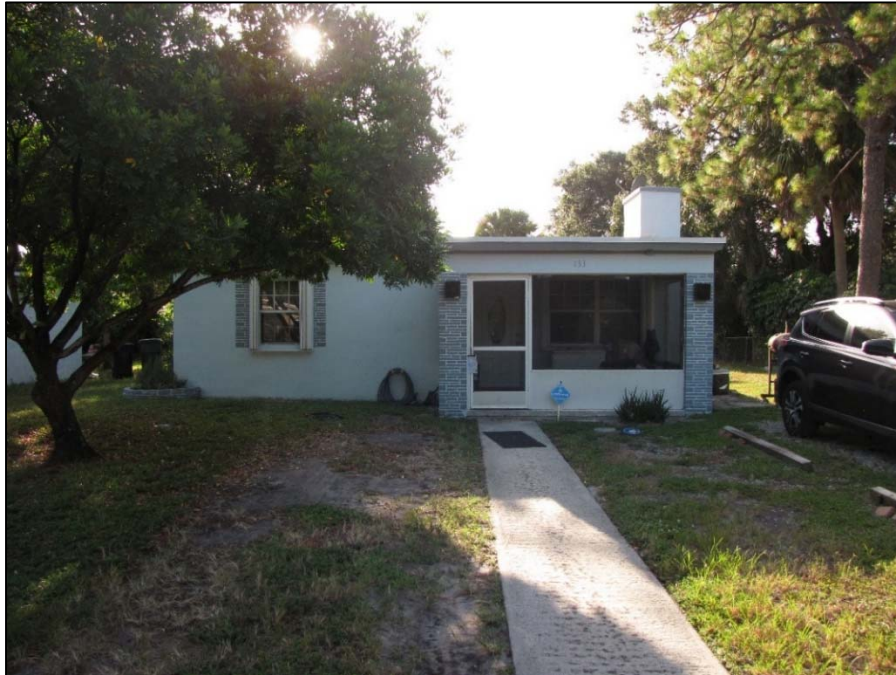
Figure 34 | 133 SW 21st Way (8BD6772), c. 1953, facing West, exhibits screened in porch, replaced windows and doors

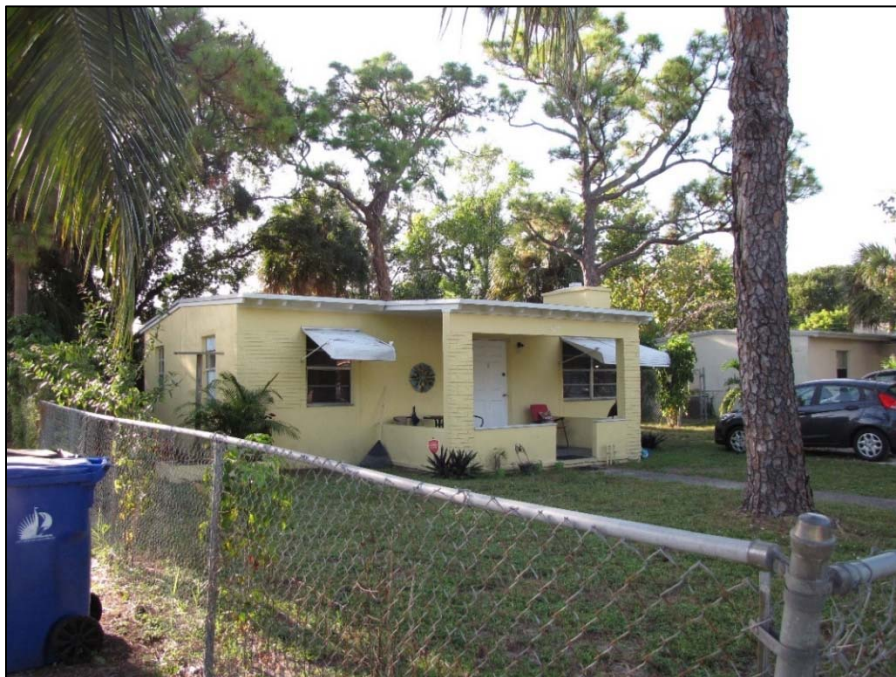
Figure 35 | 129 SW 21st Way (8BD6773), c. 1953, facing Northwest, exhibits replaced windows and doors

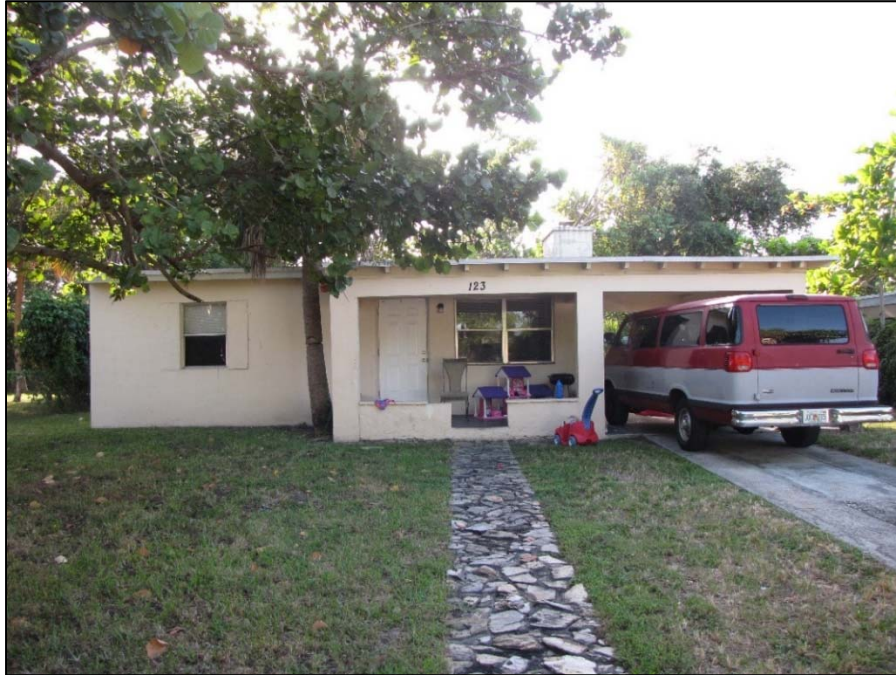
Figure 36 | 123 SW 21st Way (8BD6774), c. 1953, facing West, exhibits replaced windows and doors

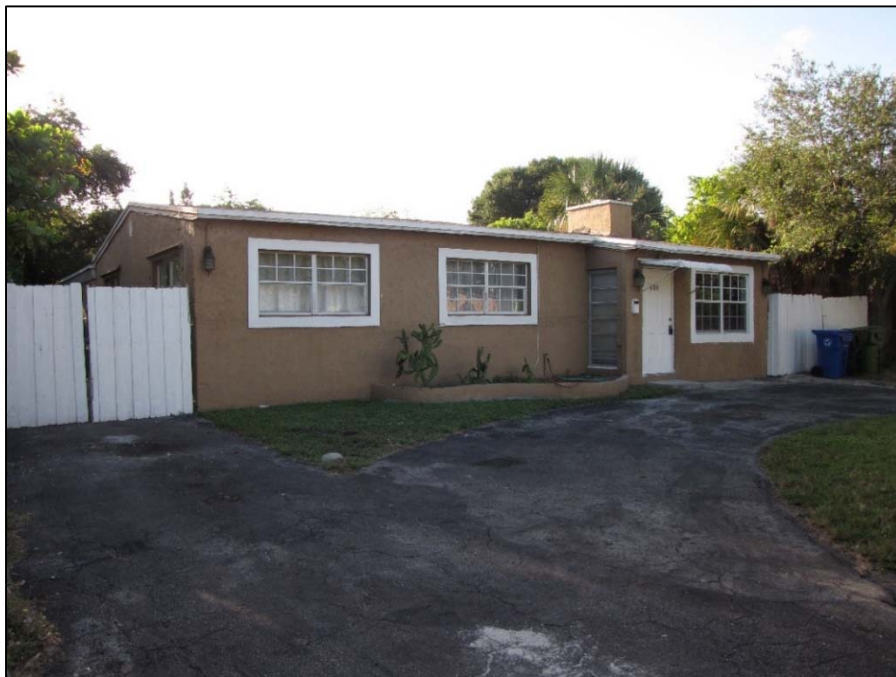
Figure 37 | 119 SW 21st Way (8BD6775), c. 1953, facing Northwest, exhibits enclosed porch, replaced windows and doors

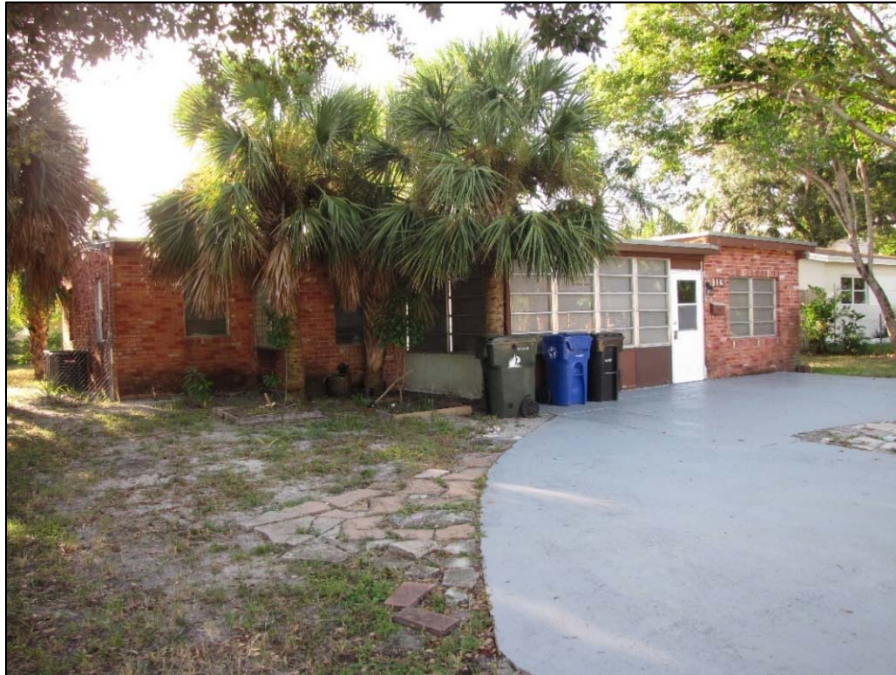
Figure 38 | 113 SW 21st Way (8BD6776), c. 1953, facing Northwest, exhibits enclosed carport and porch, replaced windows and doors

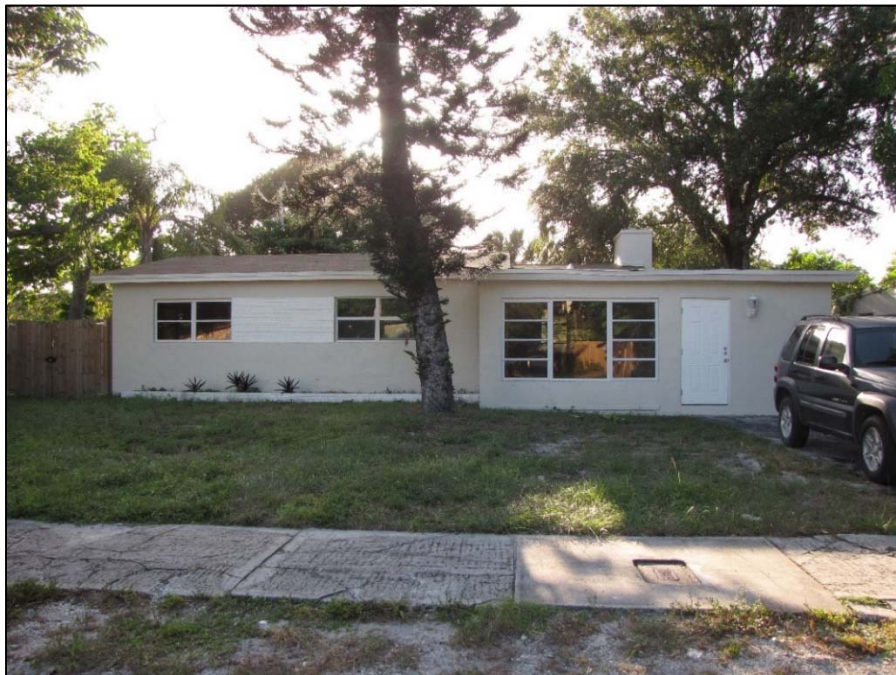
Figure 39 | 109 SW 21st Way (8BD6777), c. 1953, facing West, exhibits enclosed carport and porch, replaced windows and doors, northeast corner addition

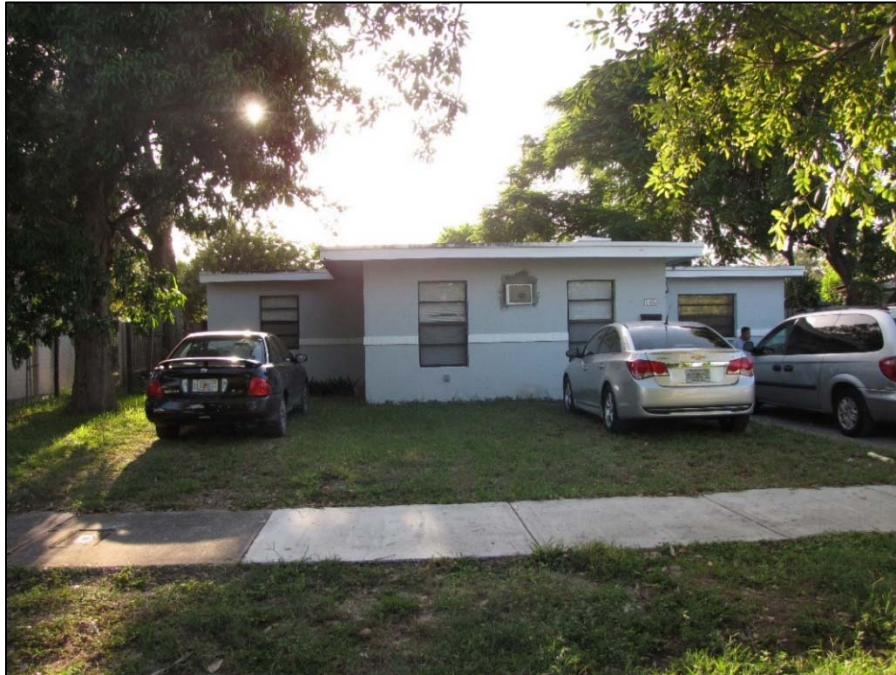
Figure 40 | 105 SW 21st Way (8BD6778), c. 1953, facing West, exhibits enclosed porch, replaced windows and doors

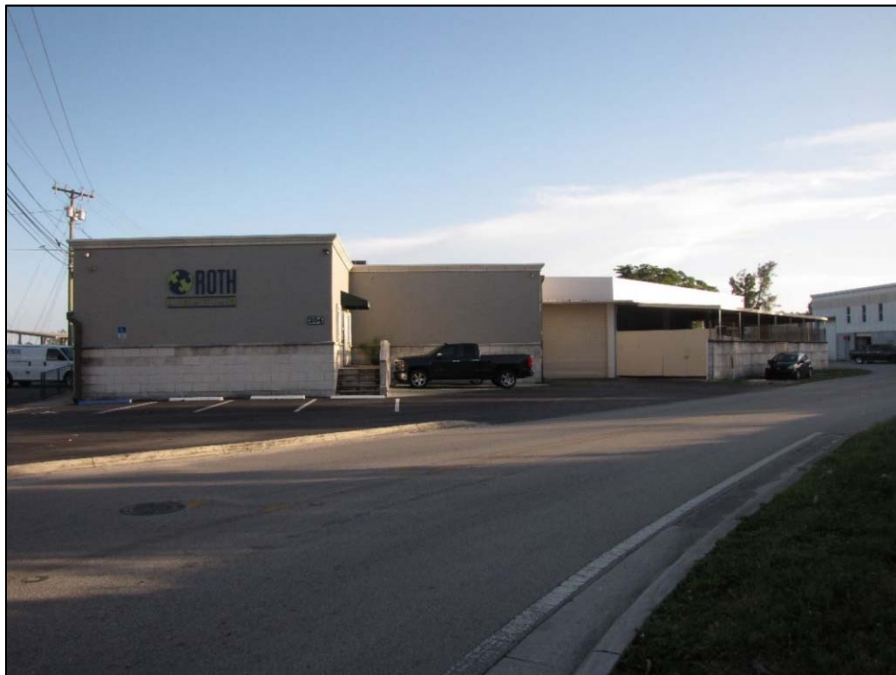
Figure 41 | Roth Lighting/204 SW 21st Terrace (8BD6779), c. 1959, facing South, exhibits replaced windows and doors, added decorative railing and stone at entrance
