# **Cultural Resource Assessment Survey**

SR 9/I-95 @ SR 842/Broward Boulevard (Broward Boulevard from West of SW 24<sup>th</sup> Avenue to East of NW/SW 18<sup>th</sup> Avenue)

Project Development & Environment (PD&E) Study

Broward County, Florida Financial Project ID Number: 435513-1-22-02

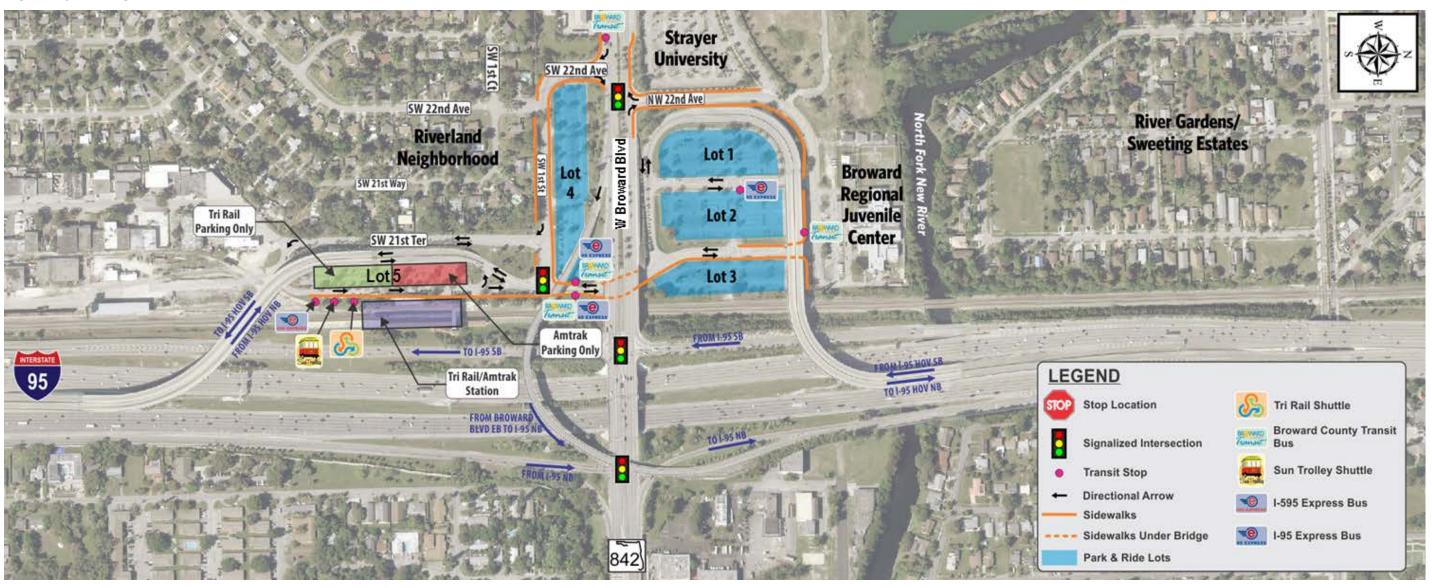
Figure 2 | Existing Park-and-Ride Conditions

Community Link). There is a Park-and-Ride lot located within the interchange area. The existing conditions at the Park-and-Ride lot include the provision of 794 parking spaces throughout five parking lots, shown in **Figure 2**. Spaces in Lot 5 are designated for Amtrak and Tri-Rail parking only while the spaces in Lots 1-4 are available for any purpose, including car pools and 95 Express Bus. There are no designated bicycle facilities within the Park-and-Ride lot and minimal sidewalk facilities. Access to the Park-and-Ride lots is provided via Broward Blvd. and I-95. Ingress from eastbound Broward Blvd. is provided via right turn lane at SW 22nd Ave/SW 1st St. Ingress from westbound Broward Blvd. is provided via right turn lanes at NW 22nd Ave. and NW 24th Ave. Egress to westbound Broward Blvd. is provided via the intersections with NW 22nd Ave. and NW 24th Ave., requiring drivers coming from the south to circulate through the northern parking areas. Egress to eastbound Broward Blvd. is provided via SW 22nd Ave/SW 1st St and NW 24th Ave.

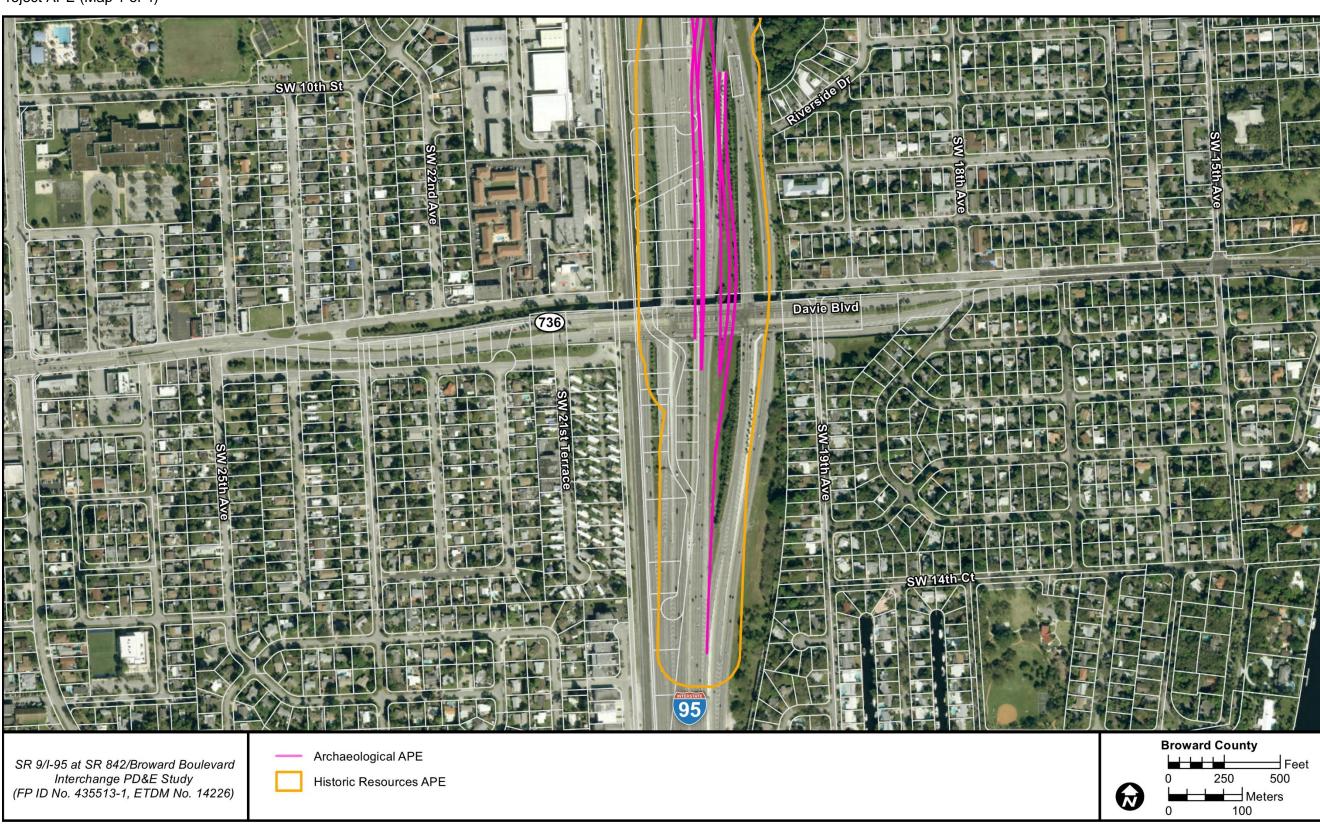
Figure 3a | Project APE (Map 1 of 4)

The historic resources APE is defined as the area within which potential effects for the improvements could be observed. The APE for historic resources where the improvements are within existing sound walls is limited to the existing ROW. The historic resources APE for improvements at grade is the footprint of the improvements and adjacent parcels within 150 feet. The historic resources APE is 250 feet from the footprint of improvements that include proposed elevated ramps. (**Figure 3a–d**).

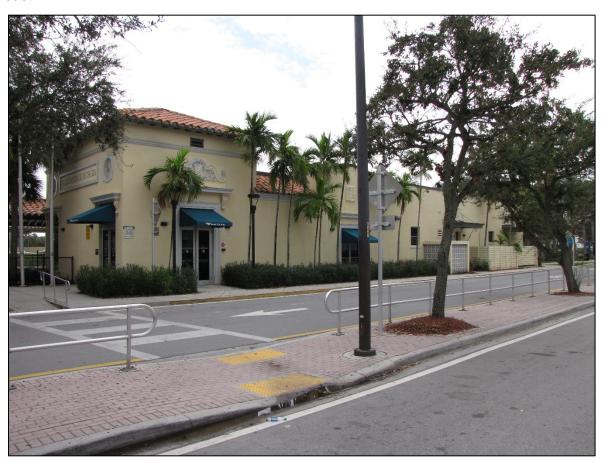
Figure 14 | Seaboard Airline Railroad Station, located at 200 SW 21st Terrace (8BD1452), facing Southeast

The circa-1926/1927 Seaboard Airline Railroad Station (8BD1452) (**Figure 14**) is located at 200 SW 21<sup>st</sup> Terrace and still serves its original purpose as a railroad station. It was designed by architect Gustav A. Maass in the Mediterranean Revival style, and is representative of the transportation boom that took place in Fort Lauderdale and across southeast Florida during the Boom Times of the 1920s. For significance under Criteria A and C in the areas of Transportation and Architecture, the SHPO determined on December 20, 1999 that the Seaboard Airline Railroad Station was eligible for listing in the National Register. This building is also locally-designated within the City of Fort Lauderdale.

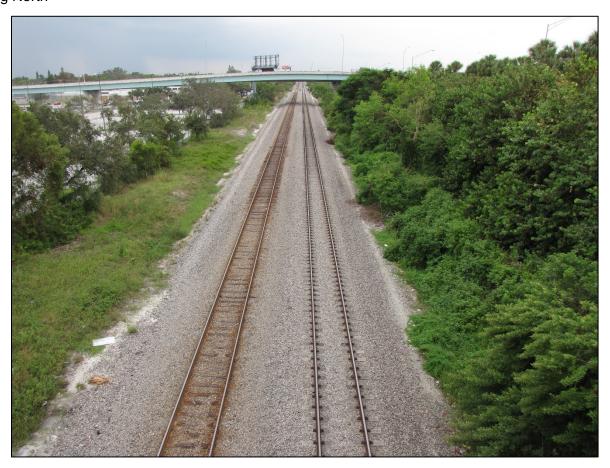
Figure 15 | Seaboard Air Line (CSX) Railroad (8BD4649), as seen from Broward Boulevard overpass, facing North

The segment of the Seaboard Air Line (CSX) Railroad (8BD4649) (**Figure 15**) within the APE is located between Sunrise Boulevard and SW 5<sup>th</sup> Place, and features a double-track configuration over a gravel ballast. The approximate 1.06 miles of tracks within the APE maintains its historic orientation and configuration and is significant for its contributions to the patterns of development and transportation in the State. Therefore, the SHPO determined on March 27, 2013 that the current segment of the Seaboard Air Line (CSX) Railroad was eligible for listing in the National Register under Criterion A in the areas of Community Planning and Development and Transportation.

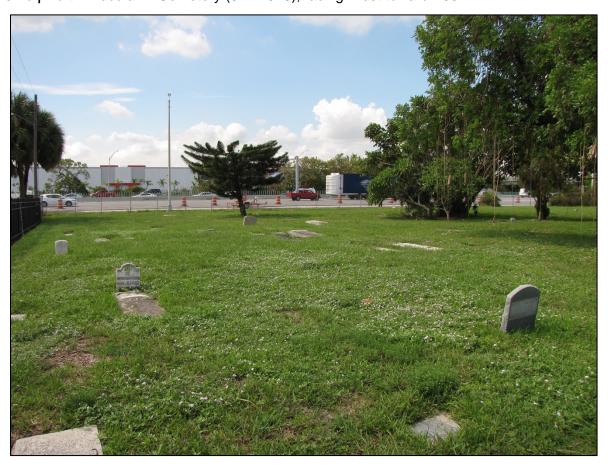
Figure 16 | North Woodlawn Cemetery (8BD4879), facing West toward I-95

North Woodlawn Cemetery (8BD4879) (**Figure 16**) was established in 1926, and is located on the west side of NW 19<sup>th</sup> Avenue, between NW 9<sup>th</sup> Street and Sunrise Boulevard. The cemetery serves as the final resting place for many of the areas pioneering African American residents. It was the only cemetery in Fort Lauderdale where African Americans could be buried until 1962 (Janus Research 2012). North Woodlawn Cemetery possesses local significance under Criterion A in the area of ethnic heritage, for its connection to the early African American community in the northwest quadrant Fort Lauderdale. The cemetery also meets National Register Criteria Consideration D for its connection to historical events, as it is one of the few remaining resources associated with Fort Lauderdale's African American community during the period of racial segregation. North Woodlawn Cemetery was determined eligible for the National Register by the SHPO on March 27, 2013. The cemetery has already passed the state review board and is currently being reviewed for listing in the National Register by the national review board as of the time of this report. North Woodlawn Cemetery is also locally-designated within the City of Fort Lauderdale.

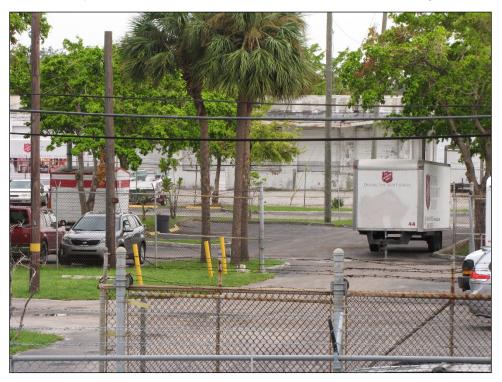
Figure 21 | Salvation Army Complex (8BD6347), Warehouse 1, c. 1957, looking North

Warehouse 1 is the oldest building on the complex having been constructed c. 1957 (**Figure 21**). This one and a half story Masonry Vernacular warehouse was built in two phases. The west half of the building was completed c. 1957, and shortly after in 1958 the east half of the building was completed. The building is constructed of concrete block painted white. There are nine bays with rolling garage doors on each of the north and south sides. The windows on the west end of the building have iron security bars, which make it impossible to see what style the windows are. There is a set of stairs with a small platform leading to a metal door on the west side. That is the only known entrance, because the east side of the building is not visible. There are flat roof overhangs on the north, east, and south sides of the east half of the building. The building has a flat built-up roof.

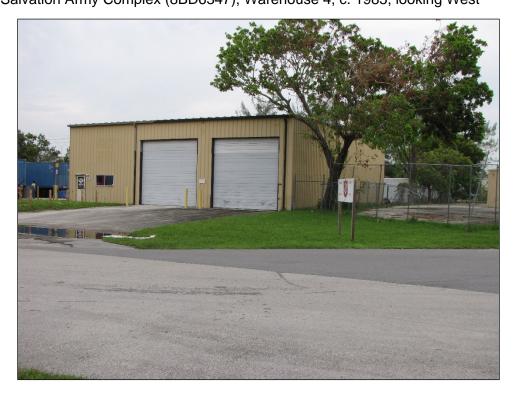
Figure 24 | Salvation Army Complex (8BD6347), Warehouse 4, c. 1985, looking West

This Industrial Vernacular building sits just north of the Adult Rehabilitation Center. It has a simple form and was constructed c. 1985 with a metal steel frame covered in metal siding (**Figure 24**). The north and south sides are blank with no window or door openings. The west side of the building is not visible. The east side has a simple metal door in the southeast corner with a two-light sliding window to its right. There are also two large bays with rolling garage doors on the east side. The roof is side-gabled and covered in standing seam metal sheets.

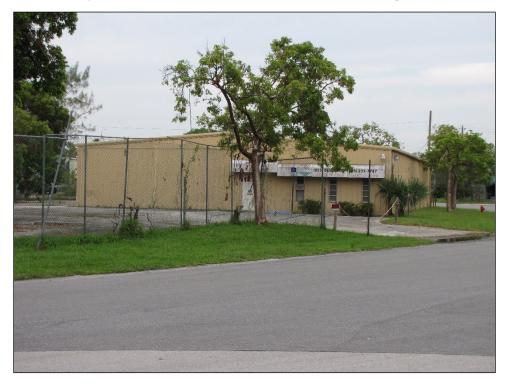
Figure 25 | Salvation Army Complex (8BD6347), Office 1, c. 1978, looking Northwest

This Industrial Vernacular building sits just northwest of Warehouse 4 (**Figure 25**). It has a simple form and was constructed c. 1978 with a metal steel frame covered in metal siding. The northwest side is blank with no window or door openings. The northeast side has six five-light awning windows, three in the center and three on the left side. The southwest side is not visible. The entrance is a simple metal door on the southeast side, which sits under a canvas awning. There is a similar awning over the three windows. The three windows are five-light awning similar to those on the northeast side. The front-gabled roof is covered in 5V crimped metal sheets.

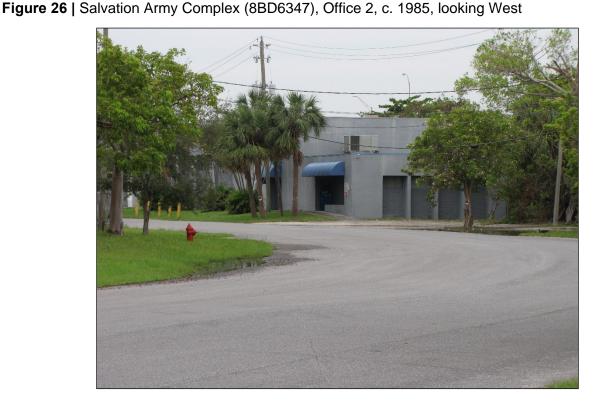
This two-story Masonry Vernacular building sits in the northwest corner of the property along the North Fork of the New River (Figure 26). It was constructed c. 1985 of concrete block and is covered in grey stucco. The building has an irregular form, and the west portion of the building was formerly a warehouse. The north and west sides of the building are not visible. The east portion of the building is only one-story tall, and contains both the main and secondary entrances recessed along its south side. The east side has four recessed bays with metal, one-light fixed windows at the top. The east-facing main entrance is a metal door with a square light recessed in the southeast corner under a canvas awning. There are four south-facing thin vertical windows recessed in the same space. The south-facing secondary entrance is a simple metal door to the left of the main entrance. It is also recessed and has a canvas awning. There were originally seven bays along the south side of the two-story portion of the building. Only the bay in the southwest corner has remained altered. The one directly to the right of it was completely enclosed with plain stucco. Each of the remaining five bays to the right were enclosed with scored stucco and a row of five four-light awning windows at the top. Both portions of the building have a flat, built-up roof.

This two-story Masonry Vernacular building sits in the northwest corner of the property along the North Fork of the New River (Figure 10). It was constructed c. 1985 of concrete block and is covered in grey stucco. The building has an irregular form, and the west portion of the building was formerly a warehouse. The north and west sides of the building are not visible. The east portion of the building is only one-story tall, and contains both the main and secondary entrances recessed along its south side. The east side has four recessed bays with metal, one-light fixed windows at the top. The eastfacing main entrance is a metal door with a square light recessed in the southeast corner under a canvas awning. There are four south-facing thin vertical windows recessed in the same space. The south-facing secondary entrance is a simple metal door to the left of the main entrance. It is also recessed and has a canvas awning. There were originally seven bays along the south side of the two-story portion of the building. Only the bay in the southwest corner has remained altered. The one directly to the right of it was completely enclosed with plain stucco. Each of the remaining five bays to the right were enclosed with scored stucco and a row of five four-light awning windows at the top. Both portions of the building have a flat, built-up roof.

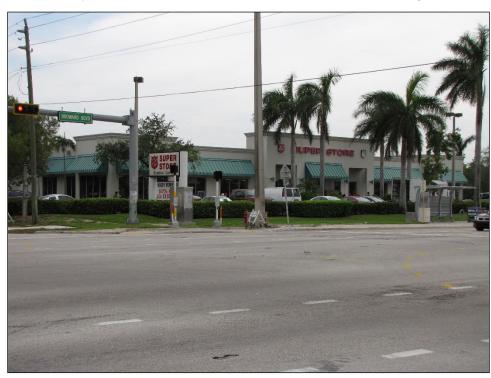
Figure 27 | Salvation Army Complex (8BD6347), Super Store, c. 2000, looking Northeast

This Masonry Vernacular building sits just east of the Adult Rehabilitation Center, at the northeast corner of W Broward Boulevard and NW 18<sup>th</sup> Avenue. The Super Store was constructed c. 2000 of concrete blocked and covered in stucco (**Figure 27**). The building is generally rectangular; however, the southwest and southeast corners extend out slightly. There are storefront windows that run from just north of and around the southwest corner, along the south side, around the southeast corner, and ending just north of the southeast corner. There are metal awnings over the windows. The south-facing commercial glass double doors with transom and side lights sits amongst the storefront windows under a portico. A two-story entry portico is located centrally along the south side, and is taller than the rest of the building. Other than the storefront windows, the east and west sides are blank with no other openings. The north side has a simple metal door and a loading bay with rolling garage door in the northeast corner. There are stucco walls around the AC units on the north side. Most of the area around the Super Store is paved for parking. The building has a flat, built-up roof.

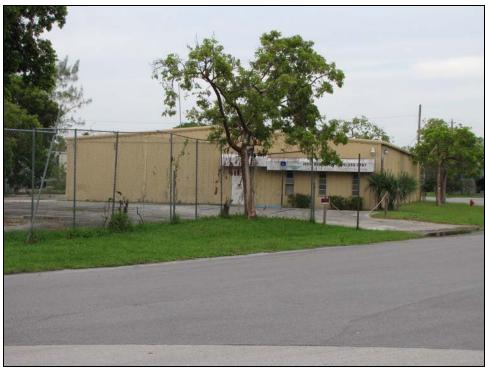
Figure 9: Salvation Army Complex (8BD6347), Office 1, c. 1978, looking Northwest

This Industrial Vernacular building sits just northwest of Warehouse 4 (Figure 9). It has a simple form and was constructed c. 1978 with a metal steel frame covered in metal siding. The northwest side is blank with no window or door openings. The northeast side has six five-light awning windows, three in the center and three on the left side. The southwest side is not visible. The entrance is a simple metal door on the southeast side, which sits under a canvas awning. There is a similar awning over the three windows. The three windows are five-light awning similar to those on the northeast side. The front-gabled roof is covered in 5V crimped metal sheets.

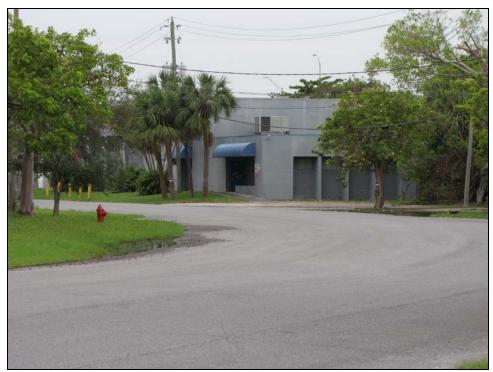
Figure 10: Salvation Army Complex (8BD6347), Office 2, c. 1985, looking West

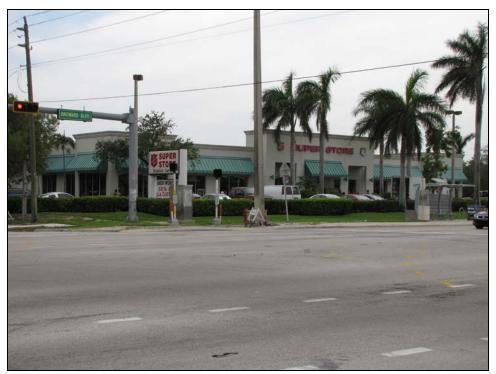
Figure 11: Salvation Army Complex (8BD6347), Super Store, c. 2000, looking Northeast
