Contamination Screening Evaluation Report

**SR-9/I-95 @ SR 842/Broward Boulevard (Broward
Boulevard from West of SW 24th Avenue to East of
NW/SW 18th Avenue)
Project Development & Environment (PD&E) Study**

Efficient Transportation Decision Making (ETDM) No.: 14226

**Broward County, Florida
Financial Project ID Number: 435513-1-22-02**

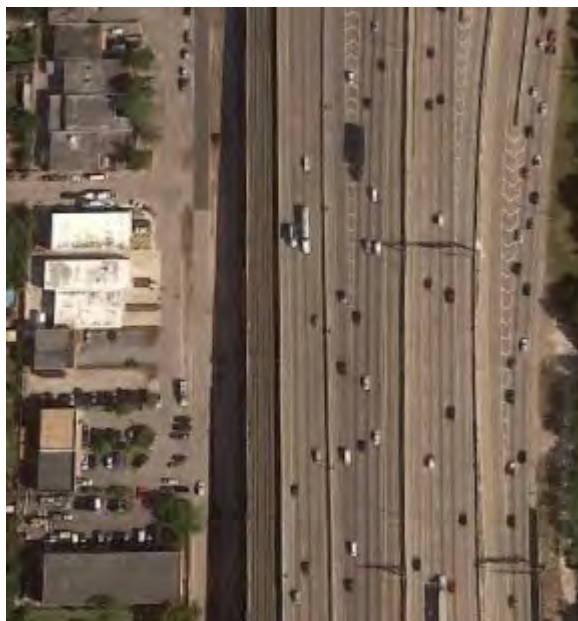
Photo 1-1

Site No. 1 – FDOT I-95 ROW/Corridor, (Former) Reliance Supply Company
Aerial March 2017

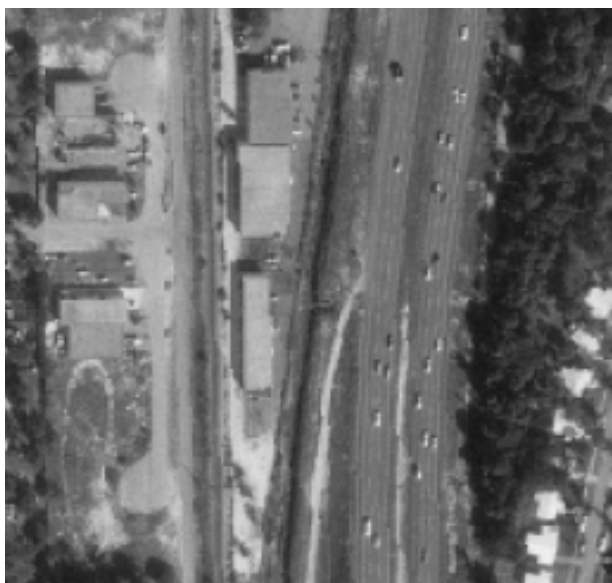
Photo 1-2

Site No. 1 – FDOT I-95 ROW/Corridor, (Former) Reliance Supply Company
Aerial January 1976

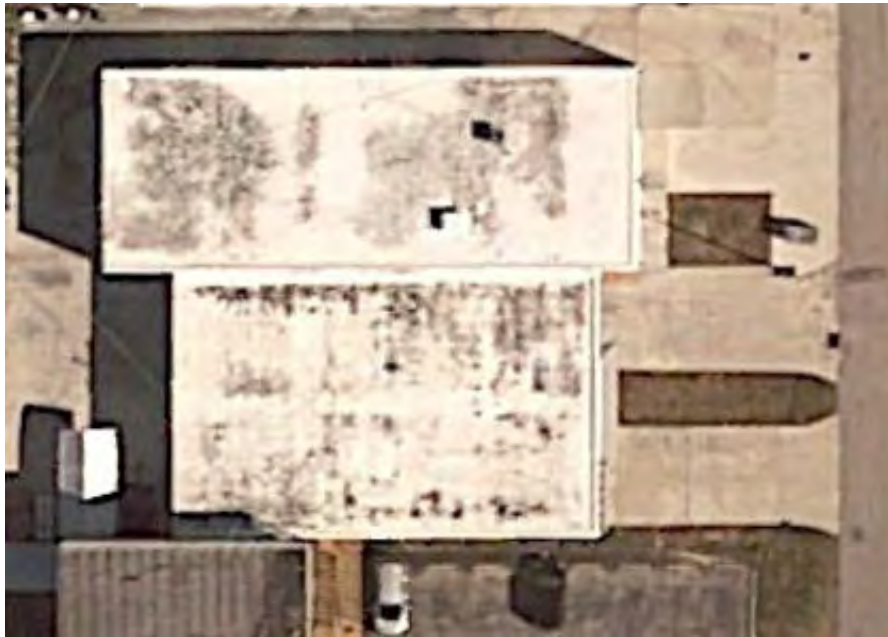
Photo 2-1

Site No. 2 – All White Manufacturing – Aerial March 2017

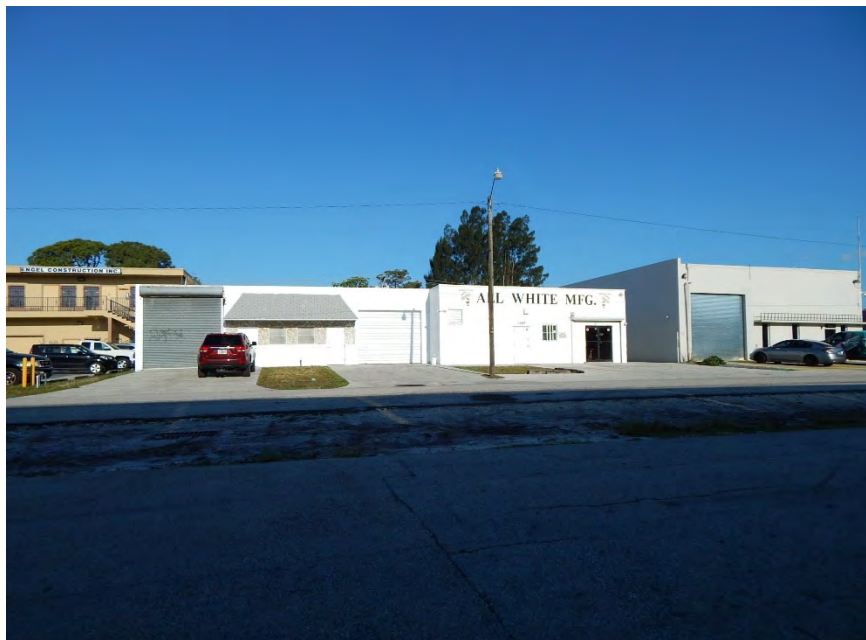
Photo 2-2

Site No. 2 – All White Manufacturing – View Towards the West

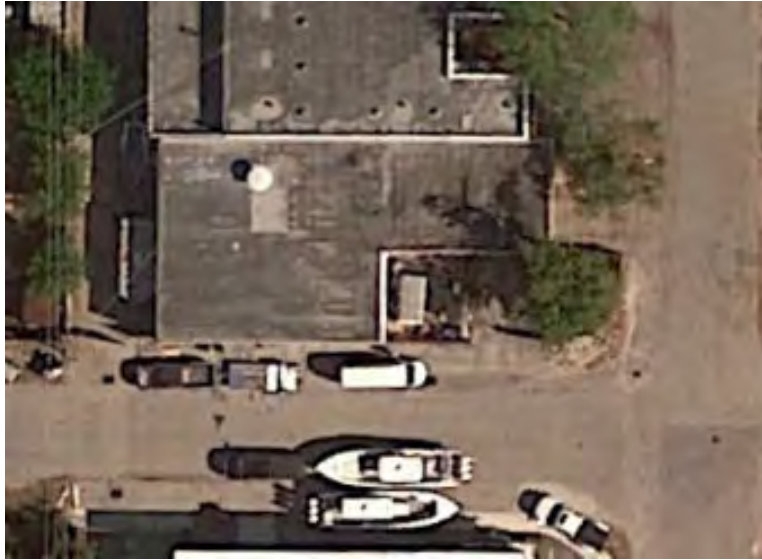
Photo 3-1

Site No. 3 – 3 Brothers Custom Interior and Exterior Yacht Painting
Aerial March 2017

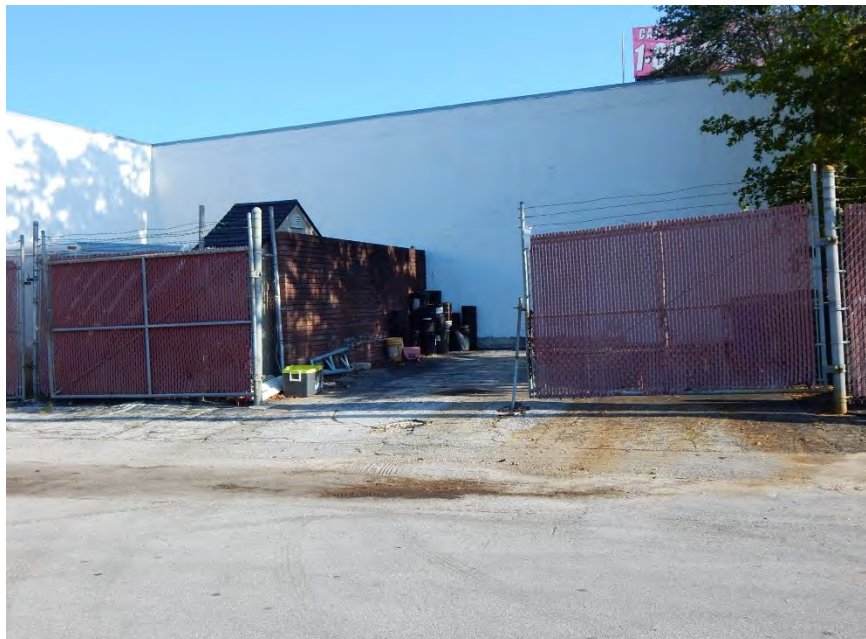
Photo 3-2

Site No. 3 – 3 Brothers Custom Interior and Exterior Yacht Painting
View Towards the Northwest

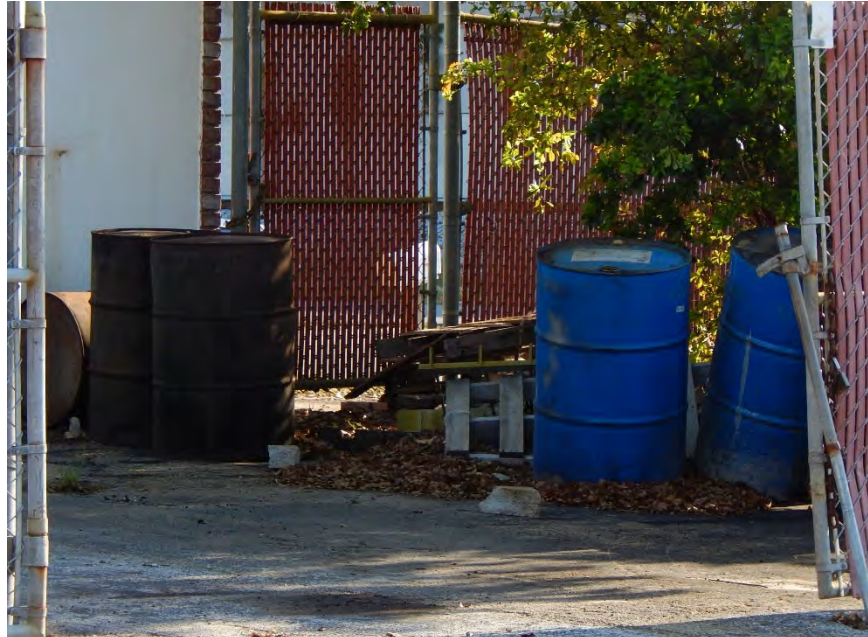
Photo 3-3

Site No. 3 – 3 Brothers Custom Interior and Exterior Yacht Painting
View Towards the Northwest

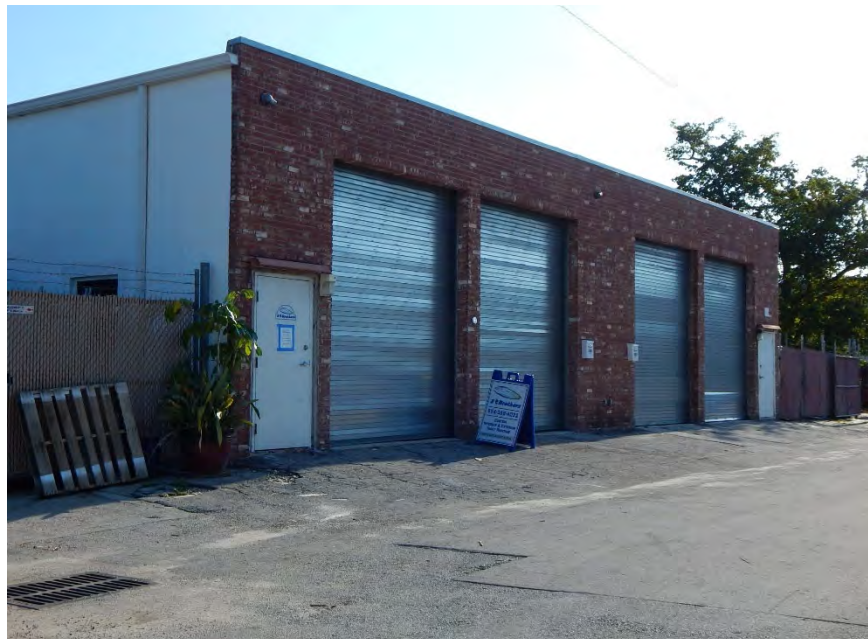
Photo 3-4

Site No. 3 – 3 Brothers Custom Interior and Exterior Yacht Painting
View Towards the Northeast

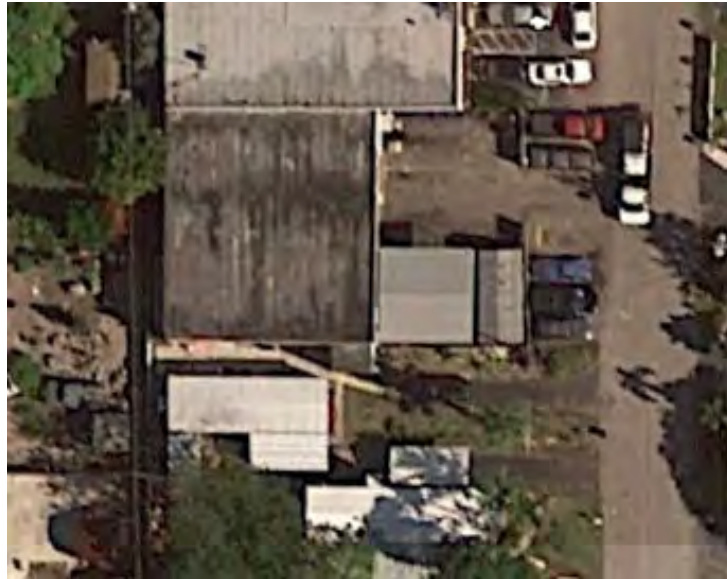
Photo 4-1

Site No. 4 – Steve's Garage – Aerial March 2017

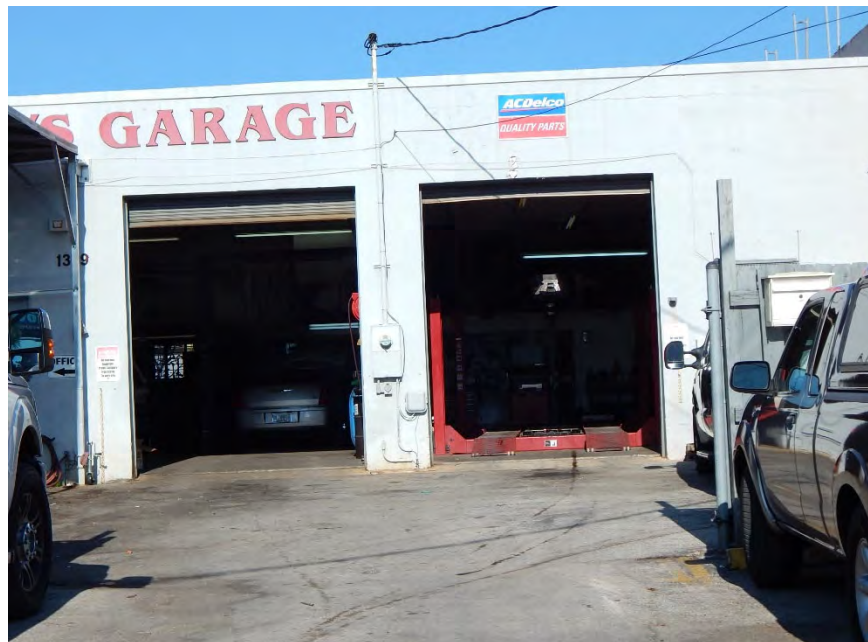
Photo 4-2

Site No. 4 - Steve's Garage – View Towards the West

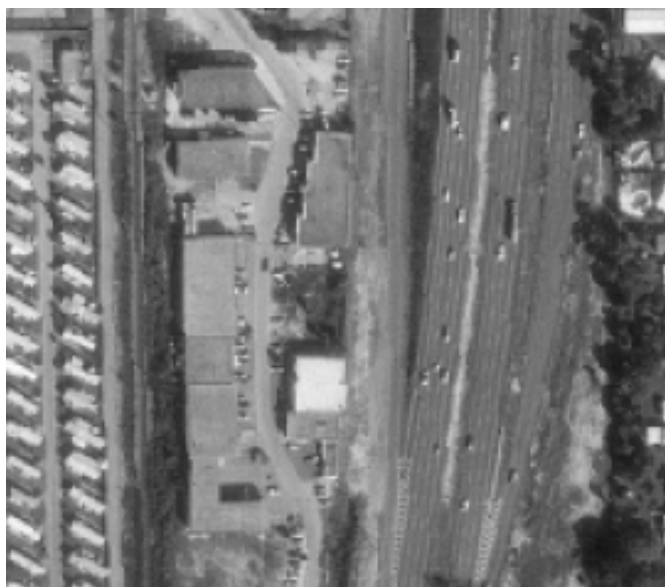
Photo 5-2

Site Nos. 5, 6, & 8 – FDOT I-95 ROW/Corridor, (Former) Holland Builders, (Former) The Steering Wheel, (Former) Rad-Air – Aerial January 1976

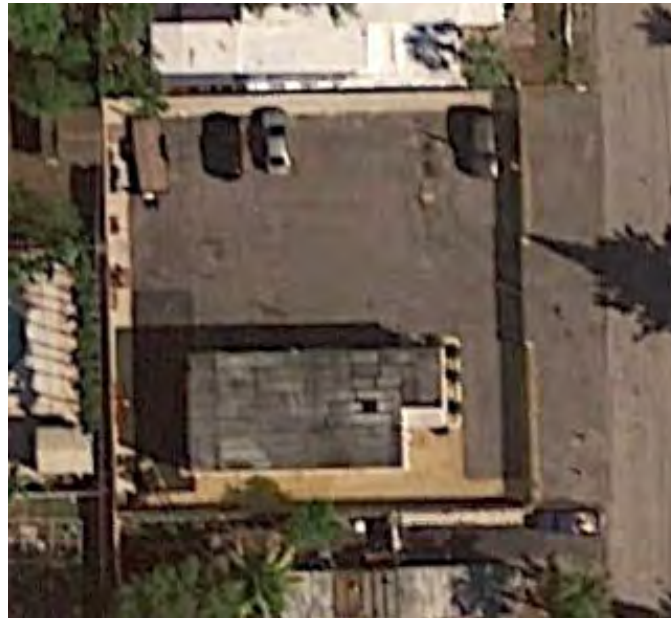
Photo 7-1

Site No. 7 – R. Hamann & Sons Demolition – Aerial March 2017

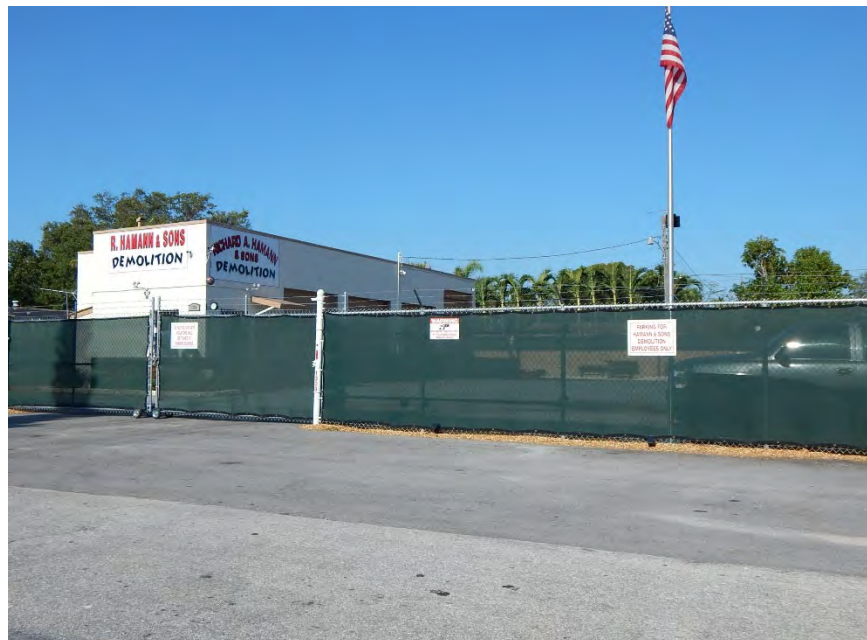
Photo 7-2

Site No. 7 – R. Hamann & Sons Demolition – View Towards the Southwest

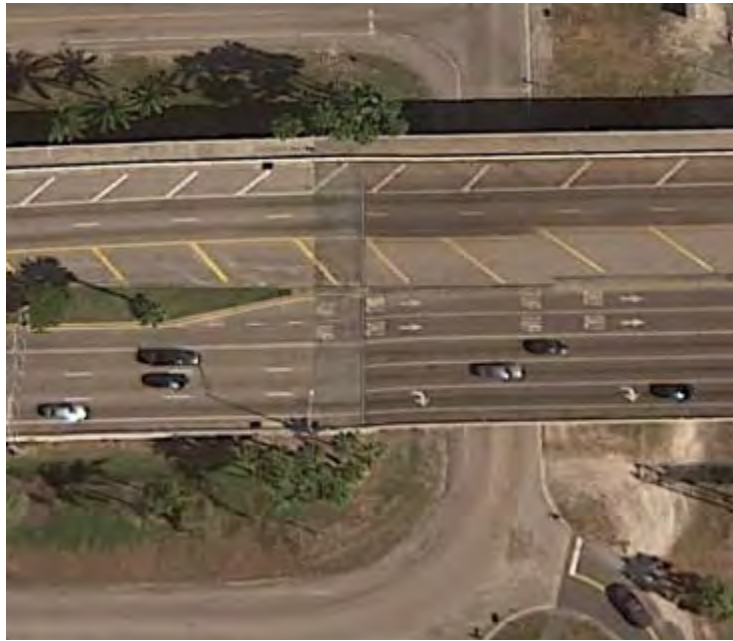
Photo 9-1

Site No. 9 – FDOT ROW, (Former) BP #00367219 – Aerial March 2017

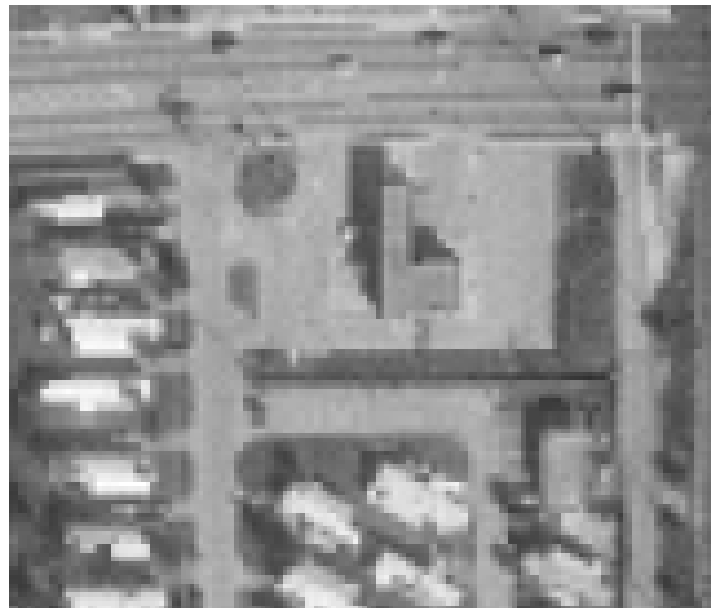
Photo 9-2

Site No. 9 – FDOT ROW, (Former) BP #00367219 – Aerial January 1976

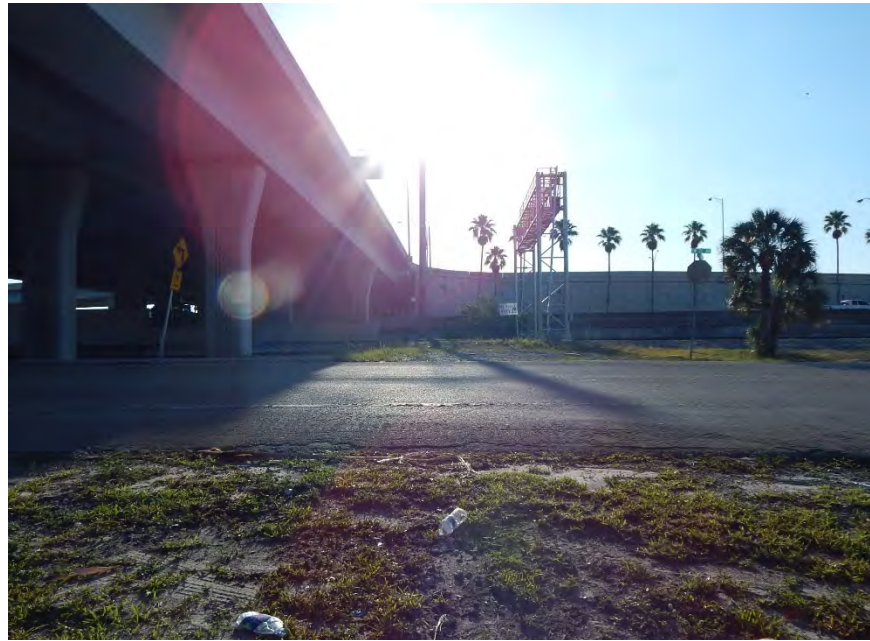
Photo 9-3

Site No. 9 – FDOT ROW, (Former) BP #00367219 – View Towards the East

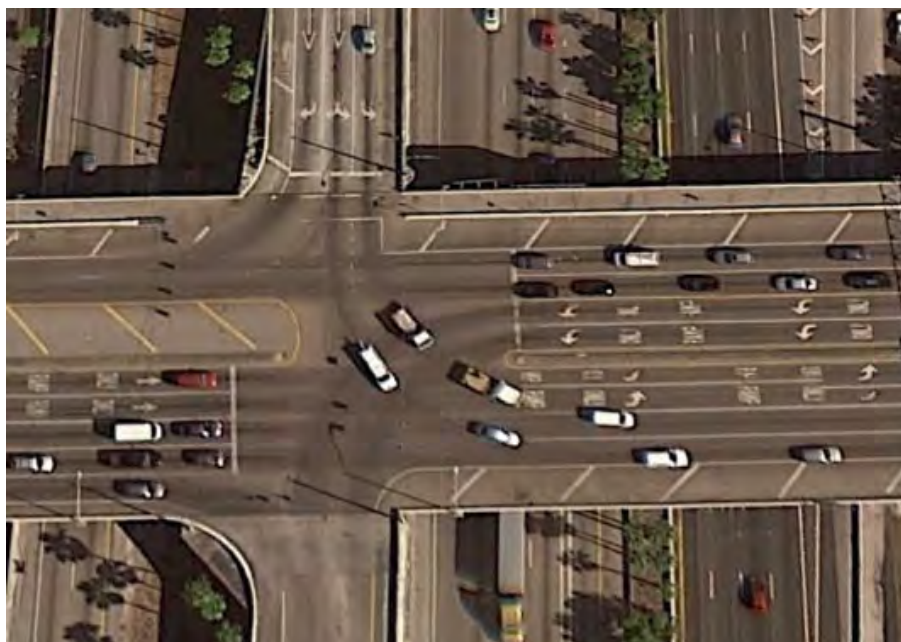
Photo 10-1

Site No. 10 – FDOT Broward Boulevard I-95 Overpass,
(Former) Exxon #5587 – Aerial March 2017

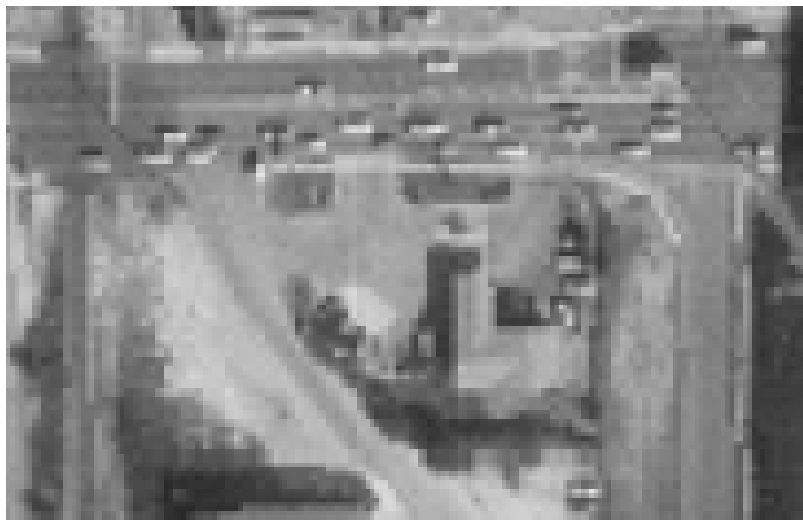
Photo 10-2

Site No. 10 – FDOT Broward Boulevard I-95 Overpass,
(Former) Exxon #5587 – Aerial January 1976

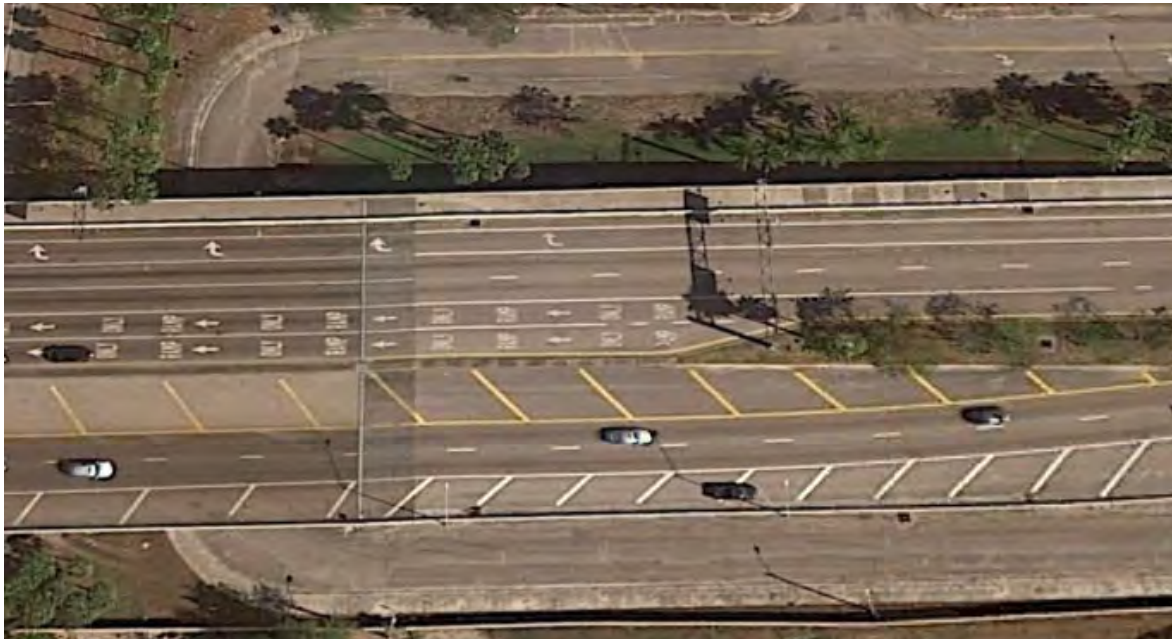
Photo 11-1

Site Nos. 11 & 12 – FDOT Broward Blvd I-95 Overpass,
(Former) Carl's Riverside Standard Service, (Former) Texaco #240211355
Aerial March 2017

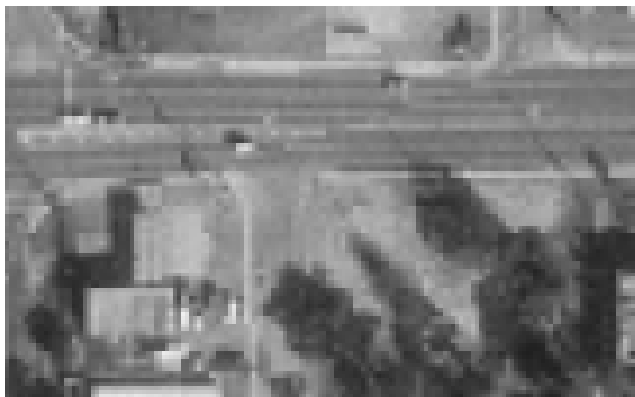
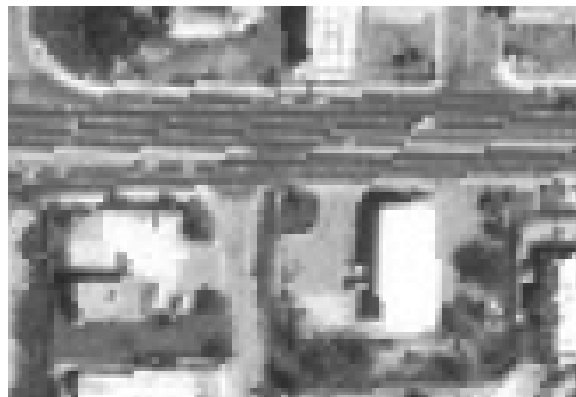
Photos 11-2 & 11-3

Site Nos. 11 & 12 – FDOT Broward Blvd I-95 Overpass,
(Former) Carl's Riverside Standard Service, (Former) Texaco #240211355

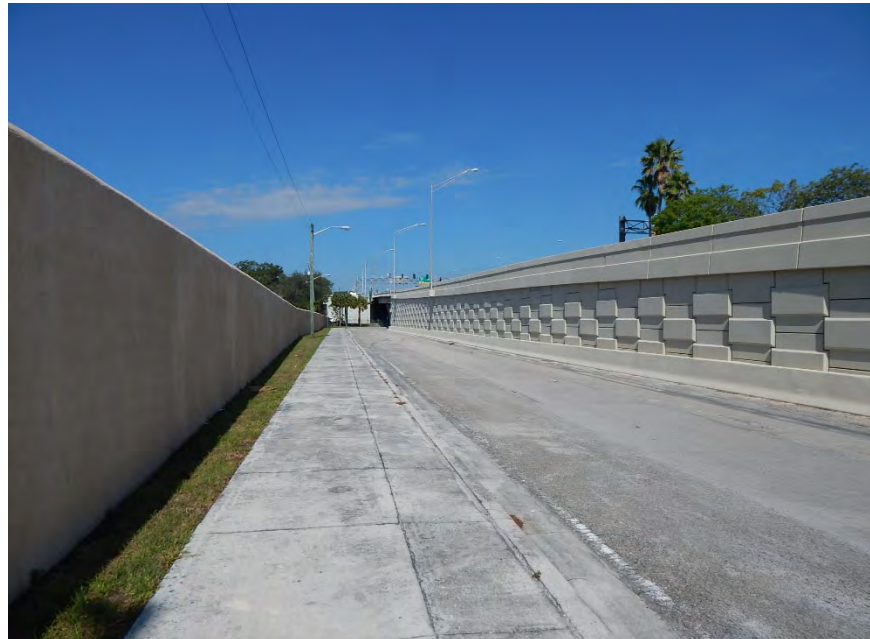
Photo 11-4

Site Nos. 11 & 12 – FDOT Broward Blvd I-95 Overpass,
(Former) Carl's Riverside Standard Service, (Former) Texaco #240211355
View Towards the West

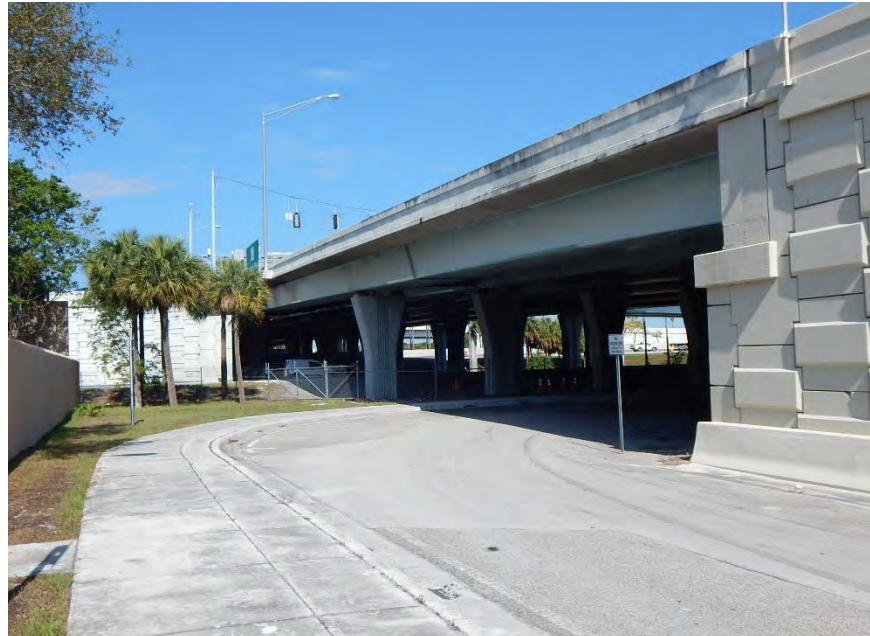
Photo 11-5

Site Nos. 11 & 12 – FDOT Broward Blvd I-95 Overpass,
(Former) Carl's Riverside Standard Service, (Former) Texaco #240211355
View Towards the West

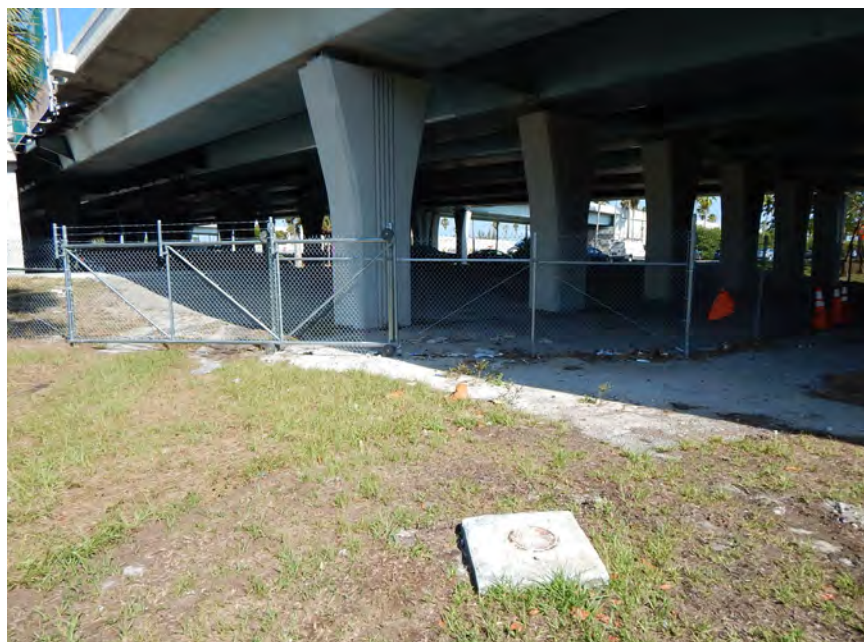
Photo 11-6

Site Nos. 11 & 12 – FDOT Broward Blvd I-95 Overpass,
(Former) Carl's Riverside Standard Service, (Former) Texaco #240211355
View Towards the West, Monitoring Well in Foreground

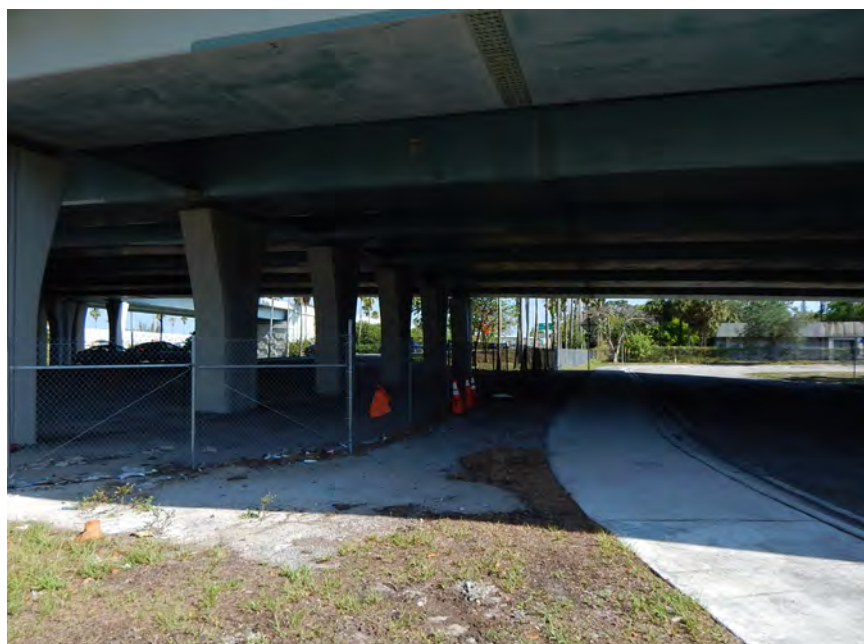
Photo 11-7

Site Nos. 11 & 12 – FDOT Broward Blvd I-95 Overpass,
(Former) Carl's Riverside Standard Service, (Former) Texaco #240211355
View Towards the Northwest

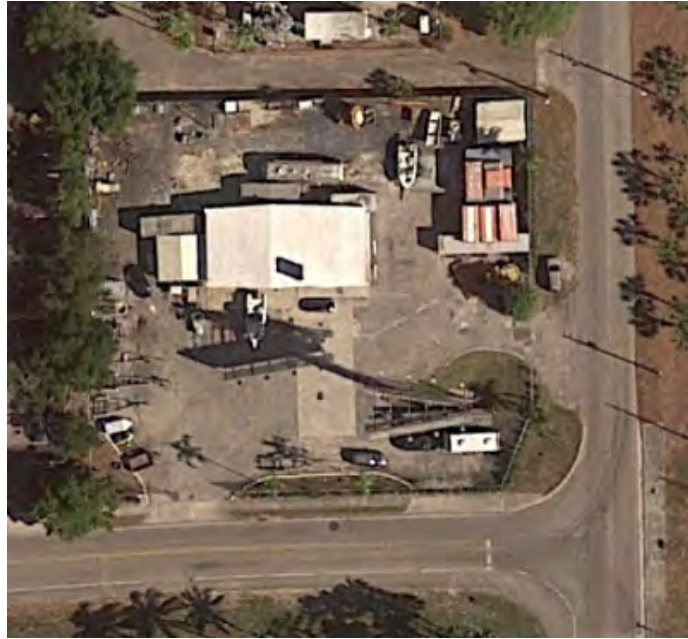
Photo 13-1

Site No. 13 – Tech Center - Shell-Davie Auto Care
Aerial March 2017

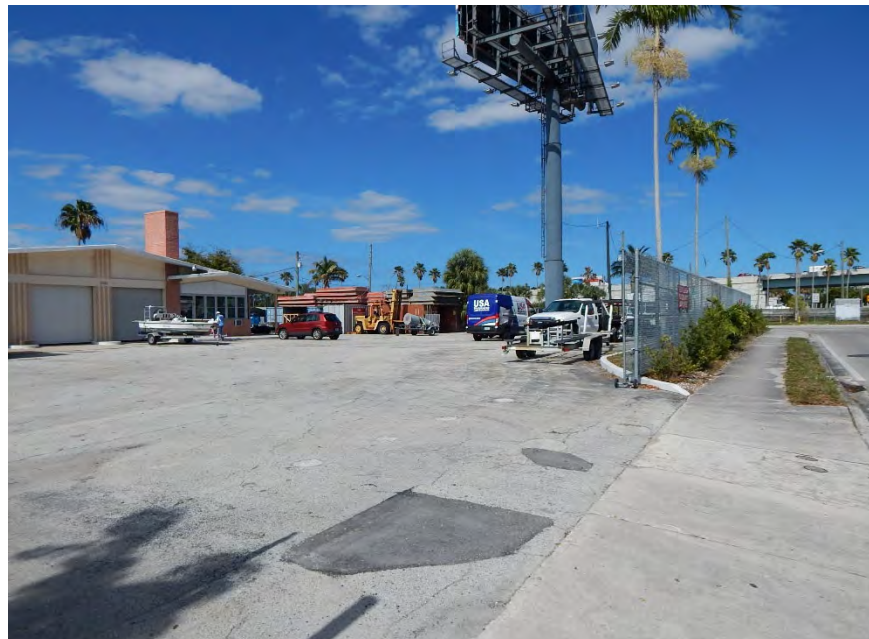
Photo 13-2

Site No. 13 – Tech Center - Shell-Davie Auto Care
View Towards the Northeast

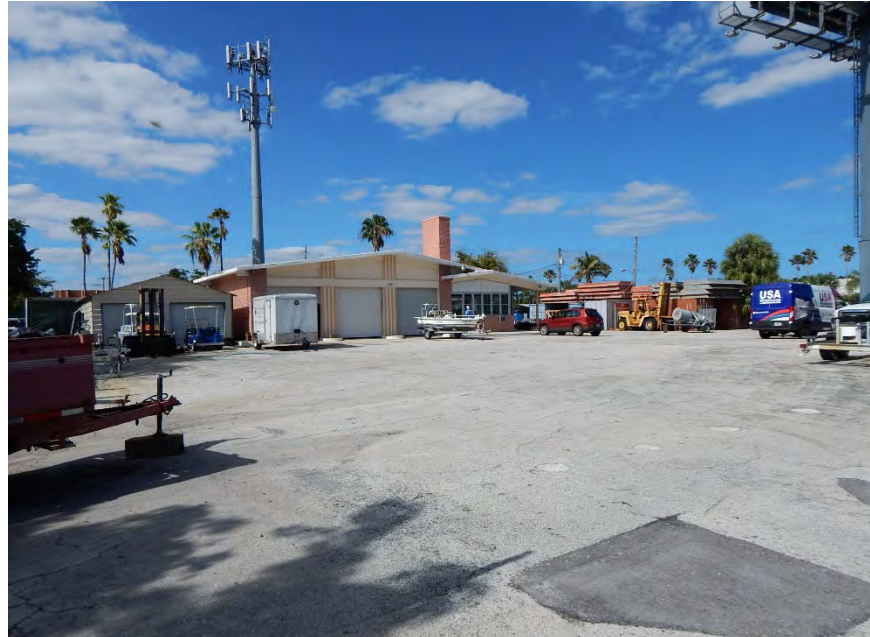
Photo 13-3

Site No. 13 – Tech Center - Shell-Davie Auto Care
View Towards the Northeast

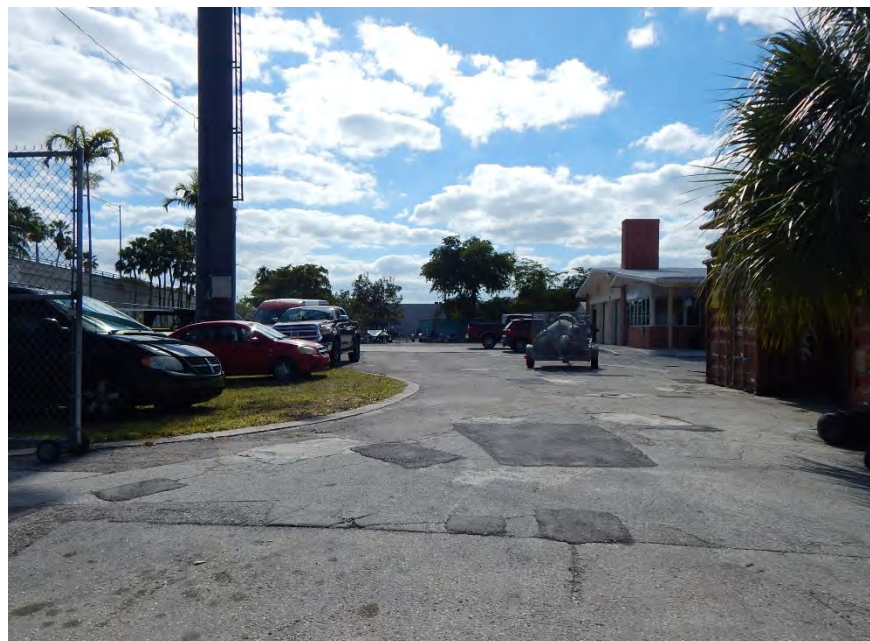
Photo 13-4

Site No. 13 – Tech Center - Shell-Davie Auto Care
View Towards the West

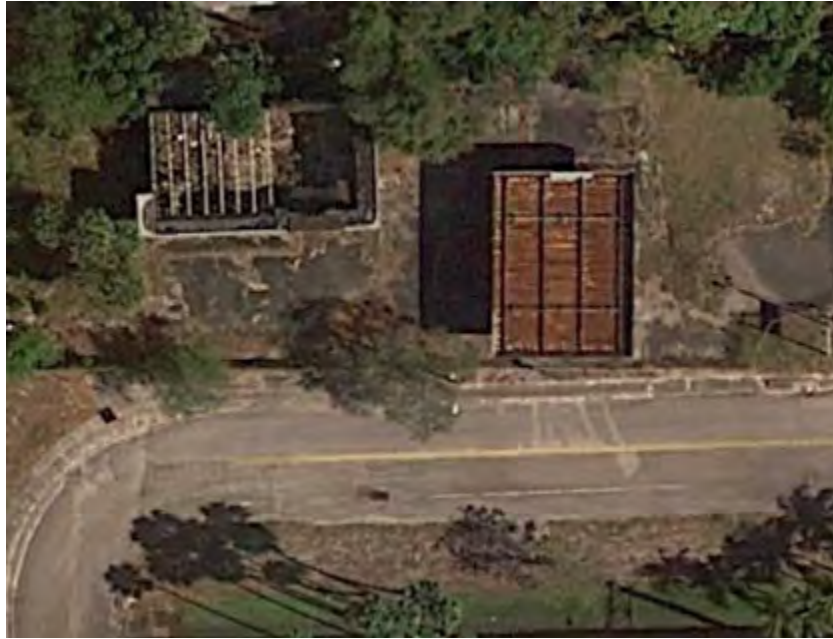
Photo 14-1

Site No. 14 – Abandoned Gas Station – Aerial March 2017

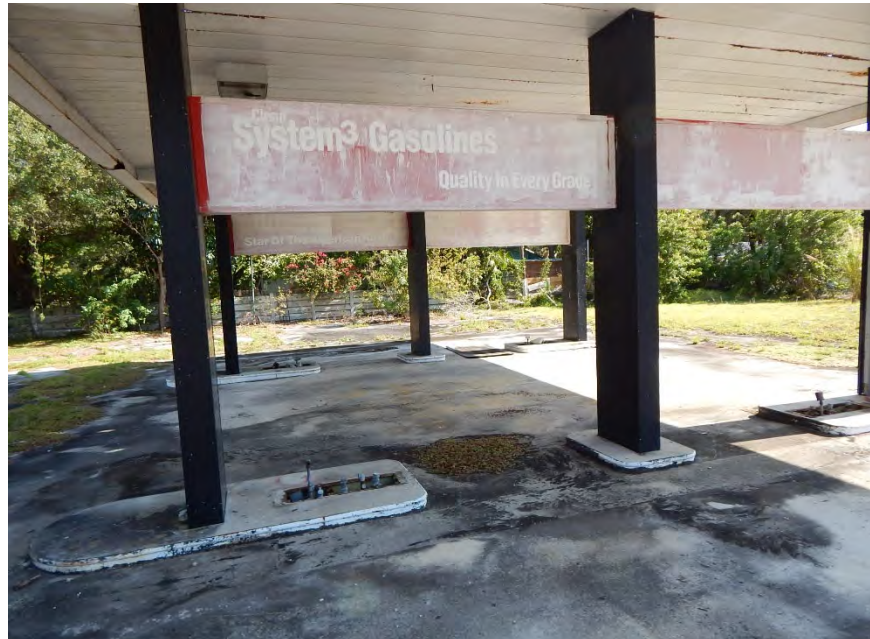
Photo 14-2

Site No. 14 – Abandoned Gas Station - View Towards the West

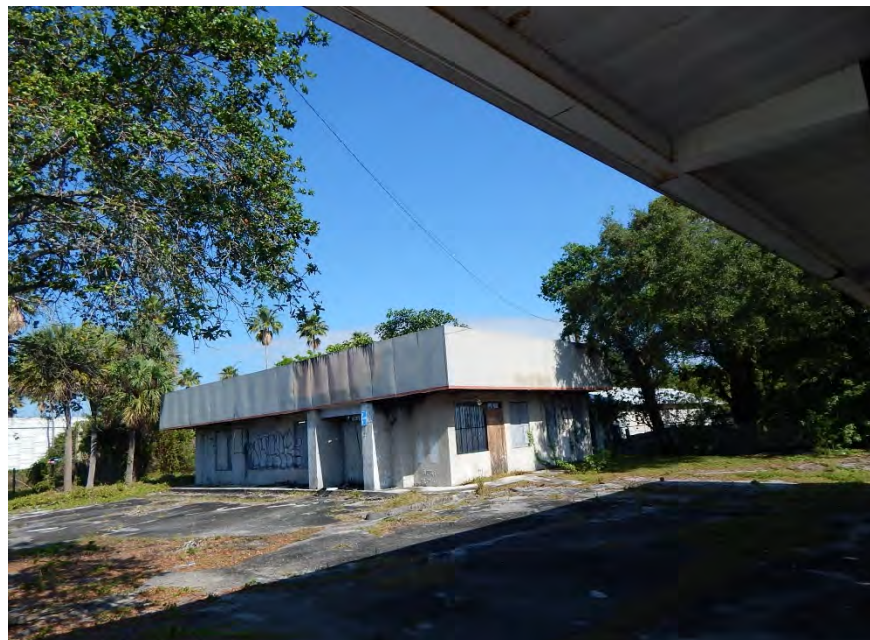
Photo 14-3

Site No. 14 – Abandoned Gas Station - View Towards the North

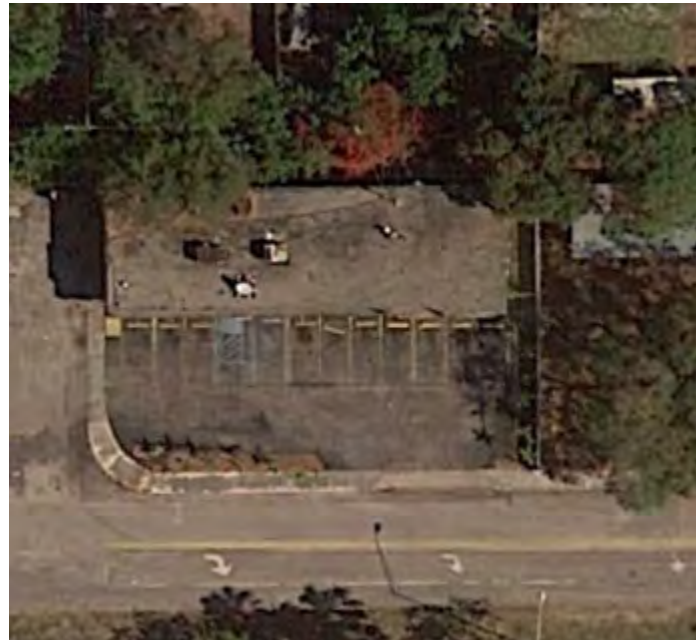
Photo 14-4

Site No. 14 – Abandoned Gas Station - View Towards the Northwest

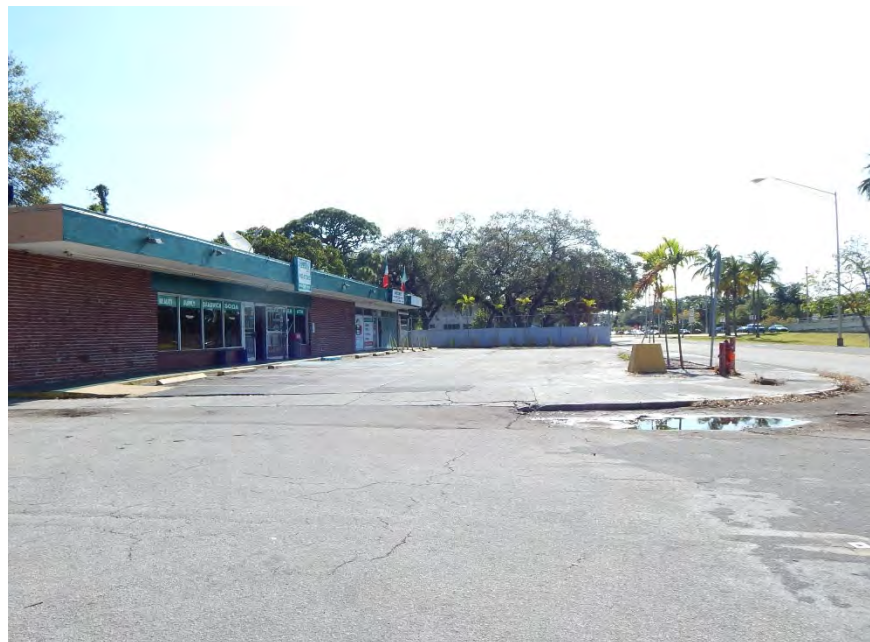
Photo 15-1

Site No. 15 - Speedy's Food Store – Aerial March 2017

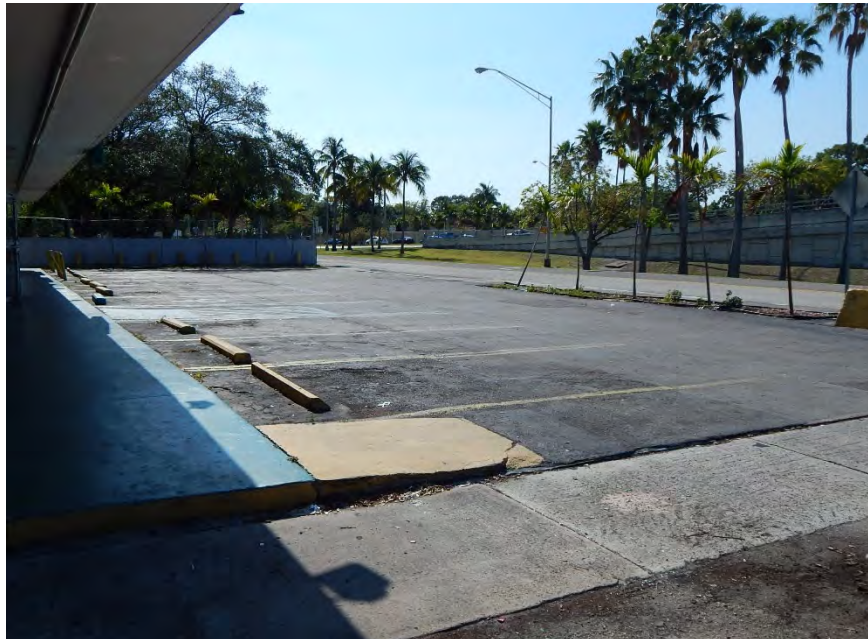
Photo 15-2

Site No. 15 - Speedy's Food Store – View Towards the East

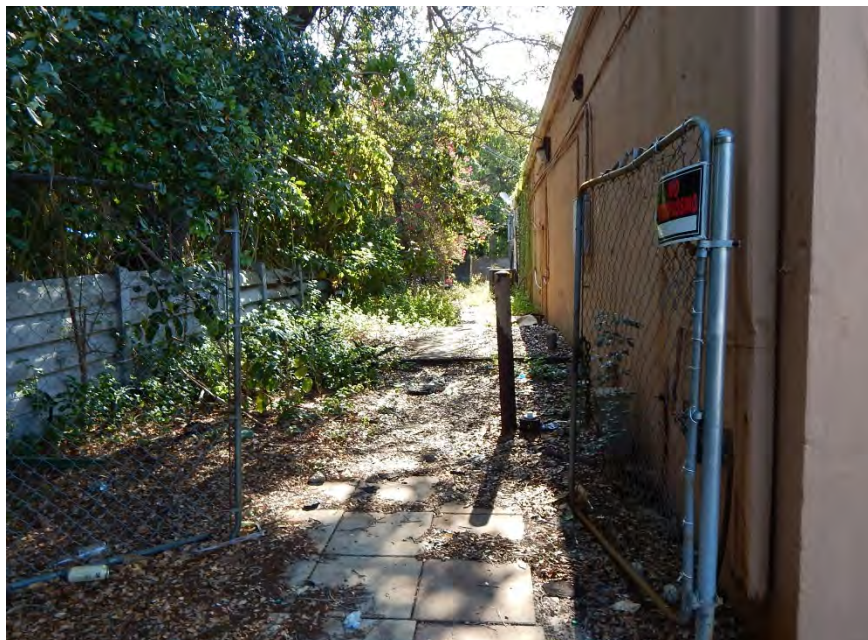
Photo 15-3

Site No. 15 - Speedy's Food Store – View Towards the Southeast

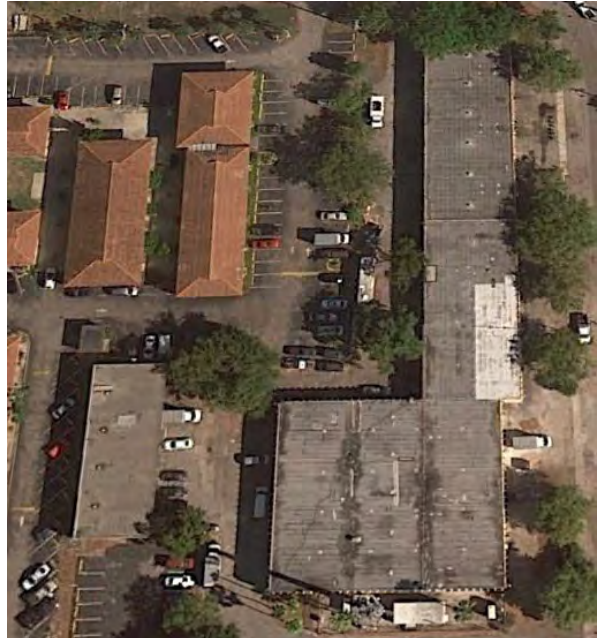
Photo 15-4

Site No. 15 - Speedy's Food Store – View Towards the East

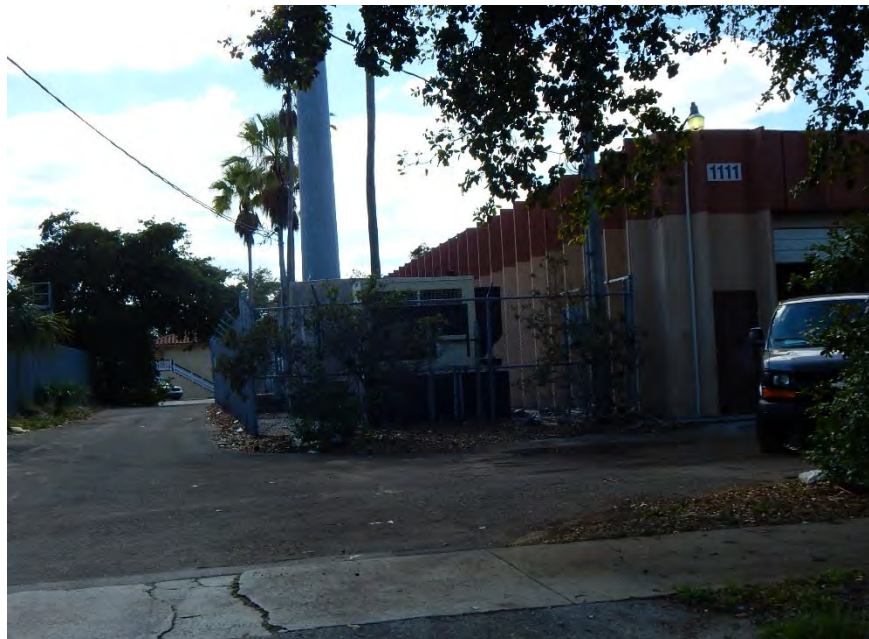
Photo 16-1

Site No. 16 – Multi-tenant Warehouse and Cell Tower
Aerial March 2017

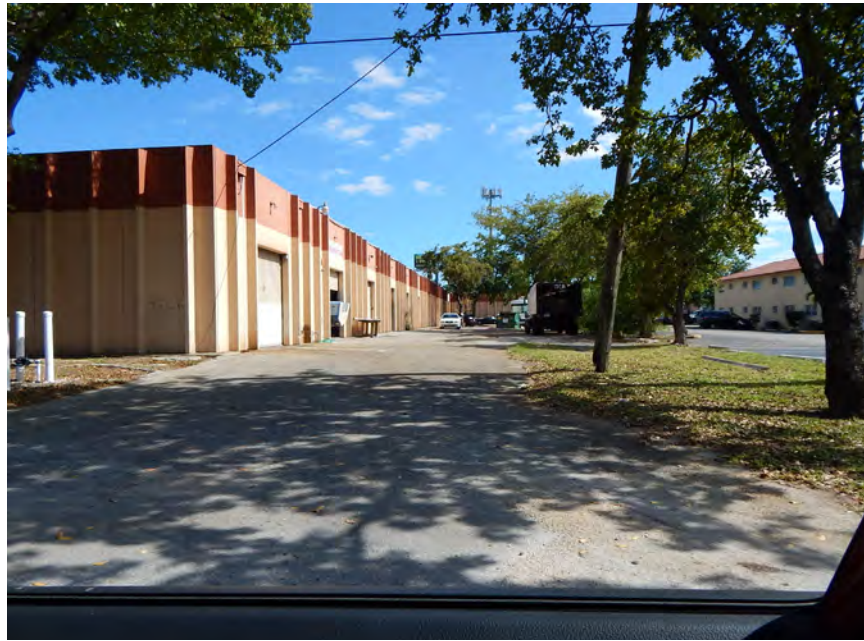
Photo 16-2

Site No. 16 – Multi-tenant Warehouse and Cell Tower
View Towards the West

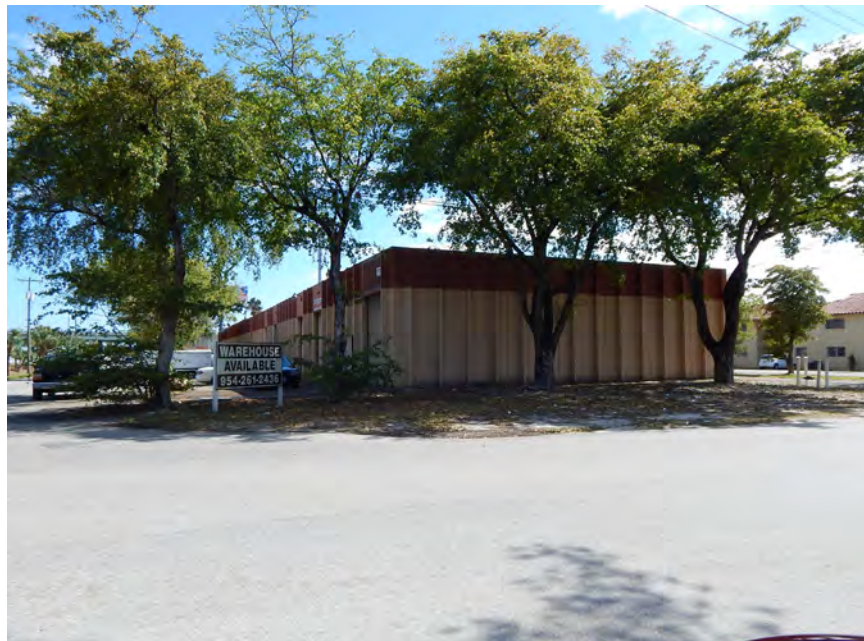
Photo 16-3

Site No. 16 – Multi-tenant Warehouse and Cell Tower
View Towards the South

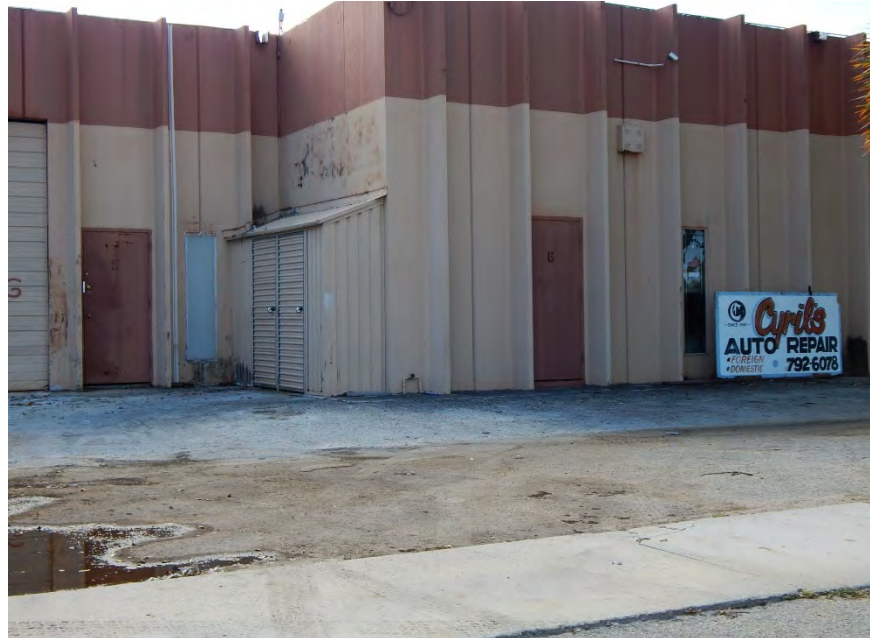
Photo 16-4

Site No. 16 – Multi-tenant Warehouse and Cell Tower
View Towards the South

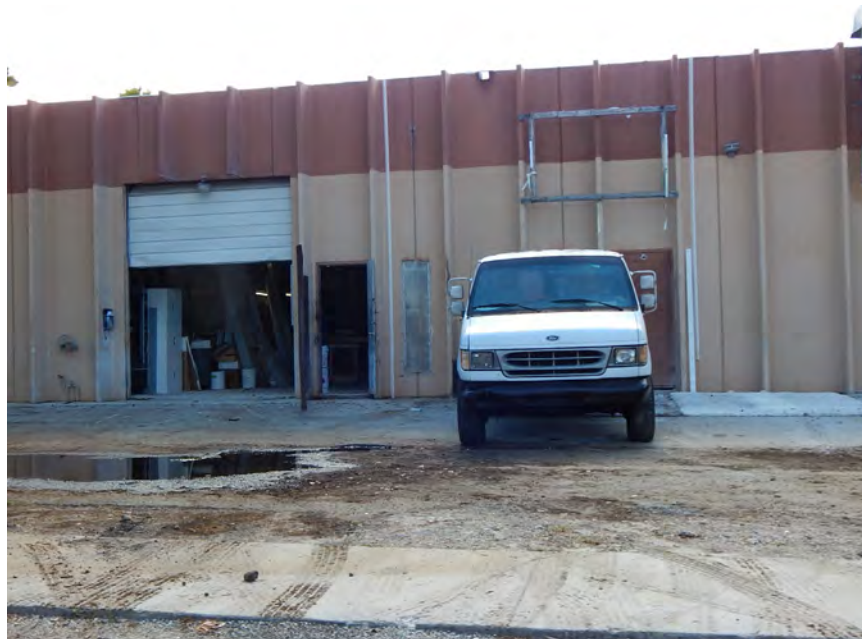
Photo 16-5

Site No. 16 – Multi-tenant Warehouse and Cell Tower
View Towards the Northwest

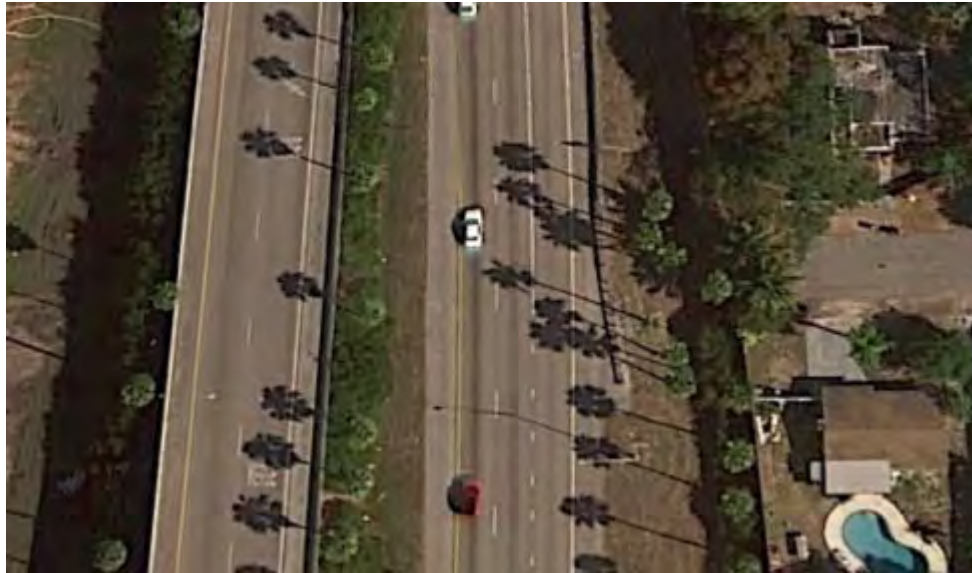
Photo 16-6

Site No. 16 – Multi-tenant Warehouse and Cell Tower
View Towards the West
