Contamination Screening Evaluation Report

**SR-9/I-95 @ SR 842/Broward Boulevard (Broward
Boulevard from West of SW 24th Avenue to East of
NW/SW 18th Avenue)
Project Development & Environment (PD&E) Study**

Efficient Transportation Decision Making (ETDM) No.: 14226

**Broward County, Florida
Financial Project ID Number: 435513-1-22-02**

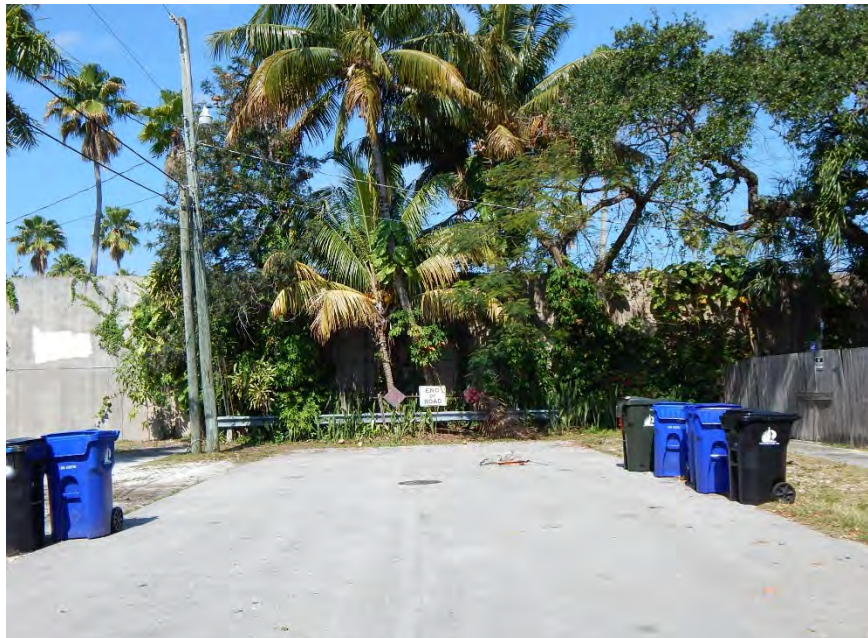
Photo 17-1

Site No. 17 - FDOT ROW, (Former) Bryan Electric , Inc. – Aerial March 2017

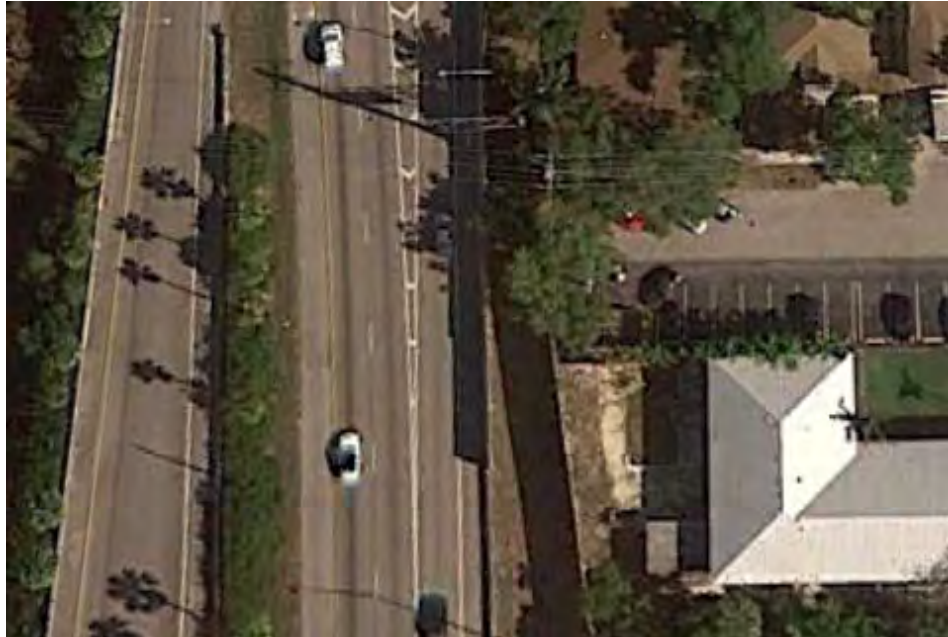
Photo 17-2

Site No. 17 – FDOT ROW, (Former) Bryan Electric , Inc.
View Towards the West

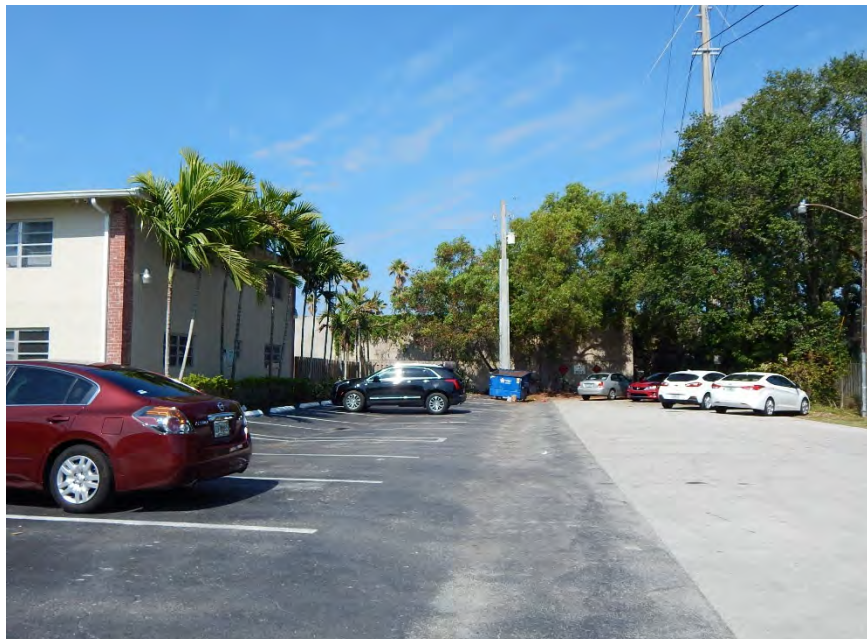
Photo 18-1

Site Nos. 18 & 19 – FDOT ROW, (Former) Steve’s Garage,
(Former) Harrell Rick’s Auto Sales Inc. – Aerial March 2017

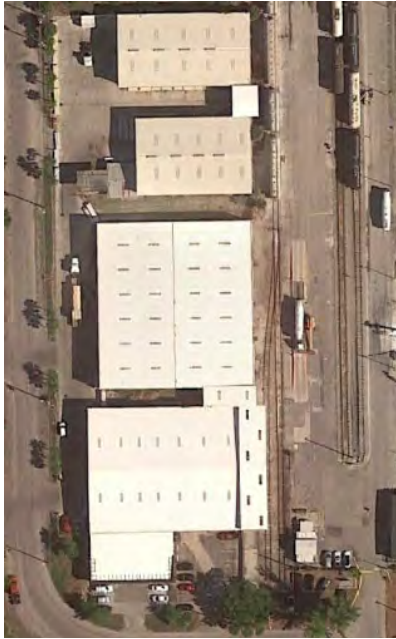
Photo 18-2

Site Nos. 18 & 19 – FDOT ROW, (Former) Steve’s Garage,
(Former) Harrell Rick’s Auto Sales Inc. – View Towards the West

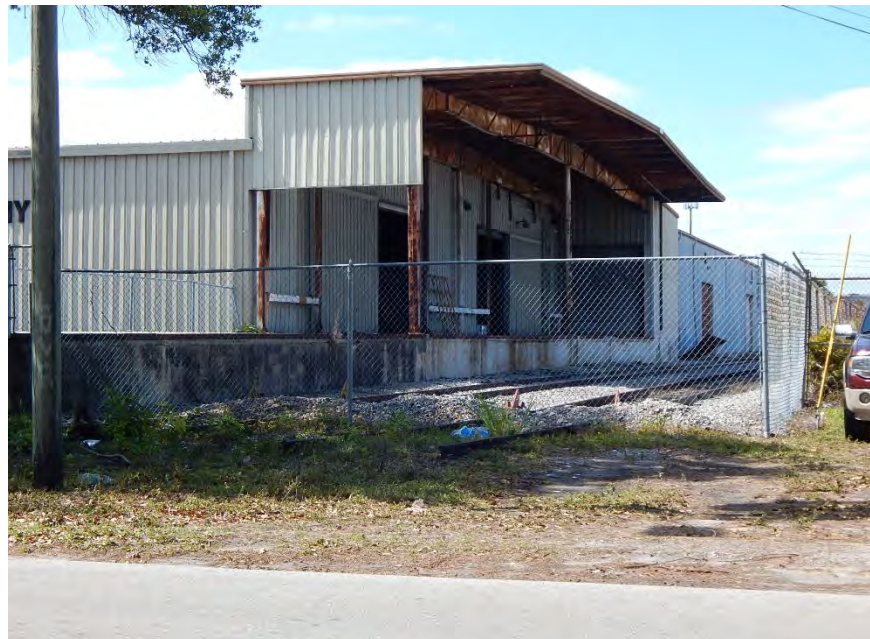
Photo 20-1

Site No. 20 – Dixie Plywood and Lumber Company –
Aerial March 2017

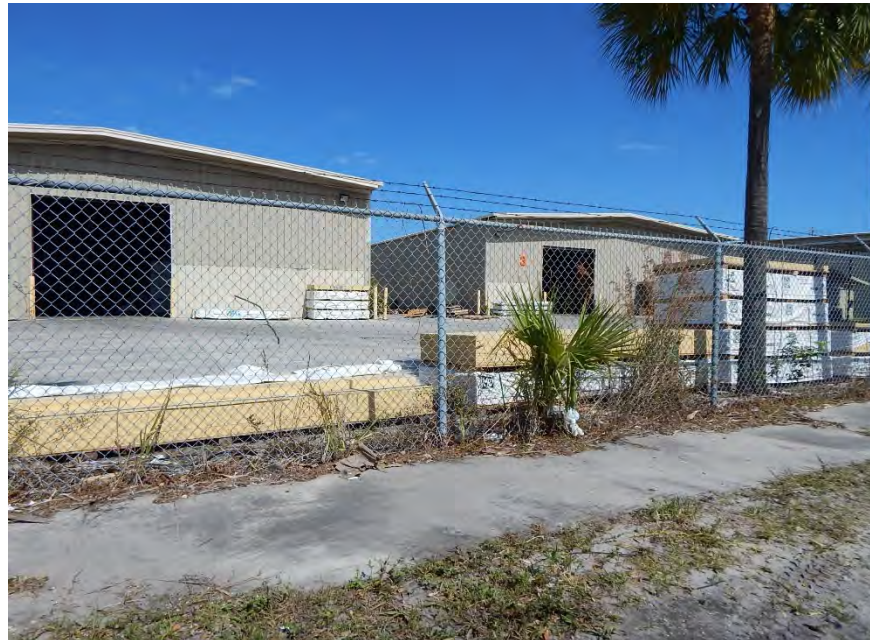
Photo 20-2

Site No. 20 - Dixie Plywood and Lumber Company –
View Towards the Northwest

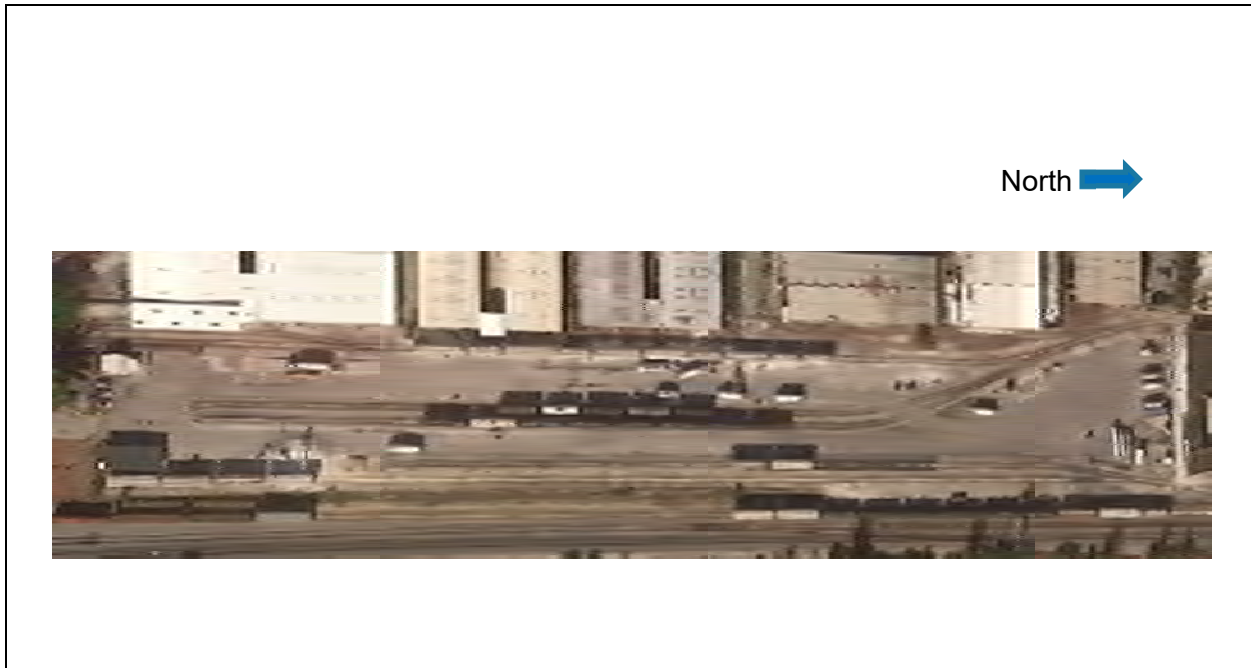
Photo 20-4

Site No. 20 - Dixie Plywood and Lumber Company –
View Towards the East

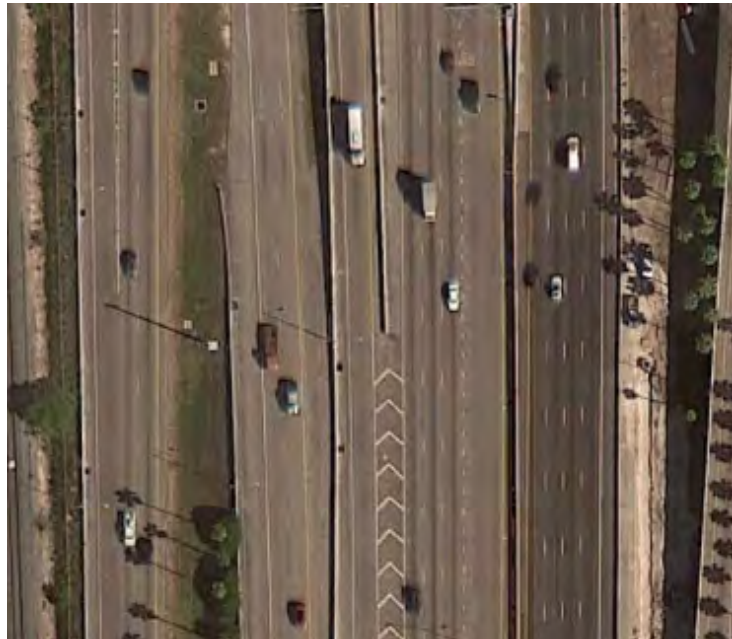
Photo 21-2

Site No. 21 – Transflo Terminal Services, Inc. – View Towards the North

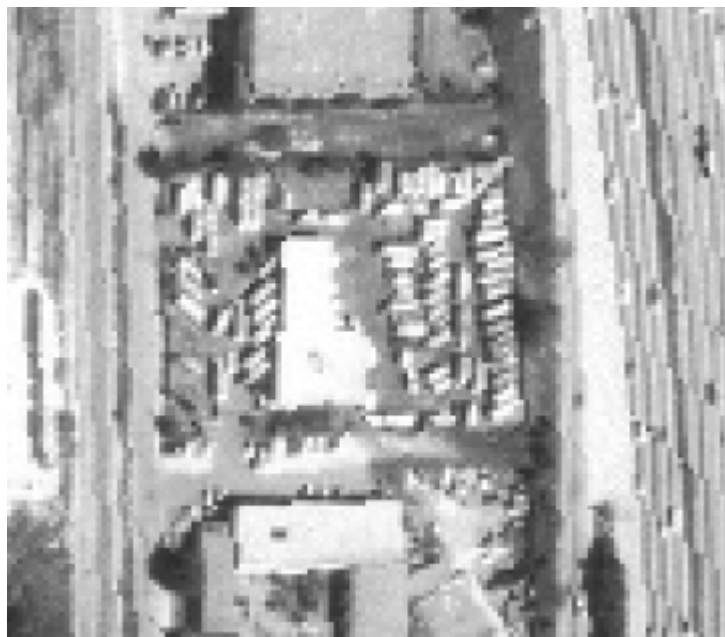
Photo 22-1

Site No. 22 – FDOT I-95 Corridor, (Former) American Land Cruisers
Aerial March 2017

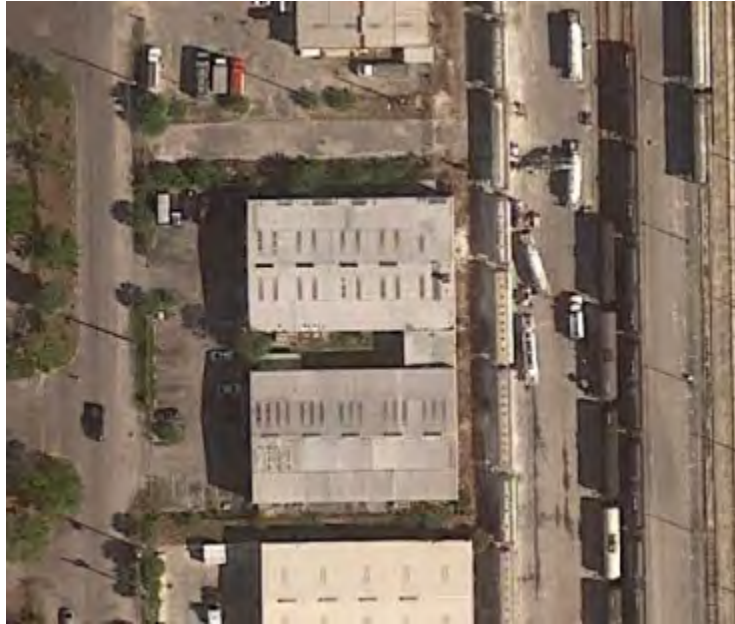
Photo 22-2

Site No. 22 – FDOT I-95 Corridor, (Former) American Land Cruisers
Aerial February 1988

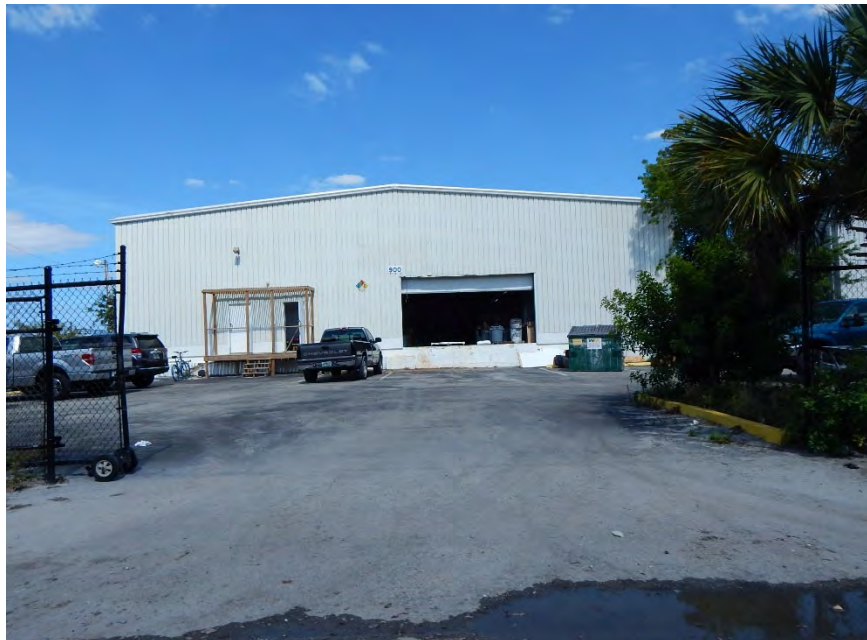
Photo 23-1

Site No. 23 - Interplex Proto-Stamp, Inc. – Aerial March 2017

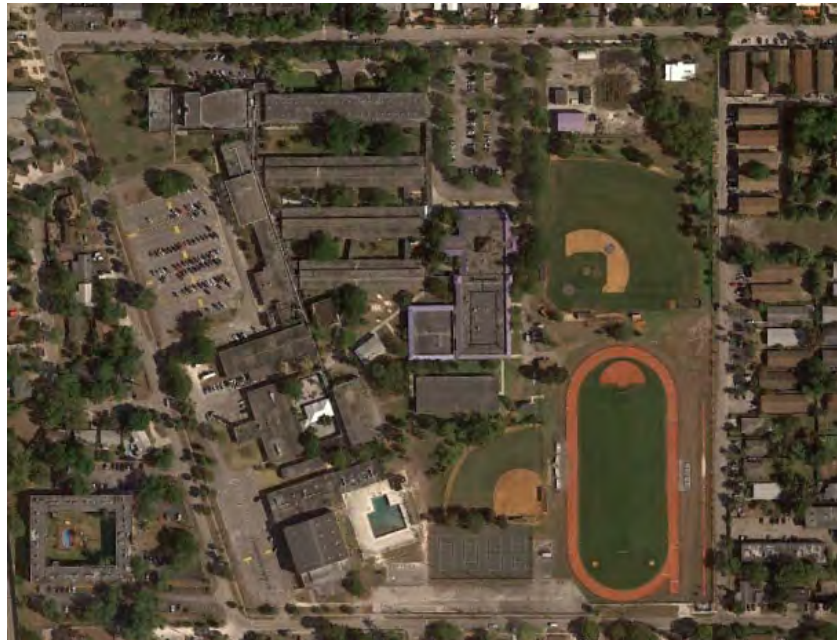
Photo 23-2

Site No. 23 - Interplex Proto-Stamp, Inc. – View Towards the East

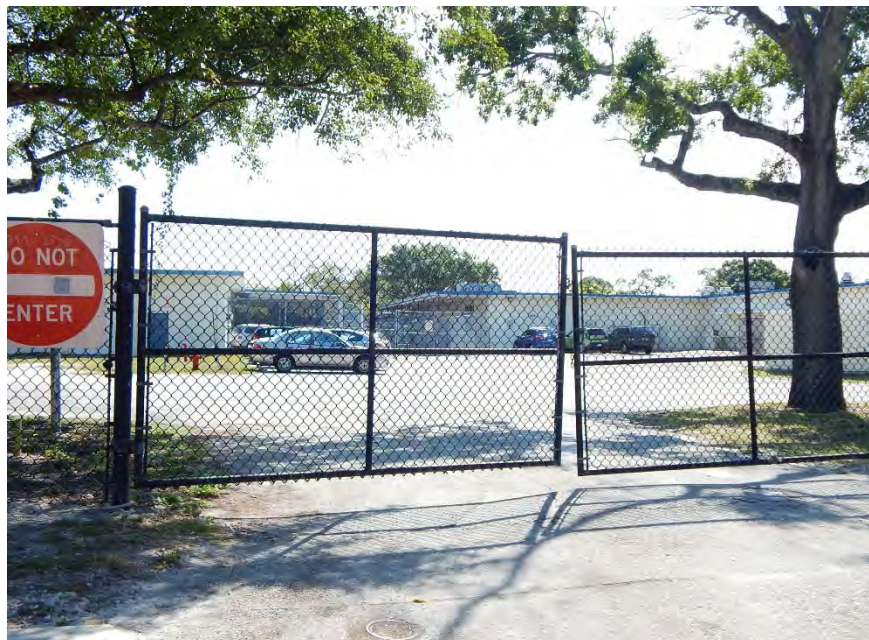
Photo 24-1

Site No. 24 - Stranahan High School – Aerial March 2017

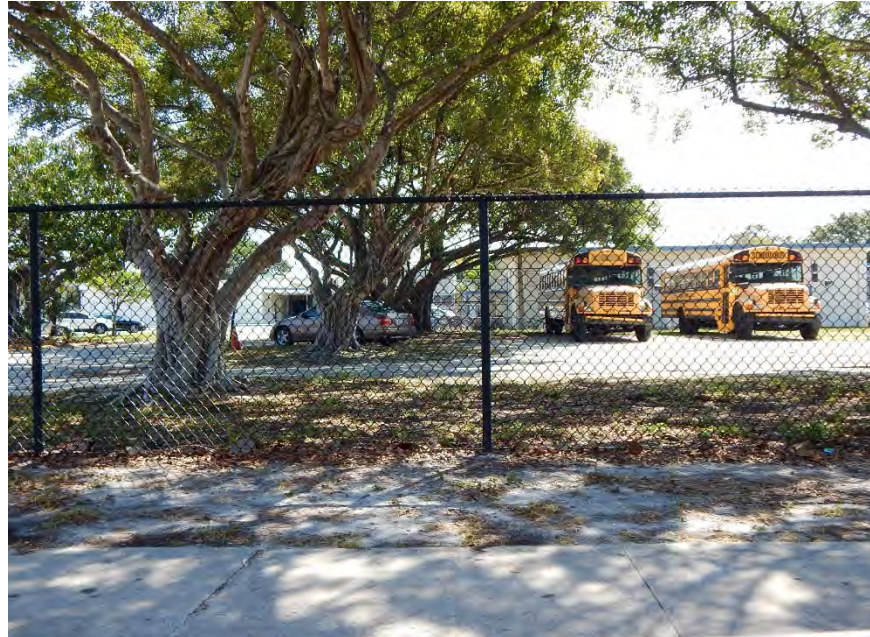
Photo 24-2

Site No. 24 - Stranahan High School – View Towards the East

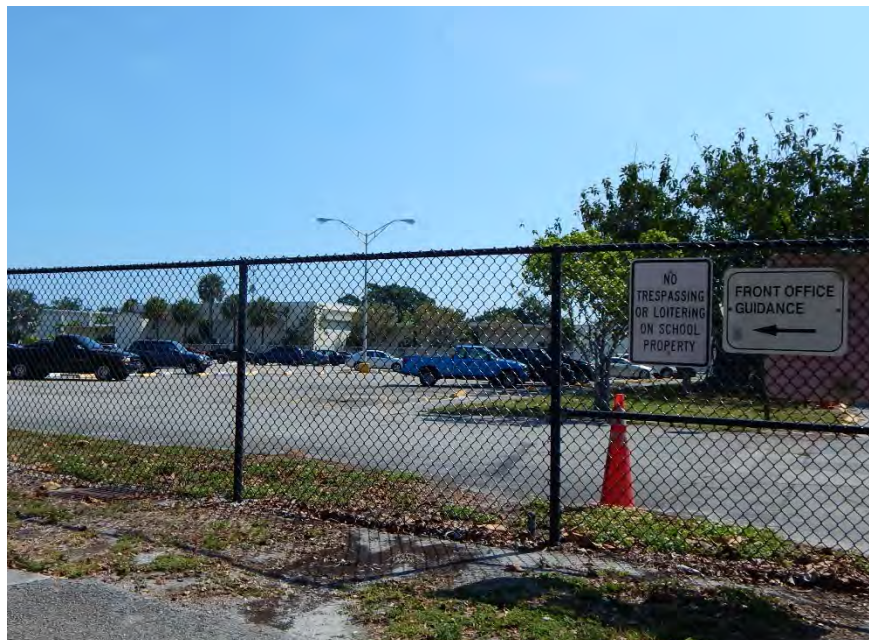
Photo 24-3

Site No. 24 - Stranahan High School – View Towards the East

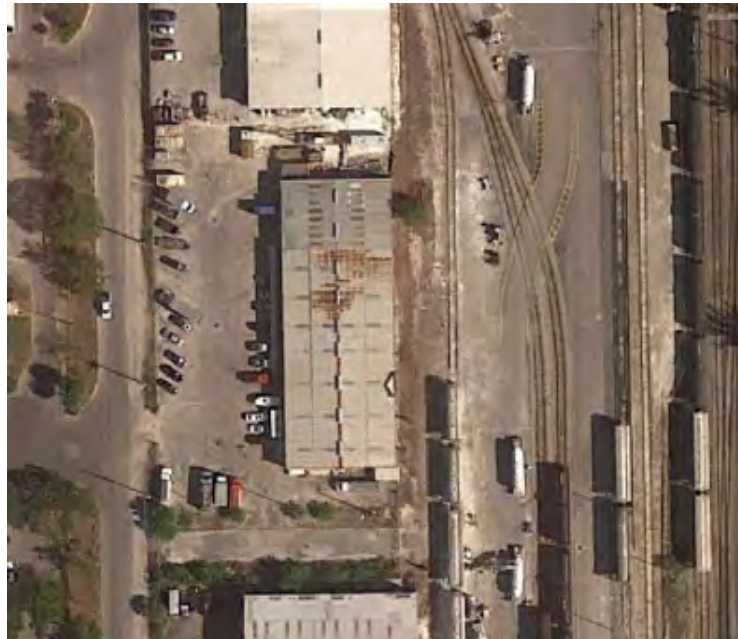
Photo 24-4

Site No. 24 - Stranahan High School – View Towards the Northeast

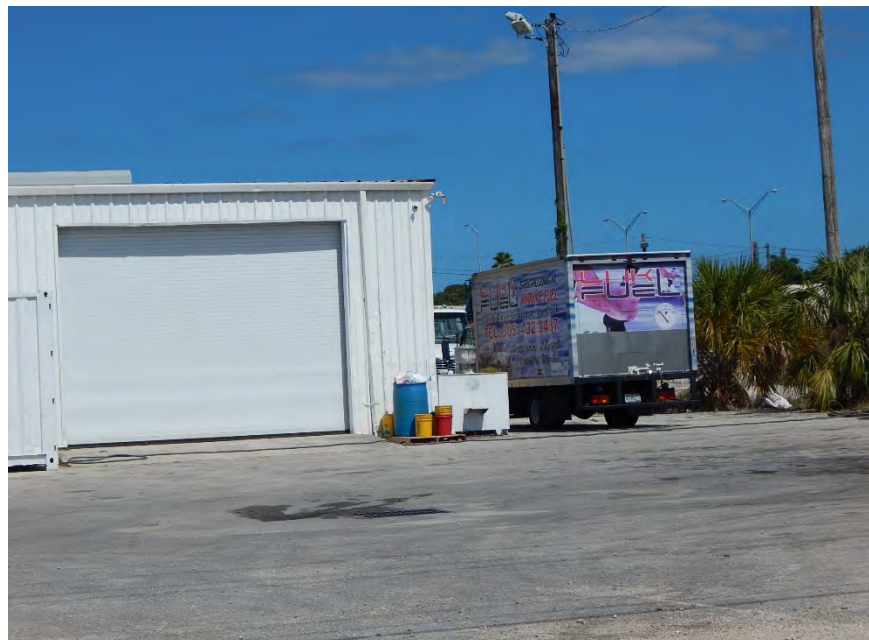
Photo 25-1

Site No. 25 – Megawattage – Aerial March 2017

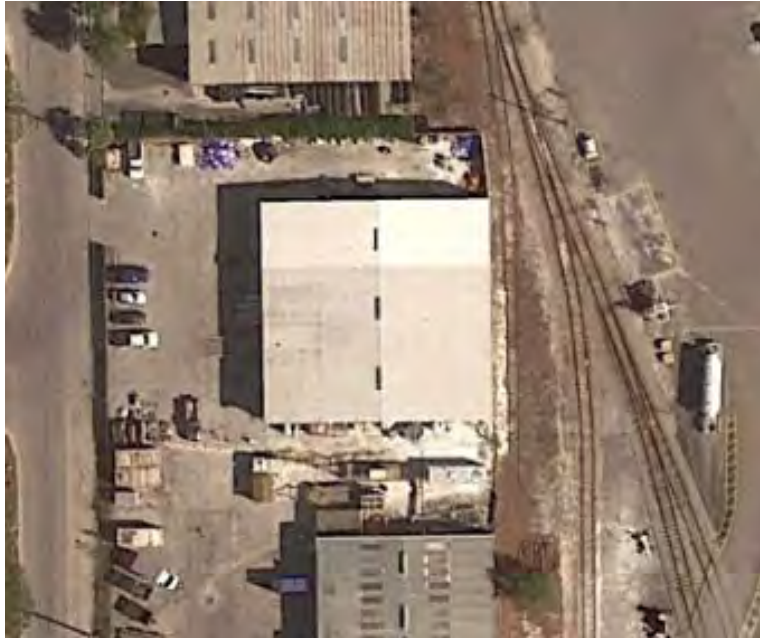
Photo 25-2

Site No. 25 – Megawattage – View Towards the East-Southeast

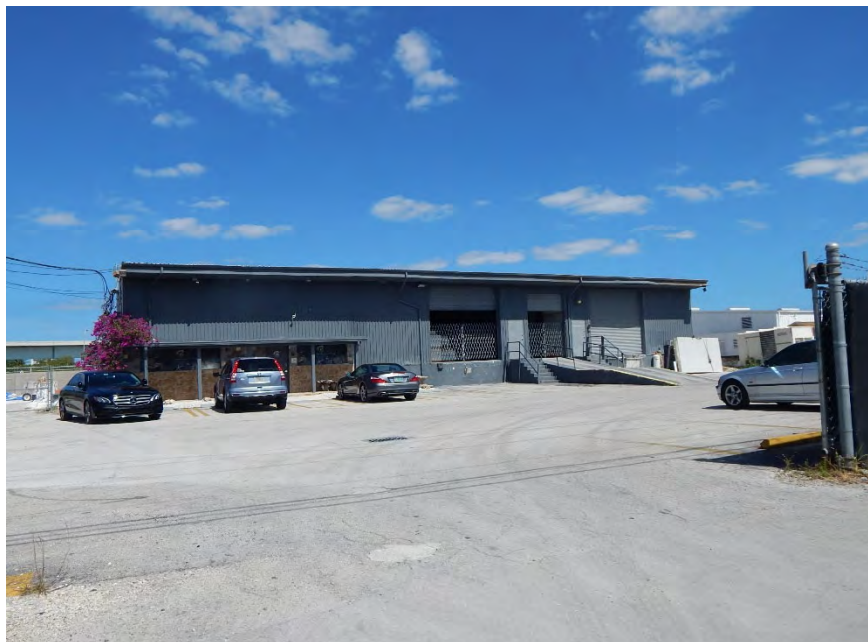
Photo 26-1

Site No. 26 – Matrix-Z LLC – Aerial March 2017

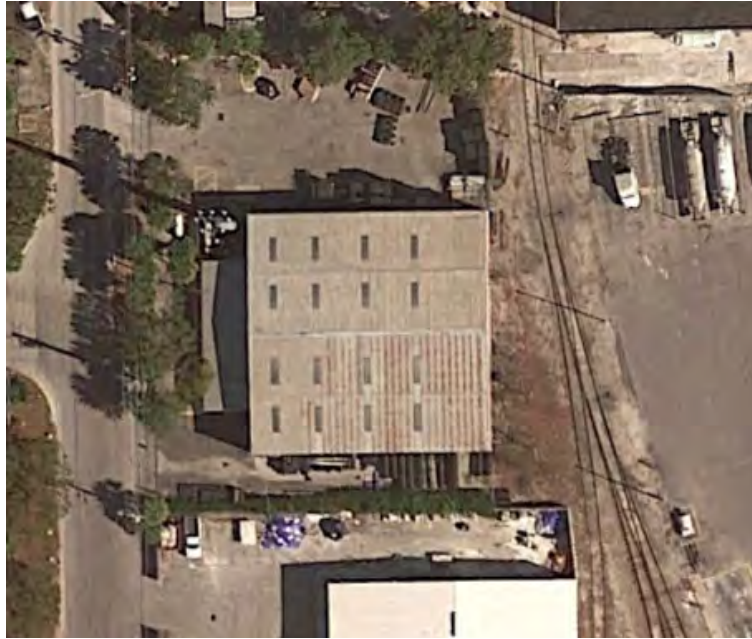
Photo 26-2

Site No. 26 – Matrix-Z LLC – View Towards the East

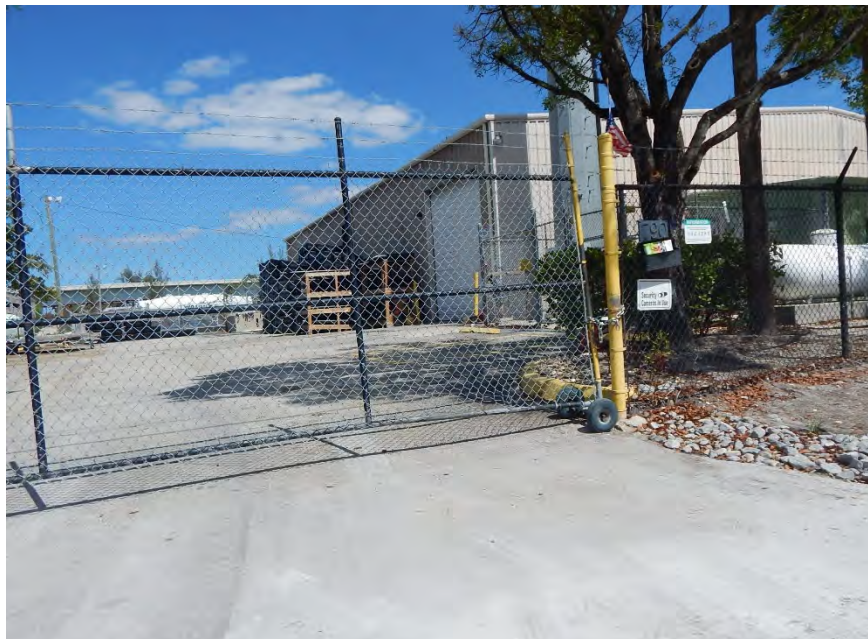
Photo 27-1

Site No. 27 - Jet Dock Systems, Verizon Wireless - Esler Site
Aerial March 2017

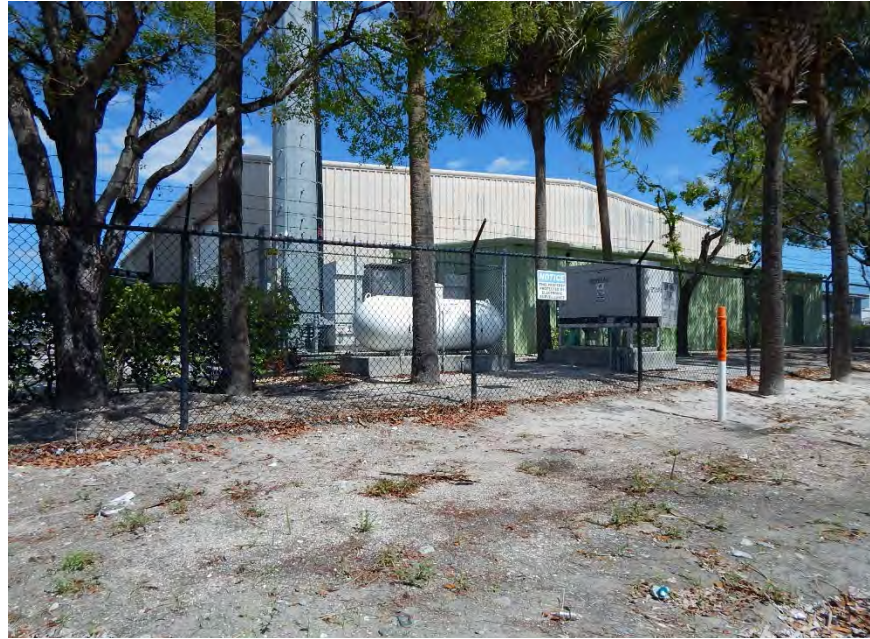
Photo 27-2

Site No. 27 - Jet Dock Systems, Verizon Wireless - Esler Site
View Towards the East

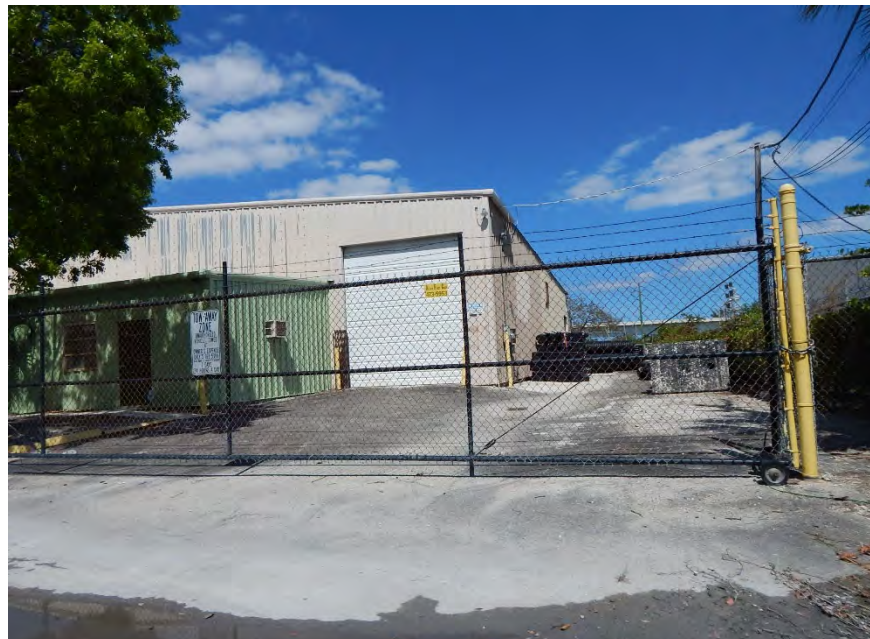
Photo 27-3

Site No. 27 - Jet Dock Systems, Verizon Wireless - Esler Site
View Towards the Southeast

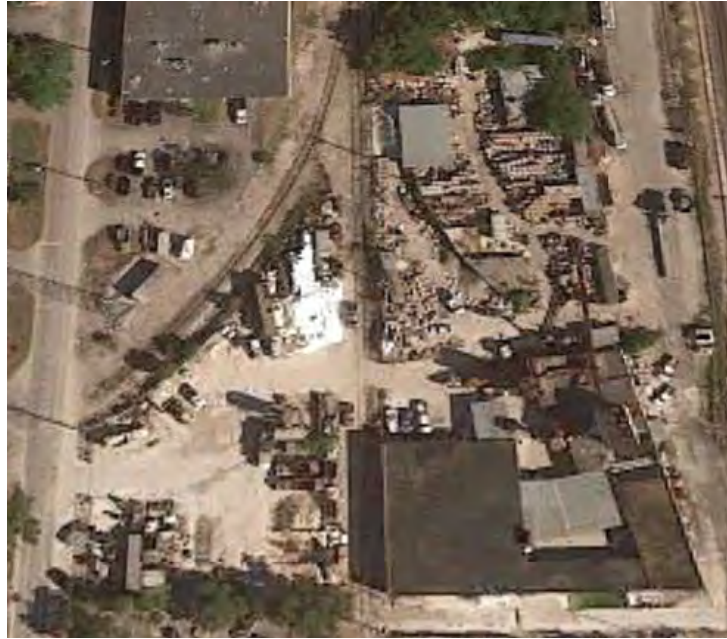
Photo 27-4

Site No. 27 - Jet Dock Systems, Verizon Wireless - Esler Site
View Towards the East

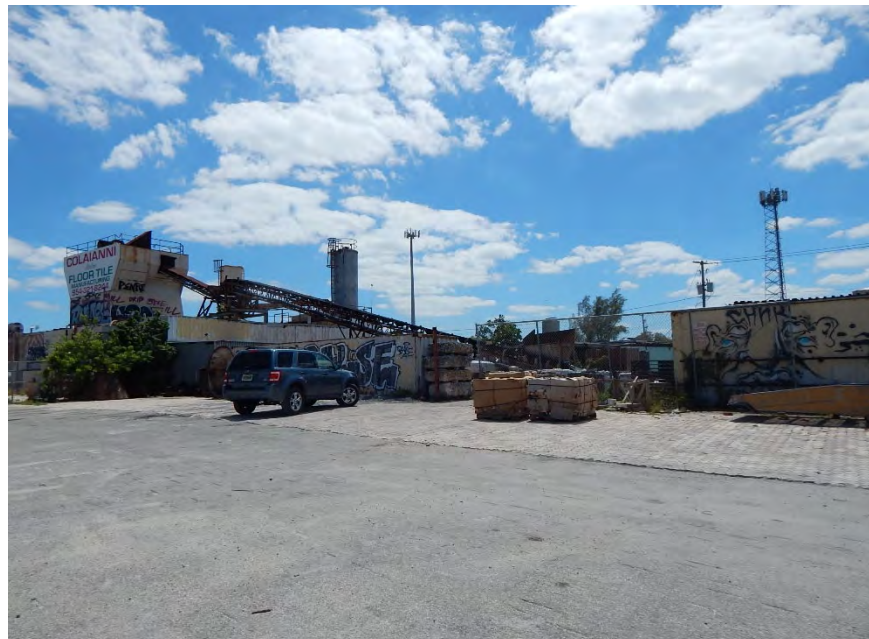
Photo 28-1

Site No. 28 – Colaianni Italian Floor Tile Manufacturing
Aerial March 2017

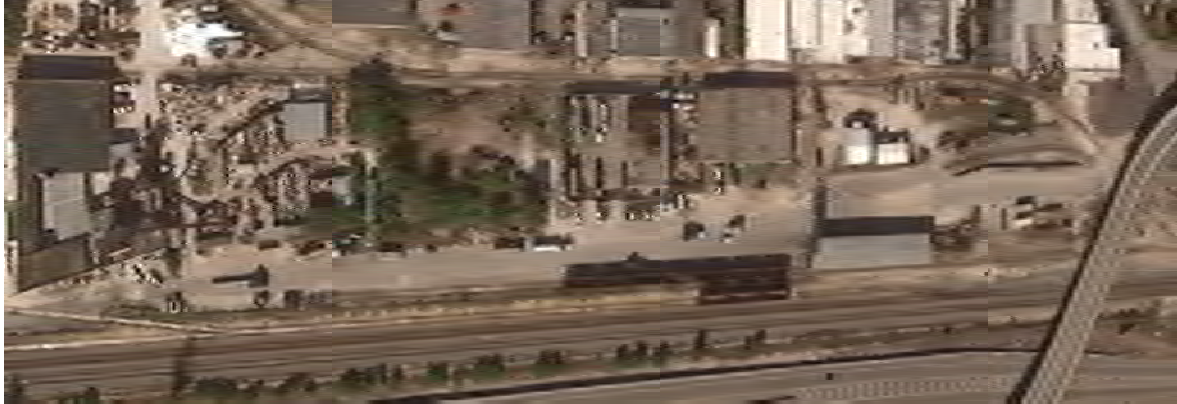
Photo 28-2

Site No. 28 – Colaianni Italian Floor Tile Manufacturing
View Towards the Southwest

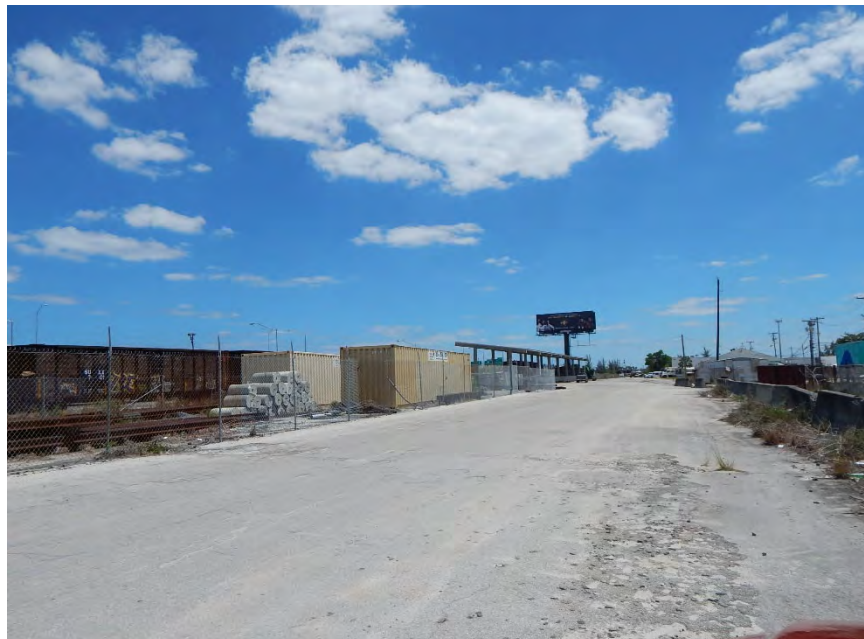
Photo 29-1

Site No. 29 – CSX Transportation Railyard
Aerial March 2017

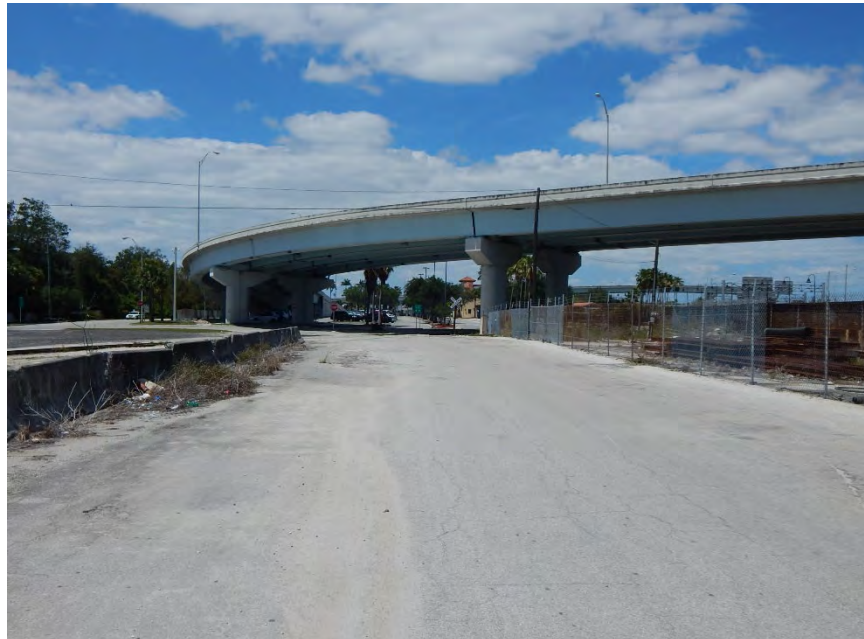
Photo 29-2

Site No. 29 – CSX Transportation Railyard
View Towards the South

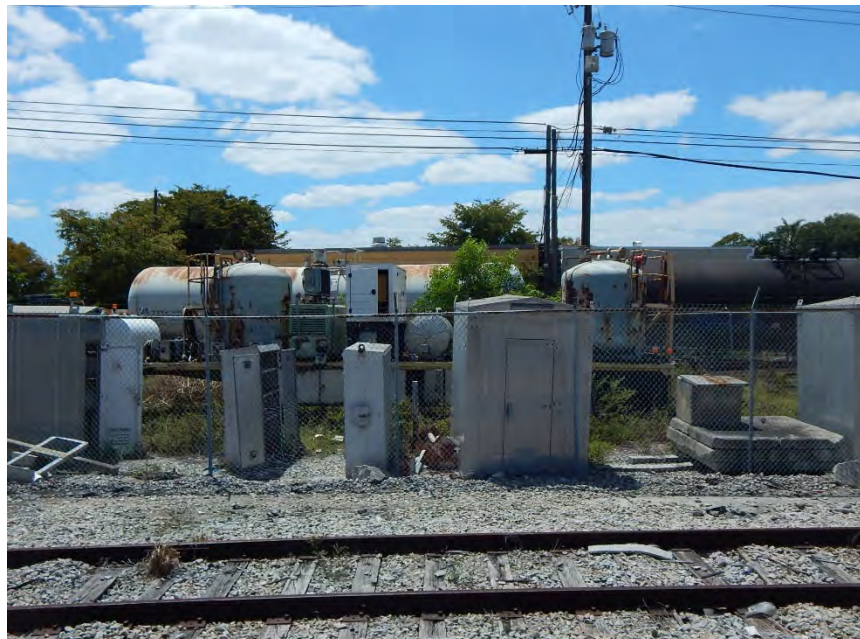
Photo 29-3

Site No. 29 – CSX Transportation Railyard & Spill
View Towards the North

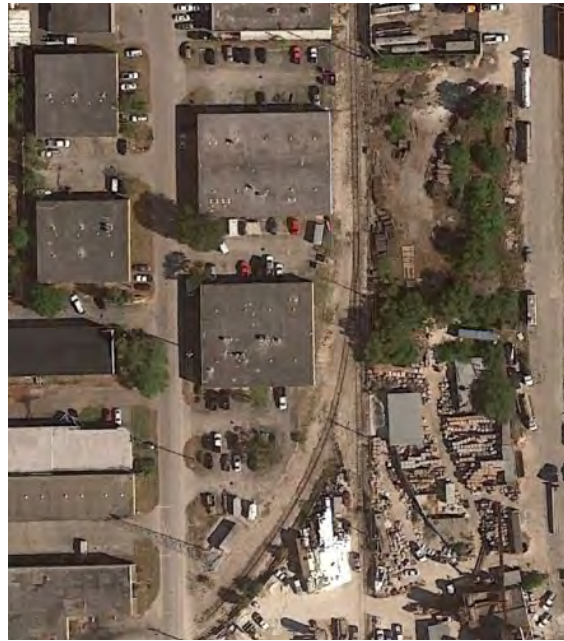
Photo 29-4

Site No. 29 – CSX Transportation Railyard & Spill
View Towards the East

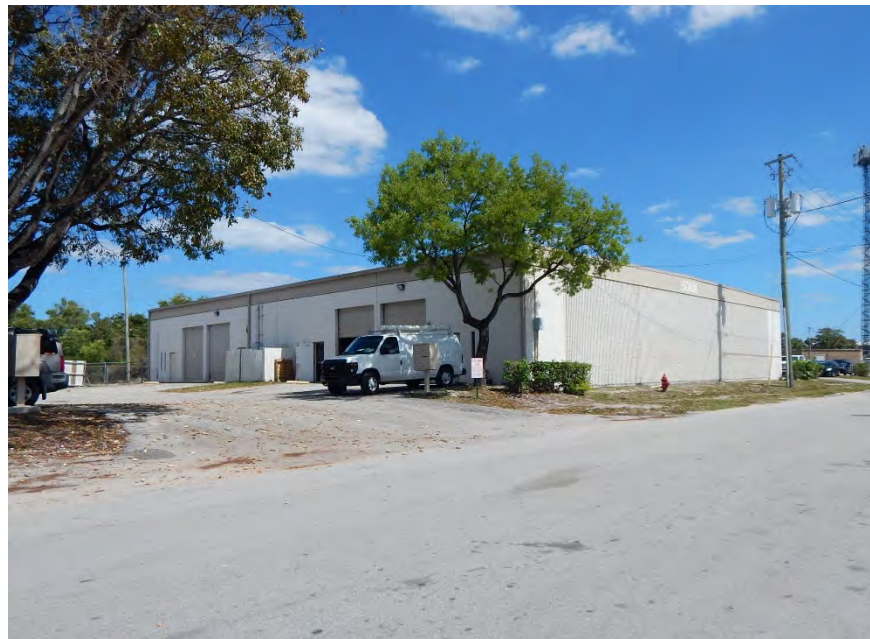
Photo 30-1

Site No. 30 – Multi-tenant Light Industrial Warehouses & Cell Tower
Aerial March 2017

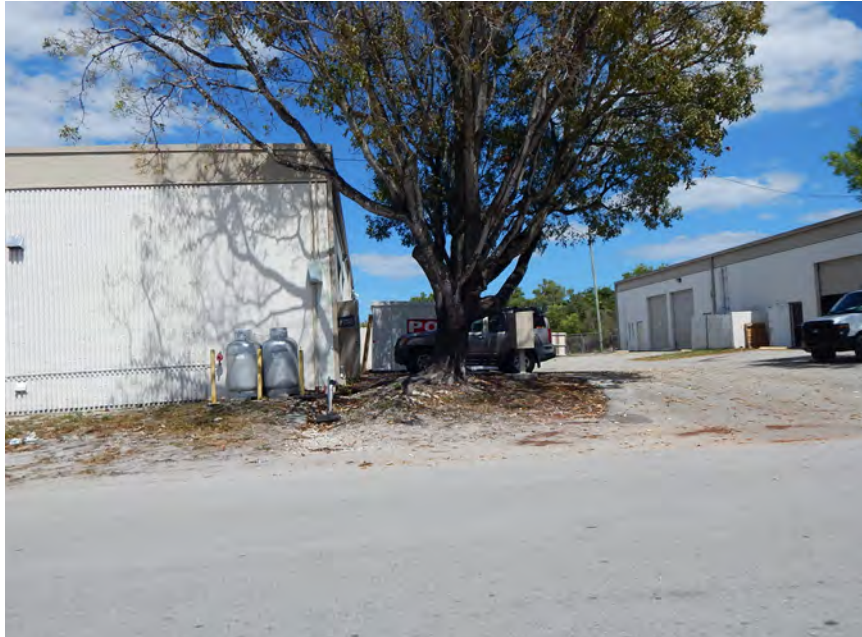
Photo 30-2

Site No. 30 – Multi-tenant Light Industrial Warehouses & Cell Tower
View Towards the Southeast

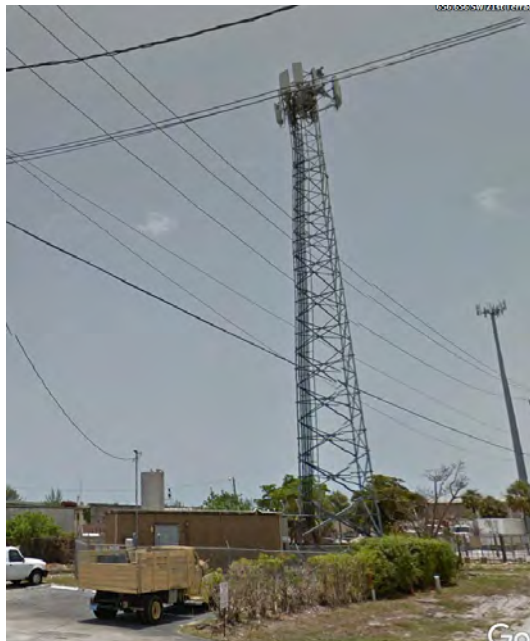
Photo 30-3

Site No. 30 – Multi-tenant Light Industrial Warehouses & Cell Tower
View Towards the East

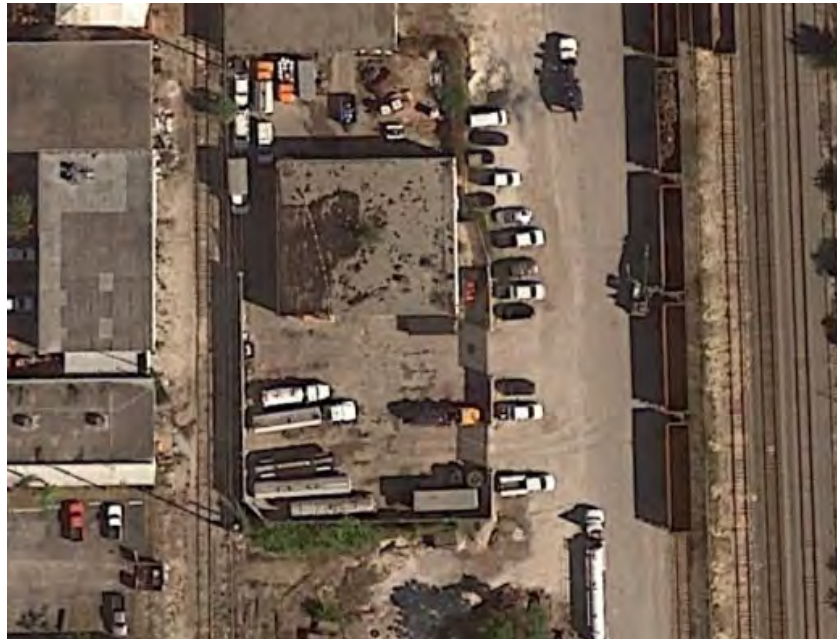
Photo 30-4

Site No. 30 – Multi-tenant Light Industrial Warehouses & Cell Tower
View Towards the Southeast

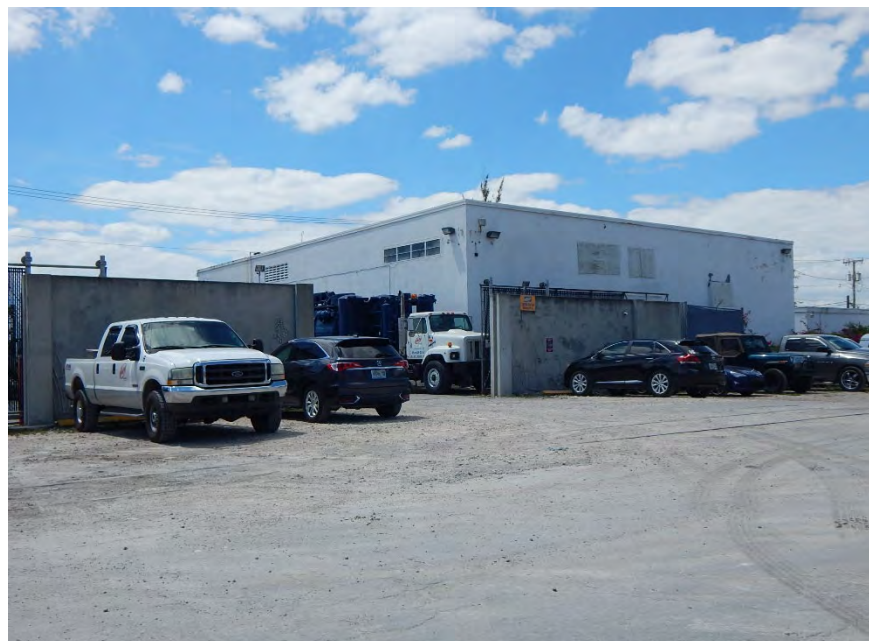
Photo 31-1

Site No. 31 - Jam Environmental & Vacuum Services LLC
Aerial March 2017

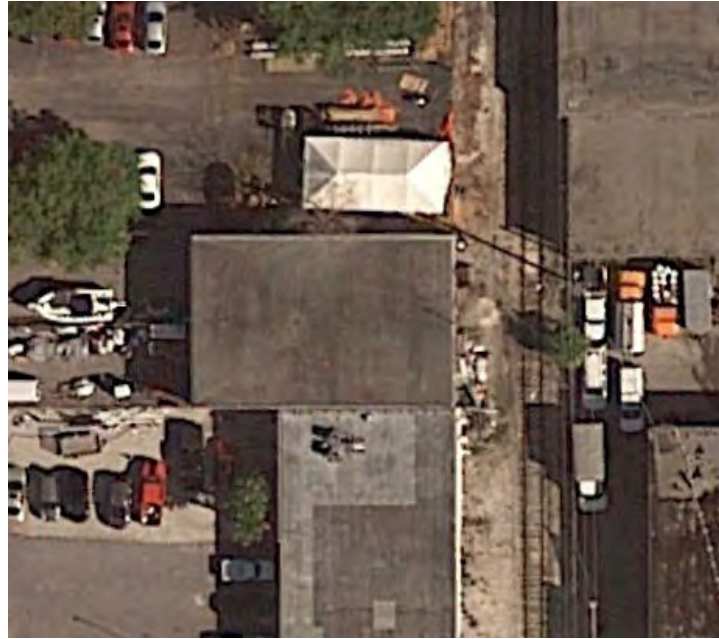
Photo 31-2

Site No. 31 - Jam Environmental & Vacuum Services LLC
View Towards the Northwest

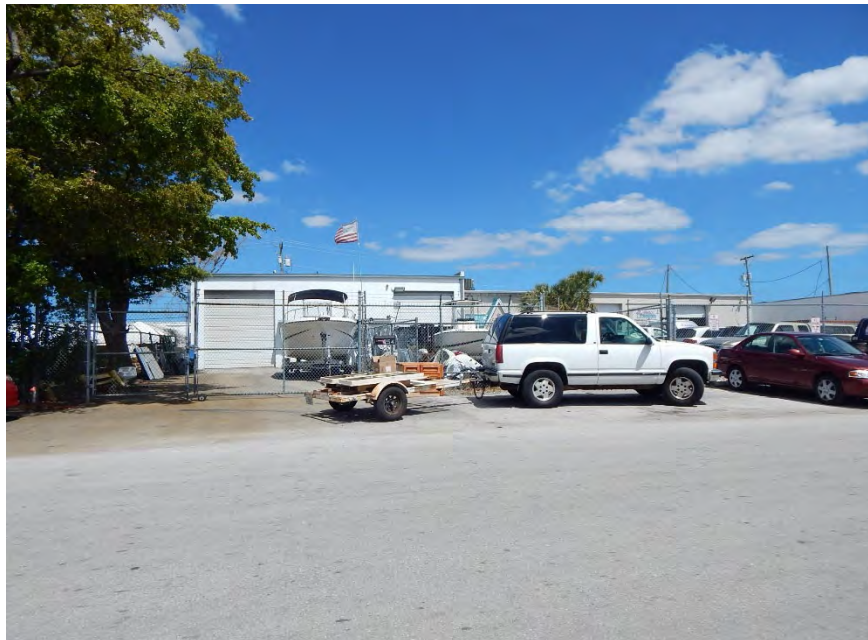
Photo 32-1

Site No. 32 - AA Carbonics – Aerial March 2017

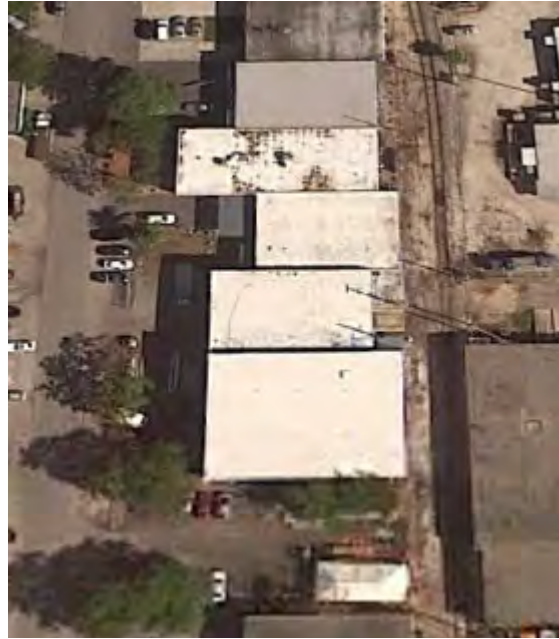
Photo 32-2

Site No. 32 - AA Carbonics – View Towards the East

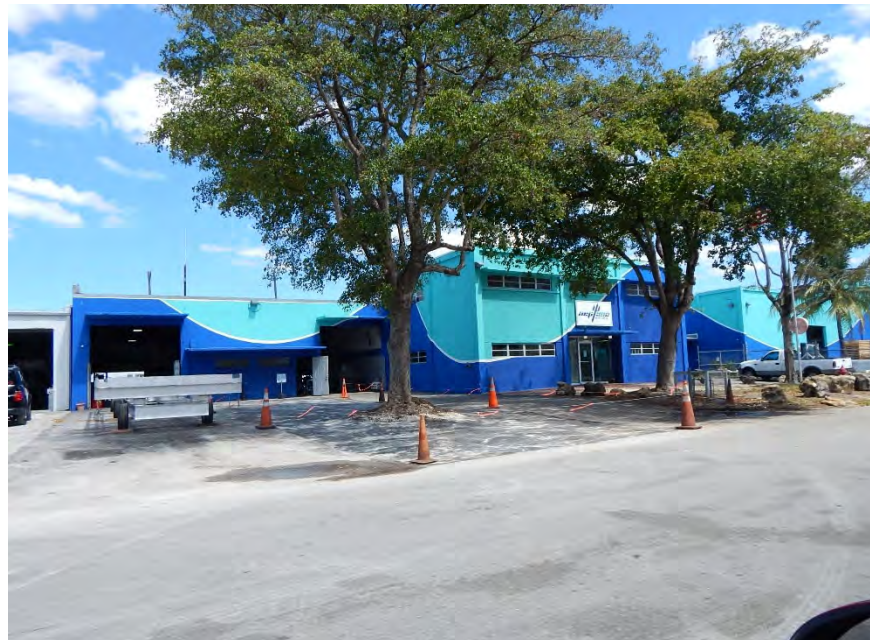
Photo 33-1

Site No. 33 - Neptune Boat Lifts – Aerial March 2017

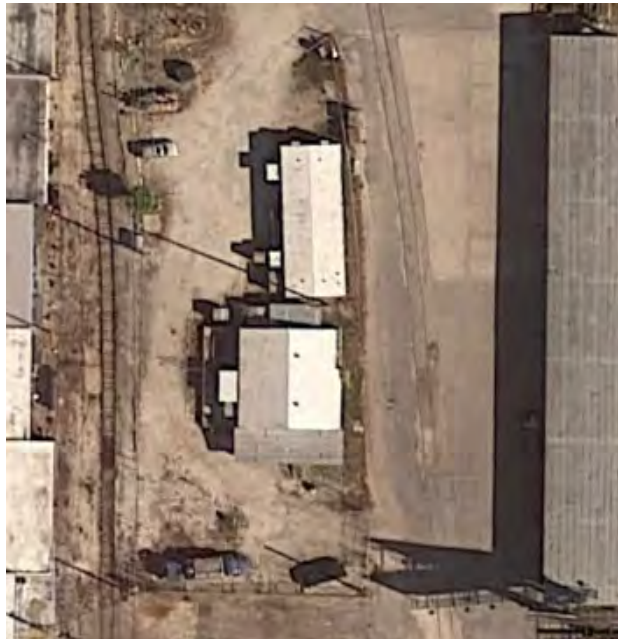
Photo 33-2

Site No. 33 – Neptune Boat Lifts – View Towards the East

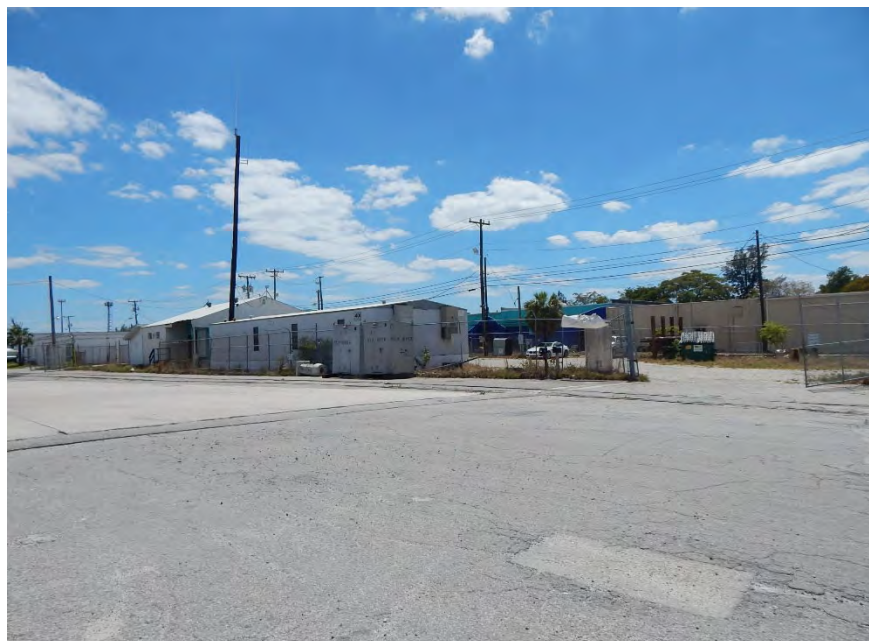
Photo 34-1

Site No. 34 - CSX Transportation Railyard, (Former) Tire Eliminators Inc.
Aerial March 2017

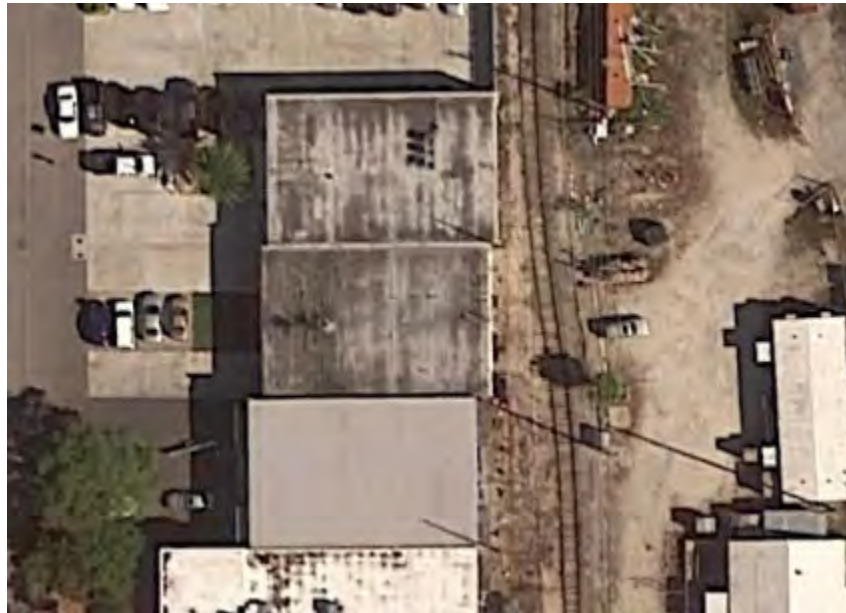
Photo 34-2

Site No. 34 - CSX Transportation Railyard, (Former) Tire Eliminators Inc.
View Towards the Southwest
