Contamination Screening Evaluation Report

**SR-9/I-95 @ SR 842/Broward Boulevard (Broward
Boulevard from West of SW 24th Avenue to East of
NW/SW 18th Avenue)
Project Development & Environment (PD&E) Study**

Efficient Transportation Decision Making (ETDM) No.: 14226

**Broward County, Florida
Financial Project ID Number: 435513-1-22-02**

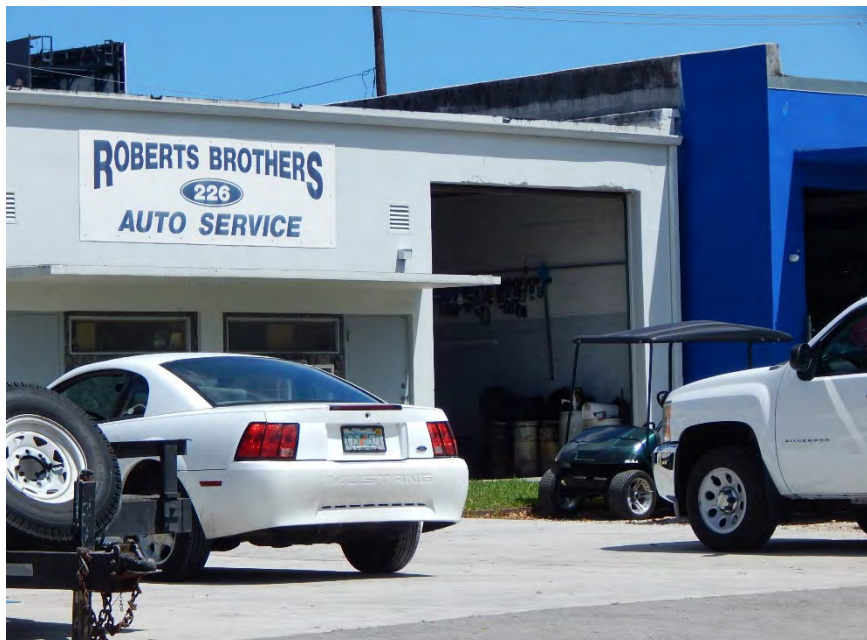
Photo 35-1

Site No. 35 - Roberts Brothers Auto Service – Aerial March 2017

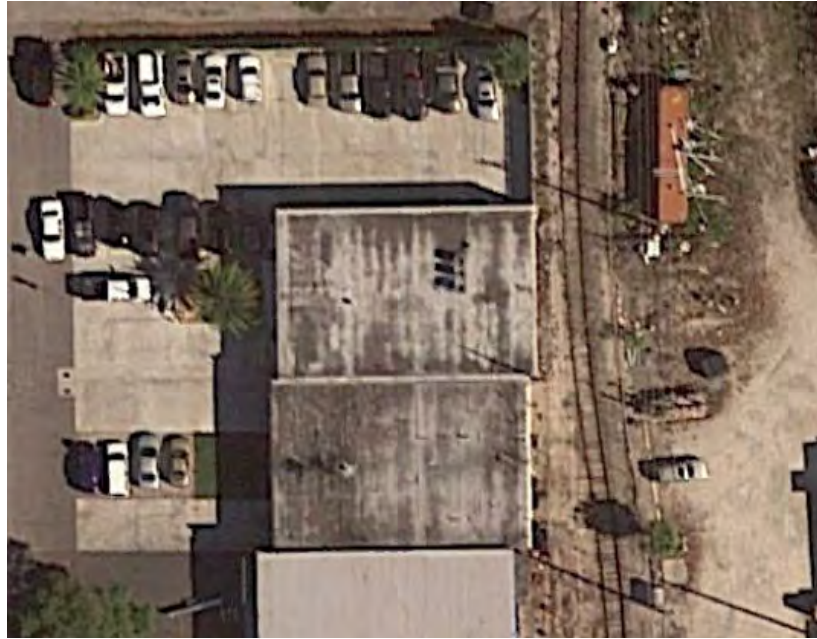
Photo 35-2

Site No. 35 - Roberts Brothers Auto Service
View Towards the Southeast

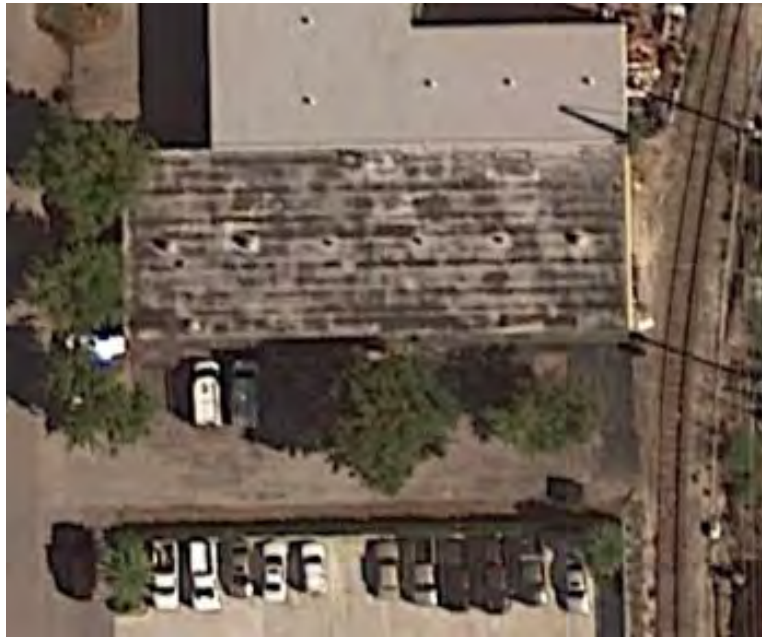
Photo 36-2

Site No. 36 - D&D Mobile Welding and Fabrication Inc.
View Towards the Southeast

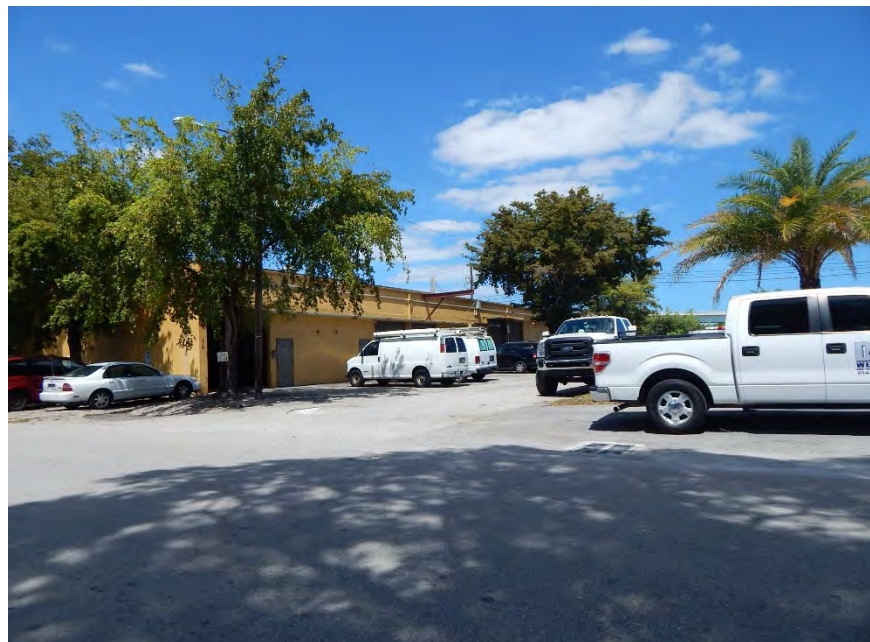
Photo 37-1

Site No. 37 – Omni Boat Canvas – Aerial March 2017

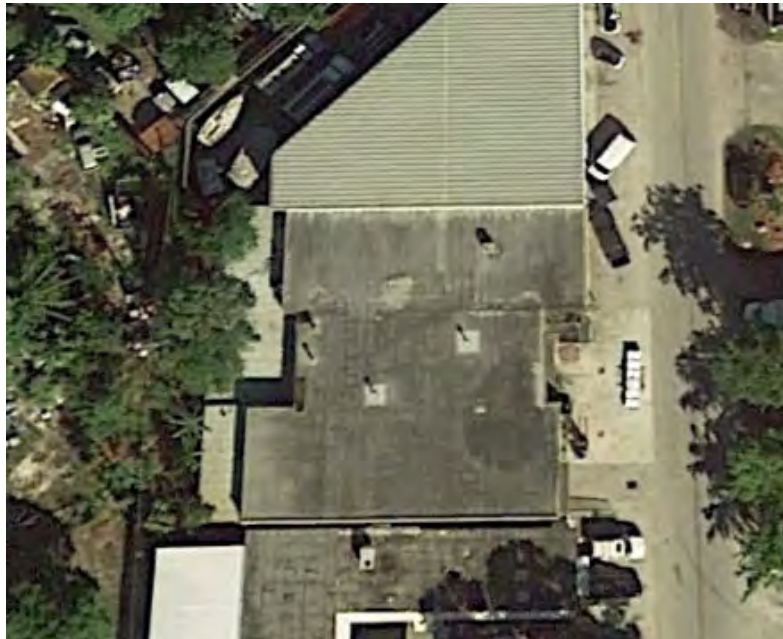
Photo 37-2

Site No. 37 - Omni Boat Canvas – View Towards the Northeast

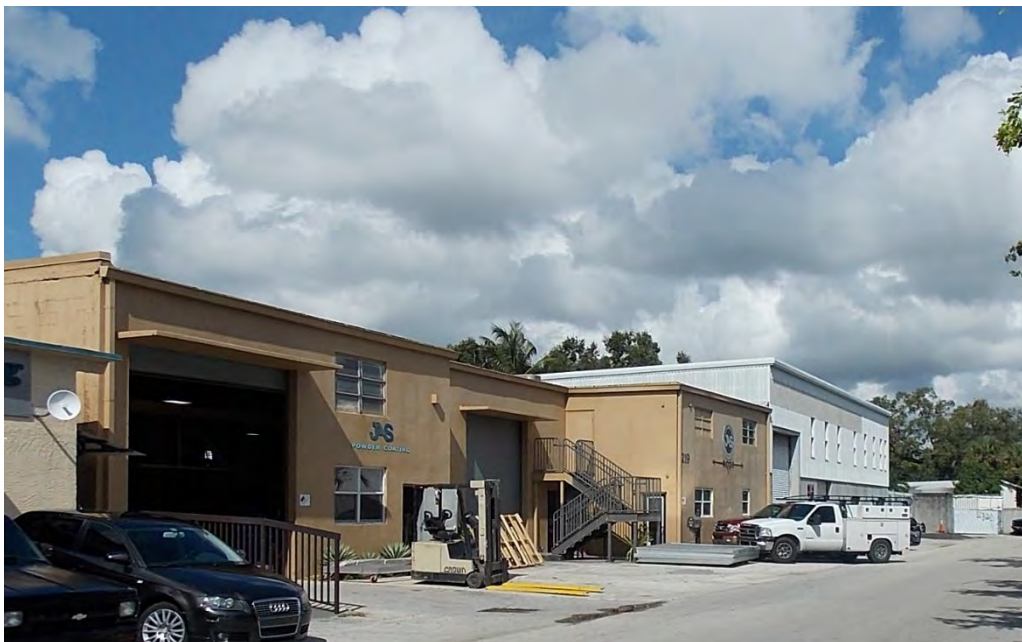
Photo 38-1

Site No. 38 – JAS Powder Coating – Aerial December 2017

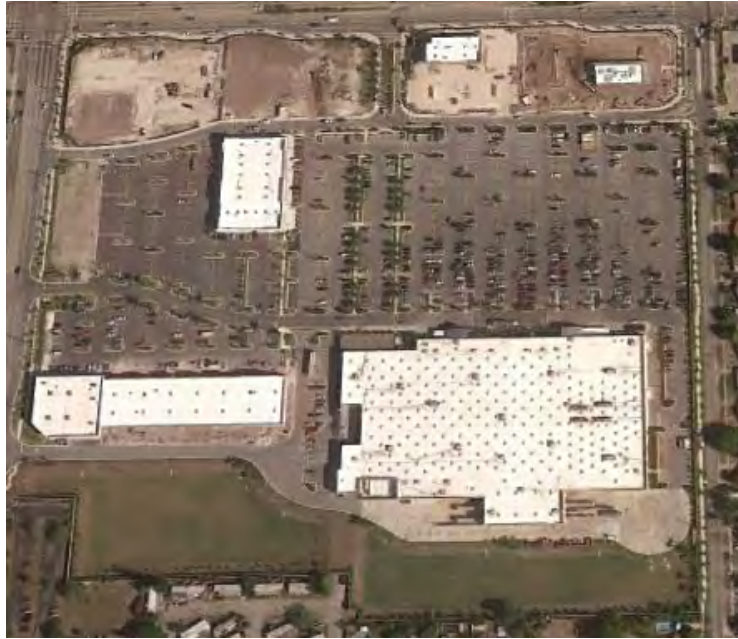
Photo 38-2

Site No. 38 – JAS Powder Coating

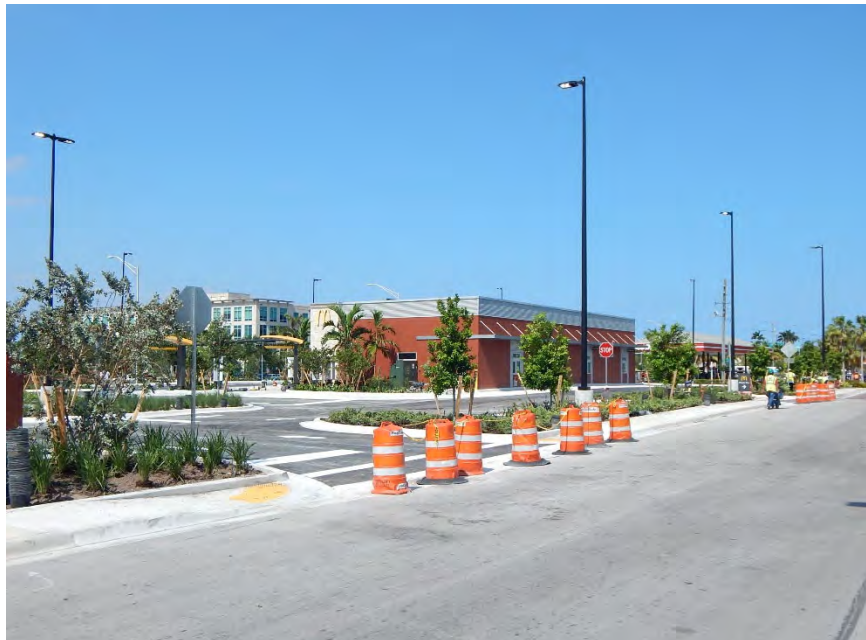
Photo 39-1

Site No. 39 - Riverbend Retail Development – Aerial March 2017

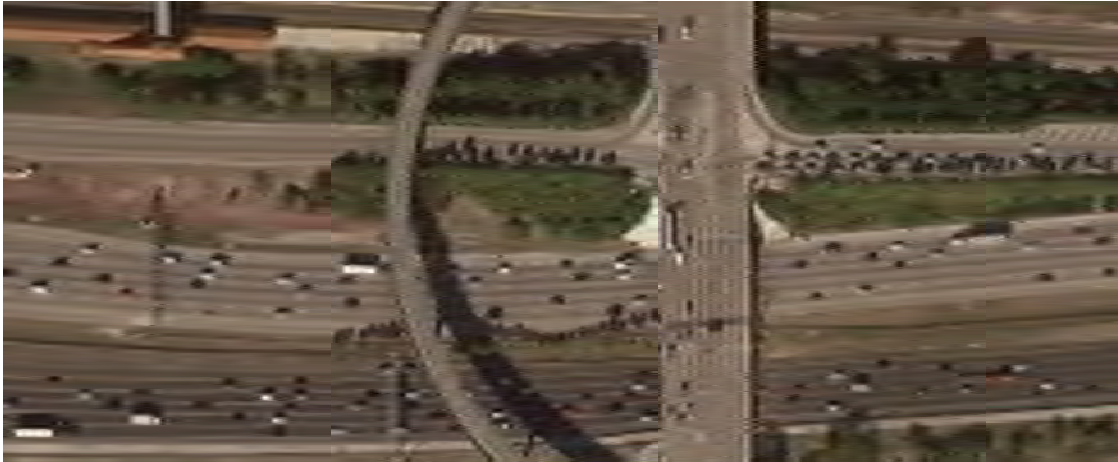
Photo 40-1

Site No. 40 – Truck/Auto Accident-Spill – Aerial March 2017

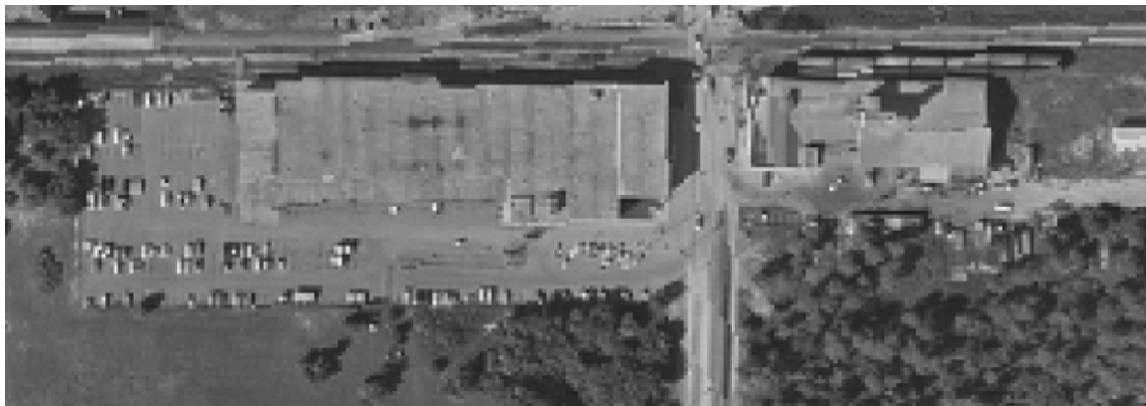
Photo 41-1

Site No. 41 - FDOT Transportation Corridor
(Former) Everglades Fertilizer Co. – Aerial March 2017

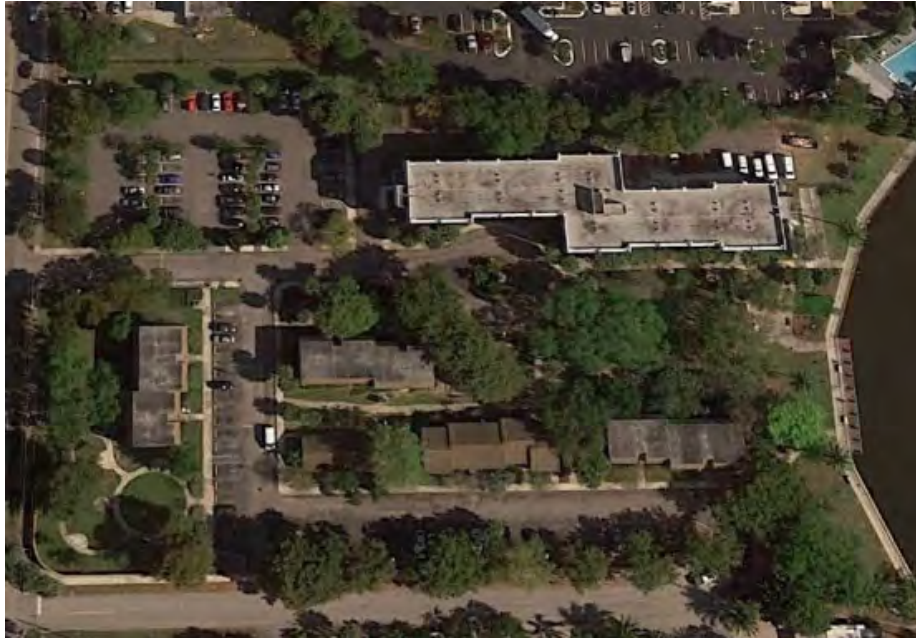
Photo 41-2

Site No. 41 - FDOT Transportation Corridor
(Former) Everglades Fertilizer Co. – Aerial December 1958

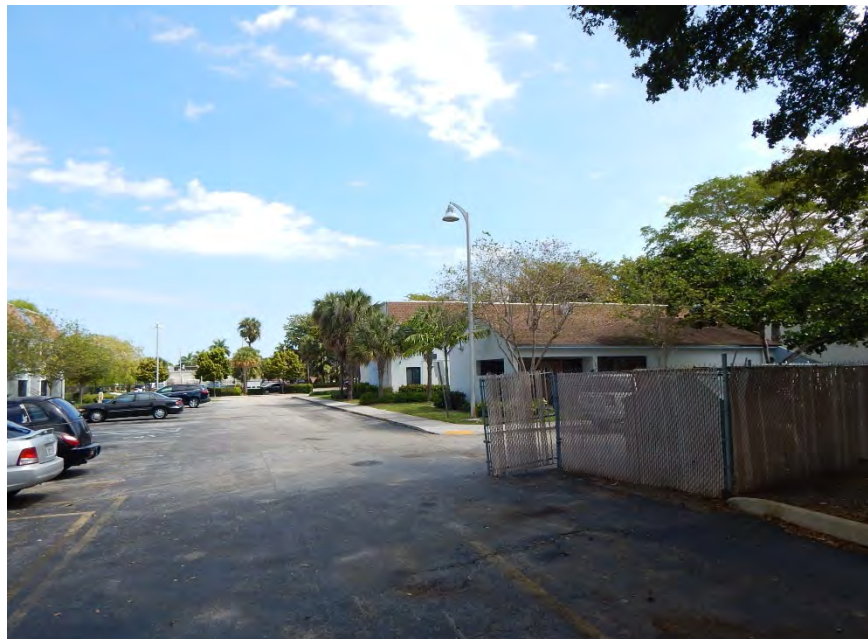
Photo 42-1

Site No. 42 - Sunnyreach Acres - Housing Authority, City of Ft. Lauderdale
Aerial March 2017

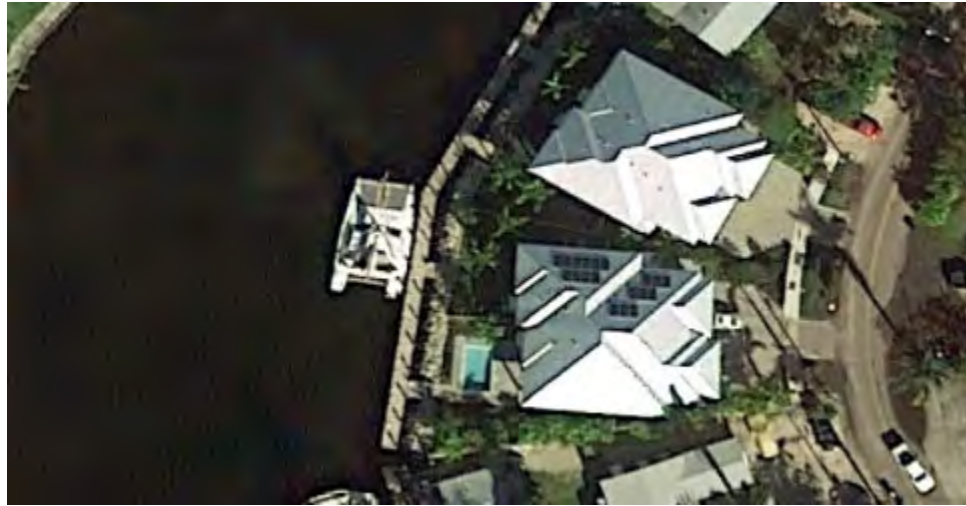
Photo 42-2

Site No. 42 - Sunnyreach Acres - Housing Authority, City of Ft. Lauderdale
View Towards the North

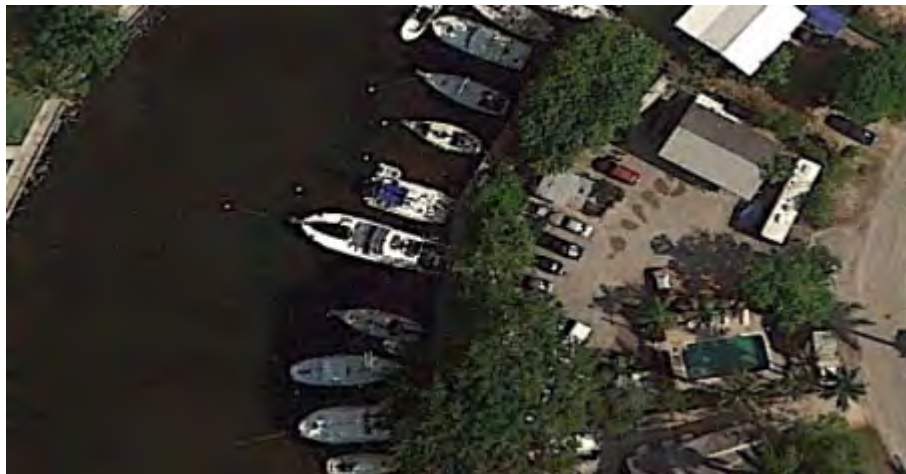
Photo 43-1

Site No. 43 - Spill – Aerial December 2017

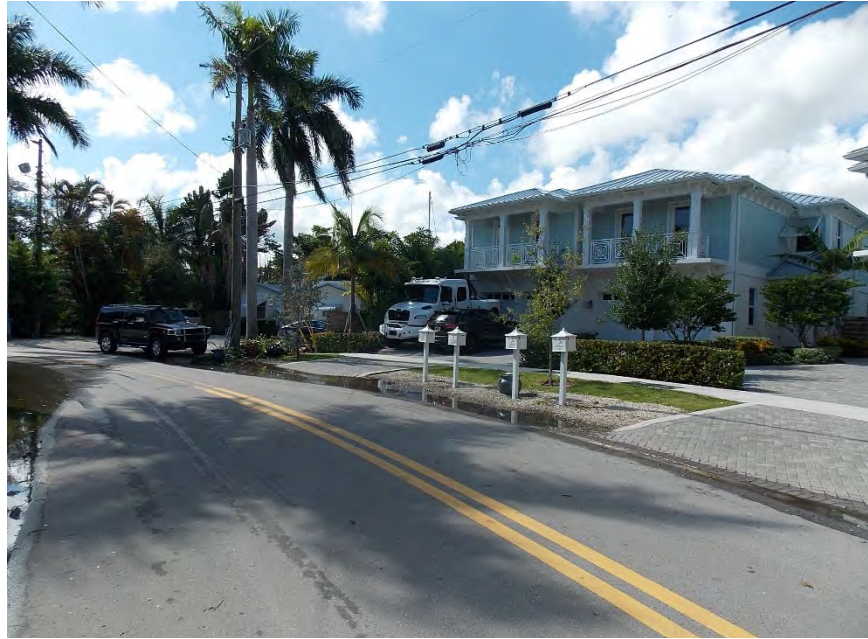
Photo 43-2

Site No. 43 – Spill – Aerial March 2011

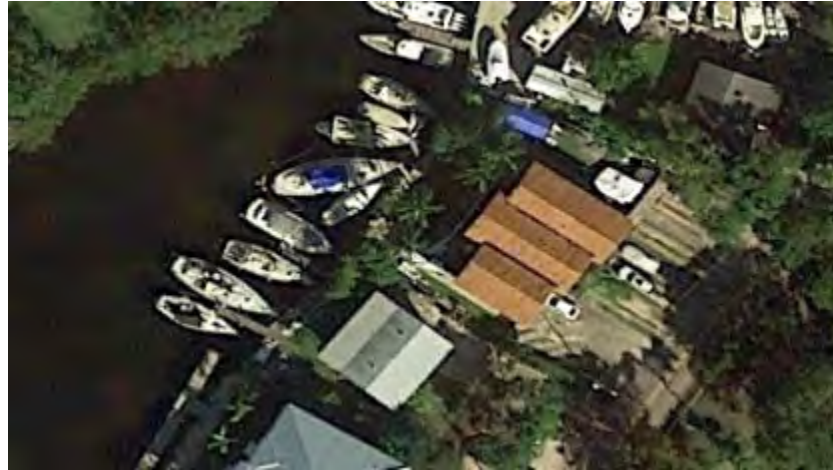
Photo 43-3

Site No. 43 - Spill – View towards the South

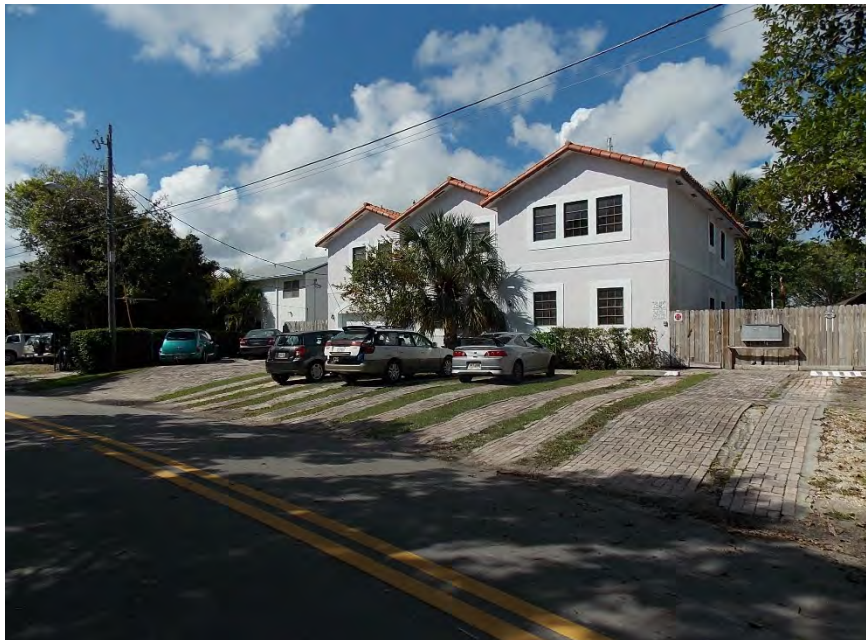
Photo 44-1

Site No. 44 - Spill – Aerial December 2017

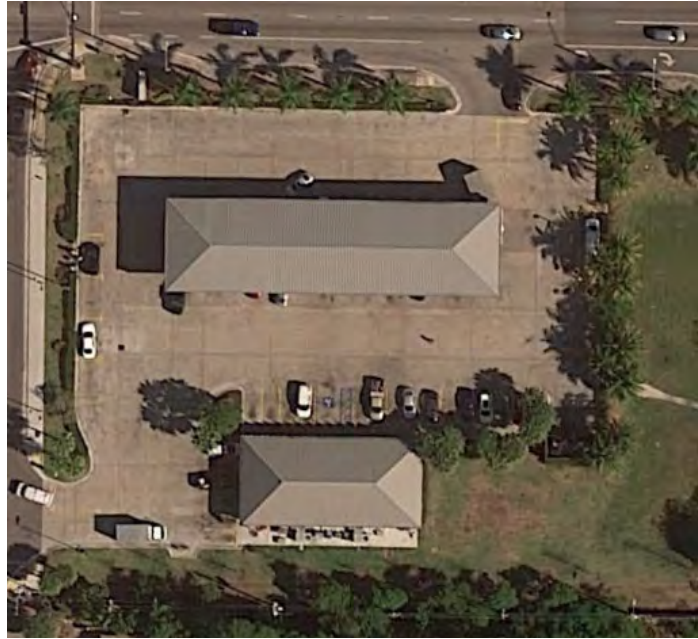
Photo 44-2

Site No. 44 – Spill
View towards the Southwest

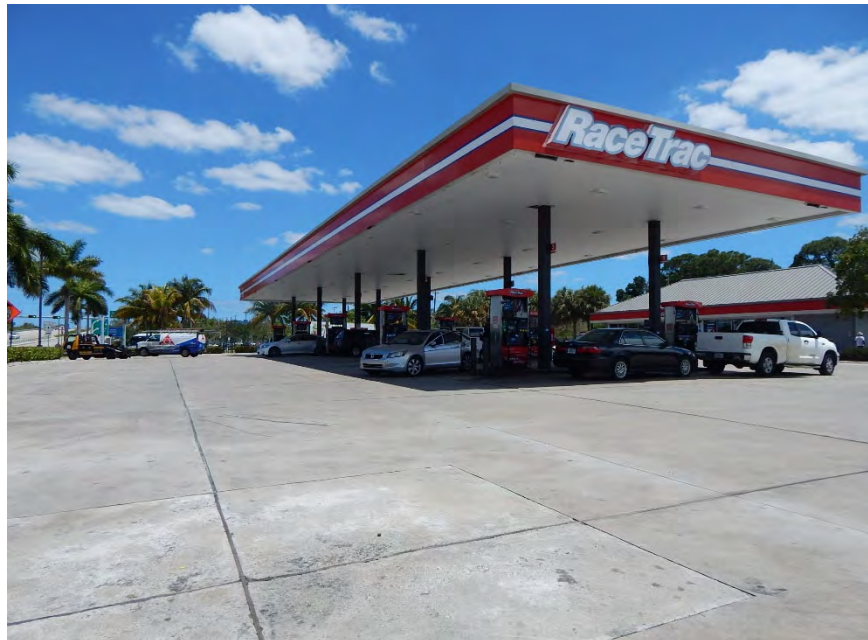
Photo 45-1

Site No. 45 - RaceTrac #665 – Aerial March 2017

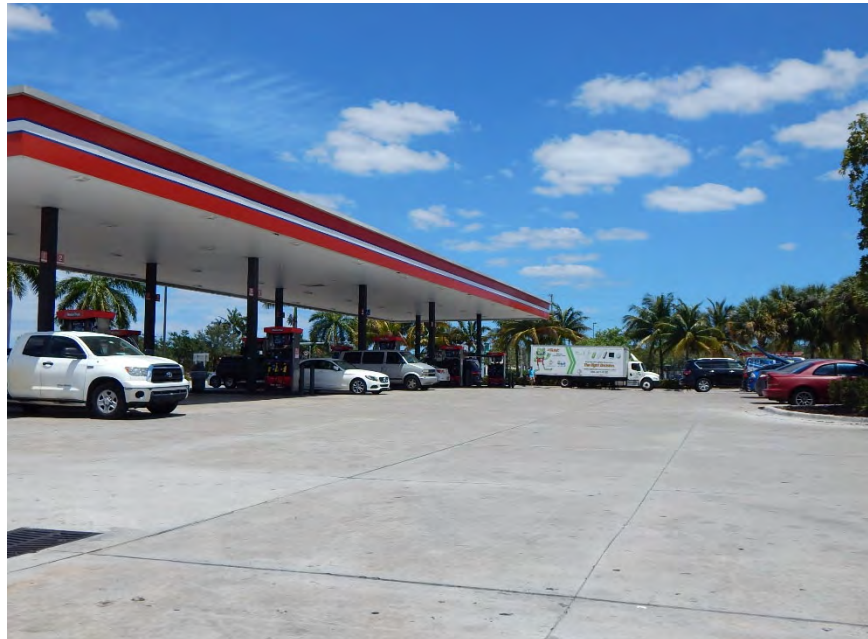
Photo 45-2

Site No. 45 - RaceTrac #665 – View Towards the Southeast

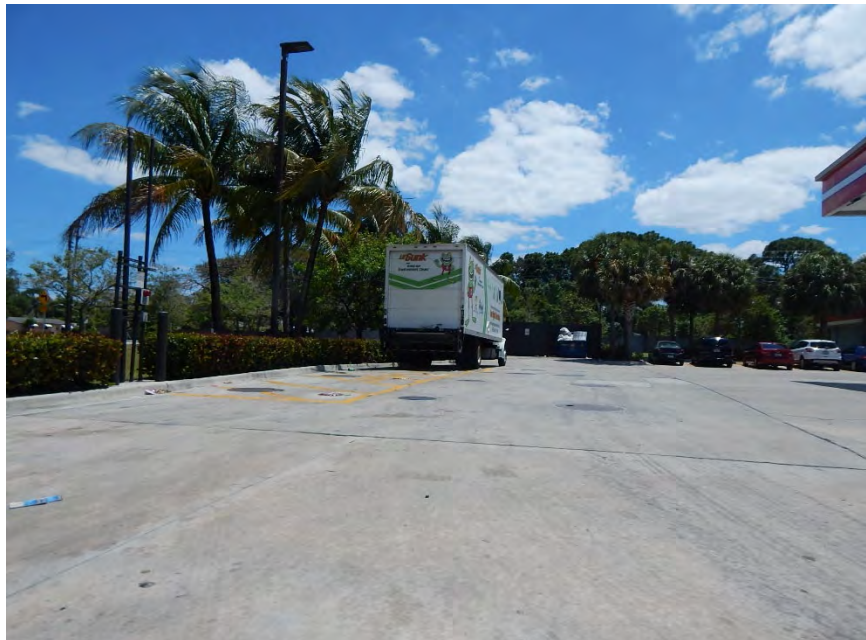
Photo 45-3

Site No. 45 - RaceTrac #665 – View Towards the East

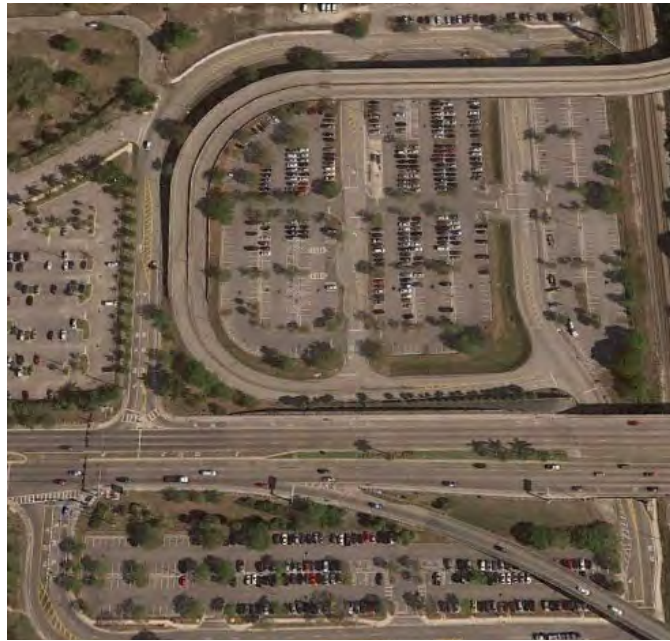
Photo 45-4

Site No. 45 - RaceTrac #665 – View Towards the South

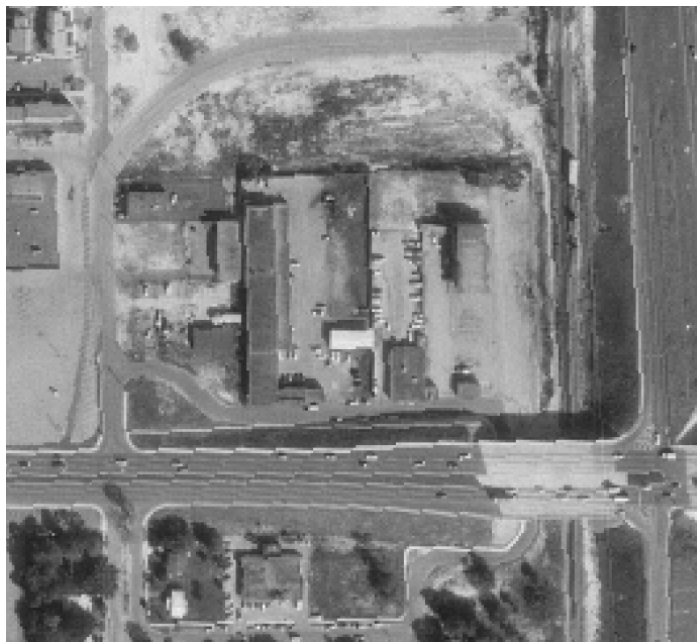
Photo 46-1

Site No. 46 - Broward Blvd Park N' Ride – Aerial March 2017

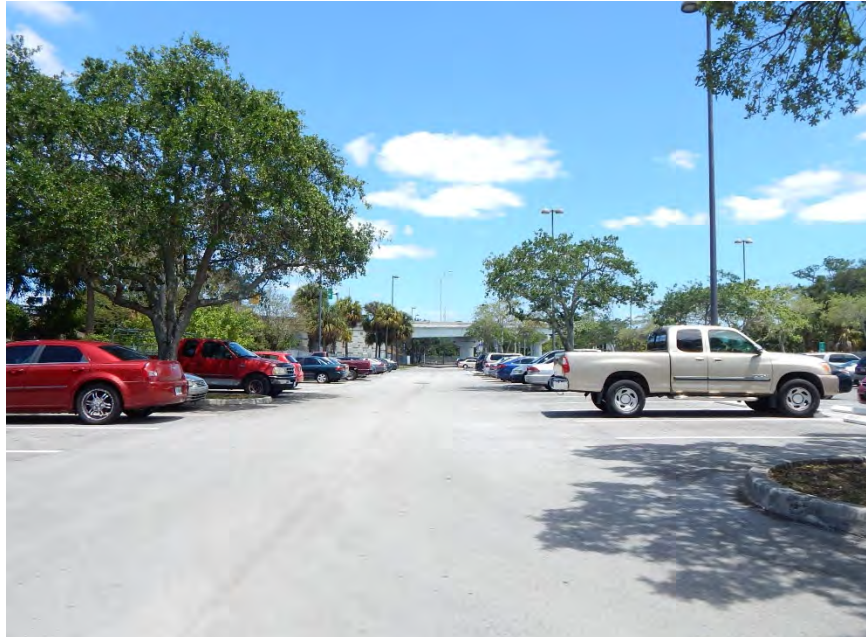
Photo 46-2

Site No. 46 - Broward Blvd Park N' Ride – Aerial January 1976

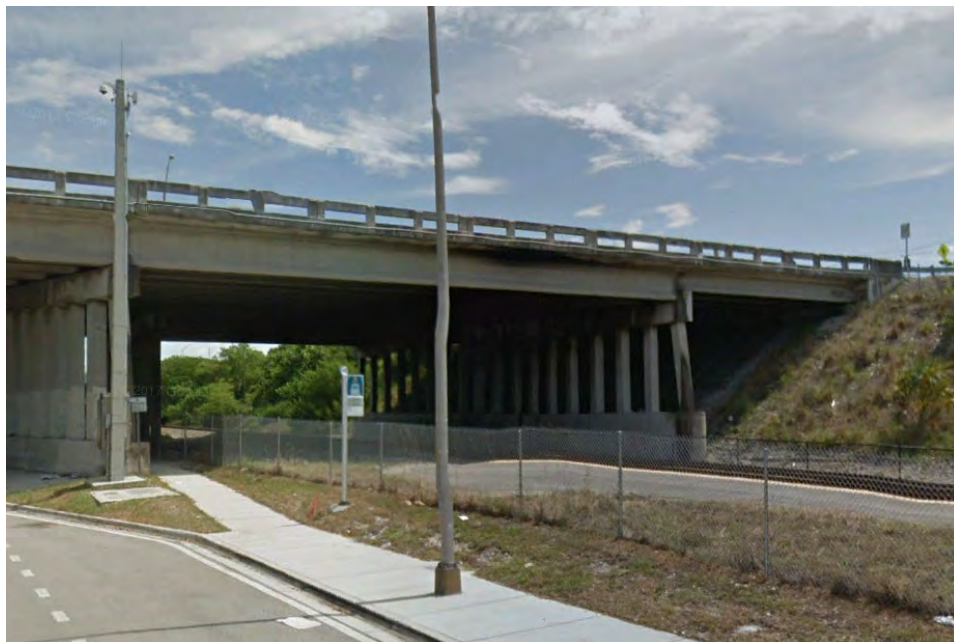
Photo 47-1

Site No. 47 – CSX Rail Corridor at Broward Boulevard – Aerial March 2017

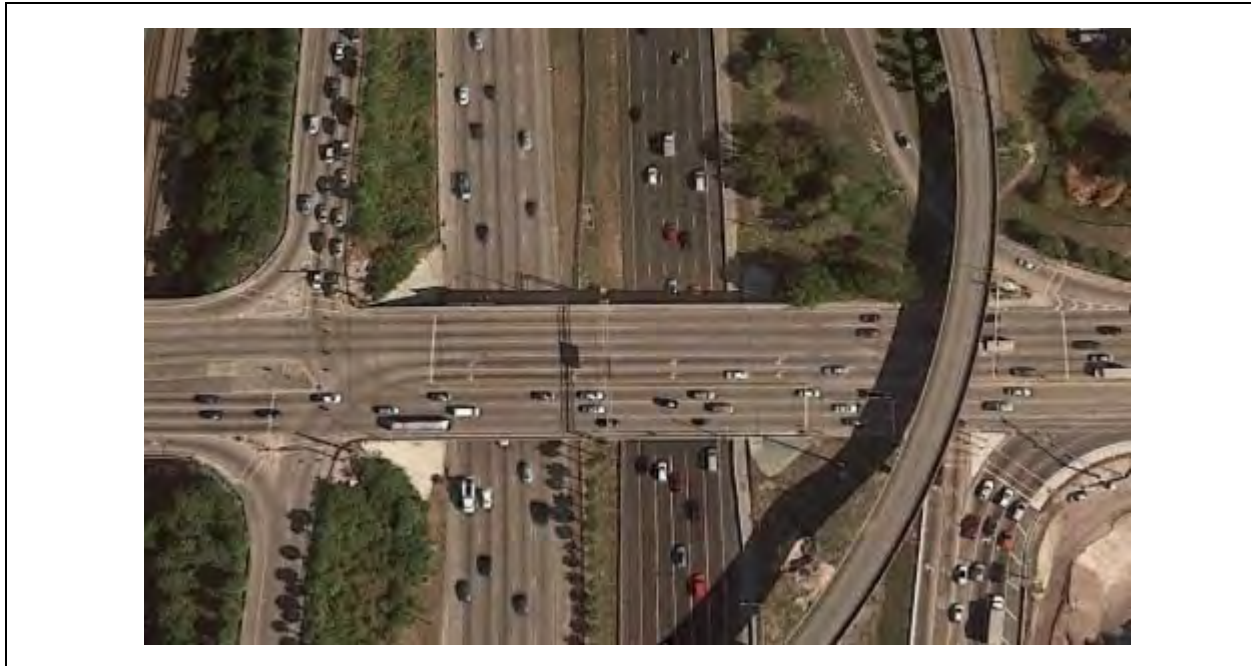
Photo 47-2

Site No. 47 - CSX Rail Corridor at Broward Boulevard
View Towards the South

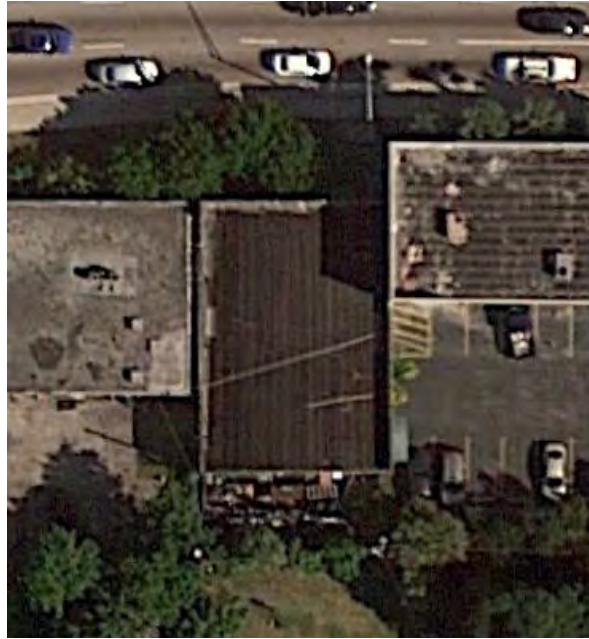
Photo 48-1

Site No. 48 – Spill – Aerial March 2017

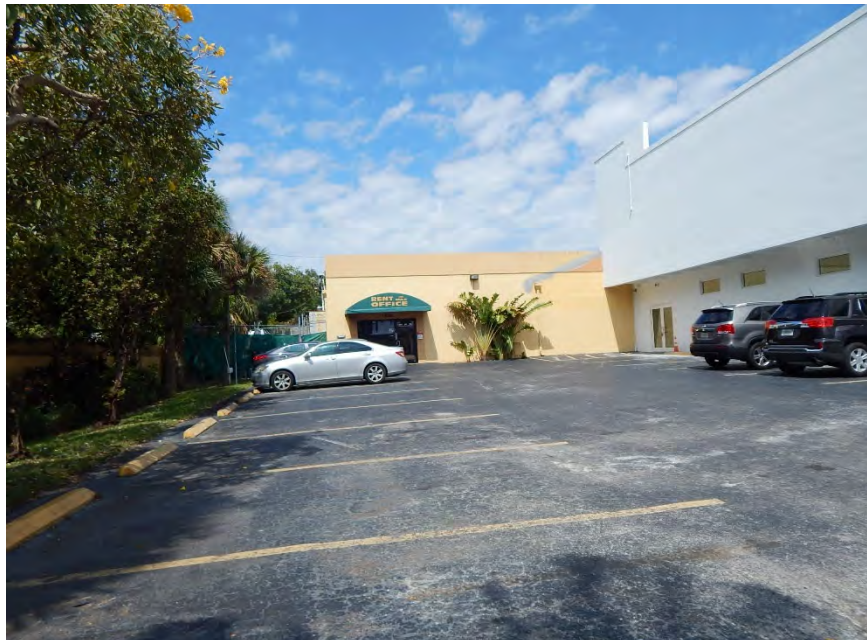
Photo 49-1

Site No. 49 - SCI FI Megaplex T. – Aerial March 2017

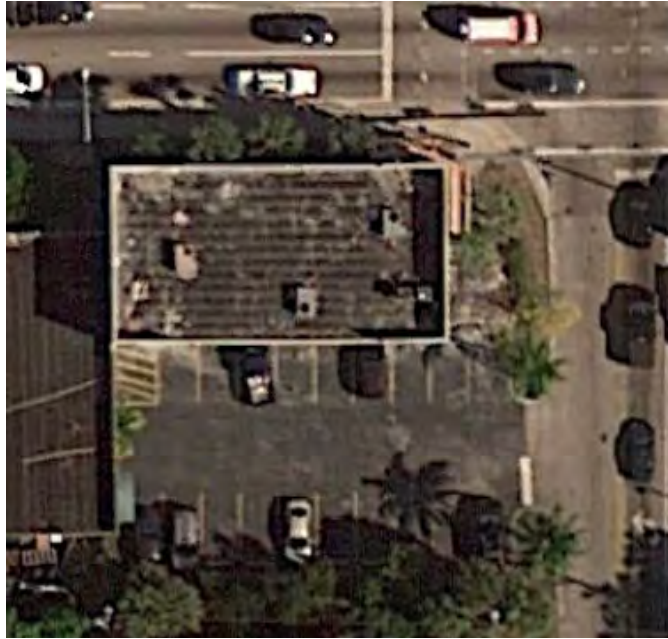
Photo 49-2

Site No. 49 - SCI FI Megaplex T. – View Towards the West

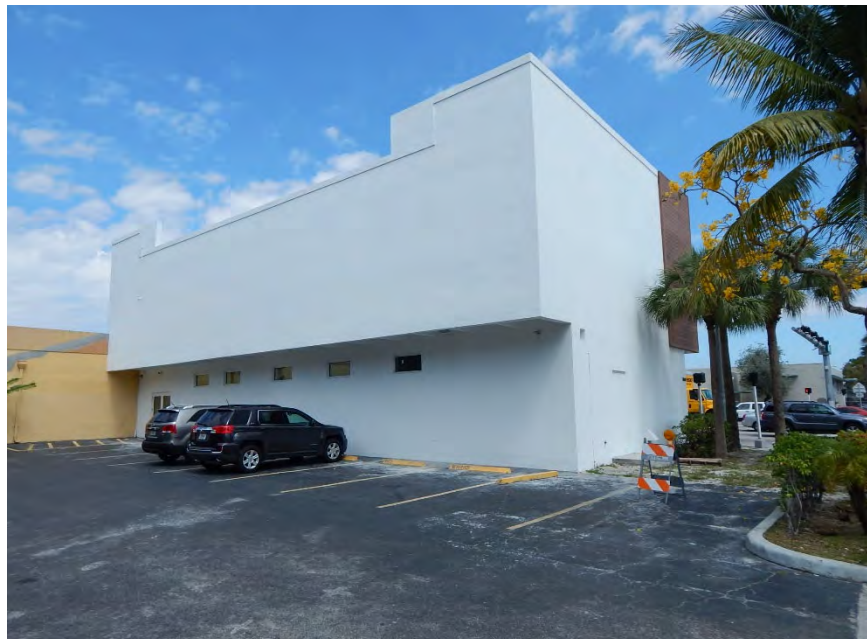
Photo 50-1

Site No. 50 - Vacant Building, (Former) Neals American Service
Aerial March 2017

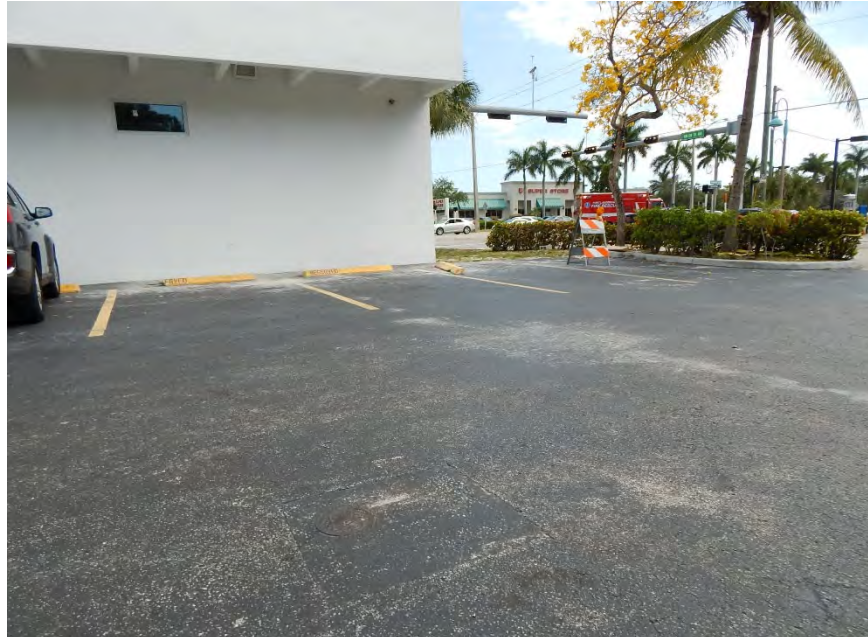
Photo 50-2

Site No. 50 - Vacant Building, (Former) Neals American Service
View Towards the Northwest

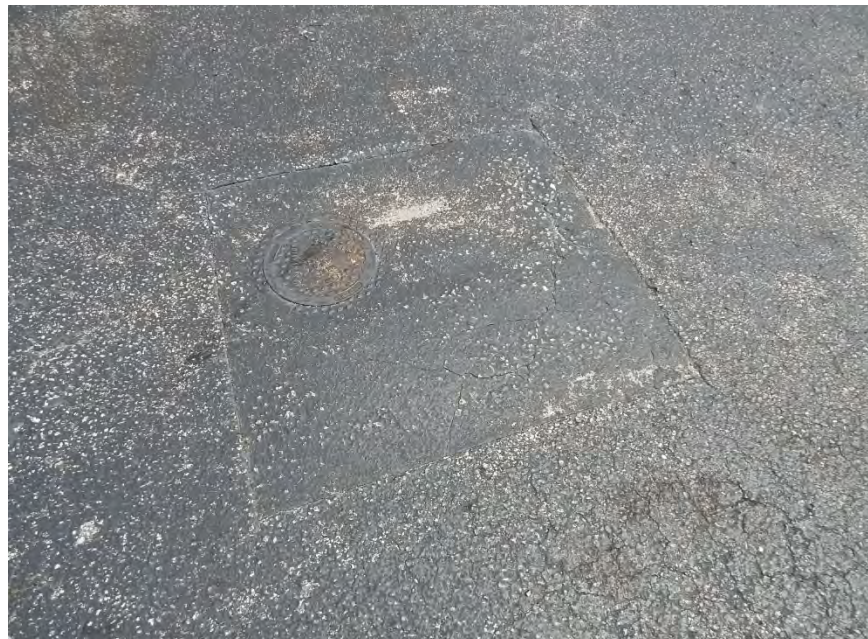
Photo 50-3

Site No. 50 - Vacant Building, (Former) Neals American Service
View Towards the Northeast

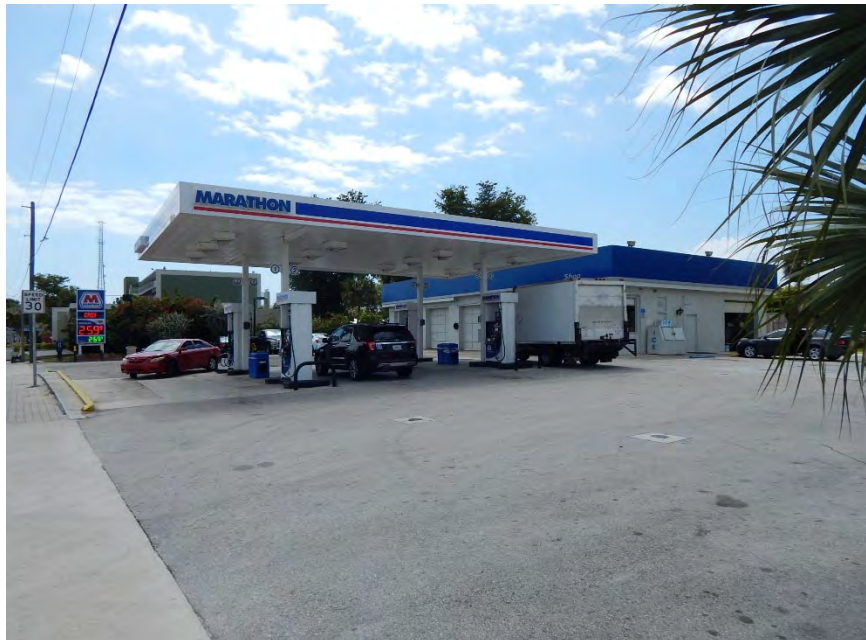
Photo 51-1

Site No. 51 - Marathon-Broward #572 – Aerial March 2017

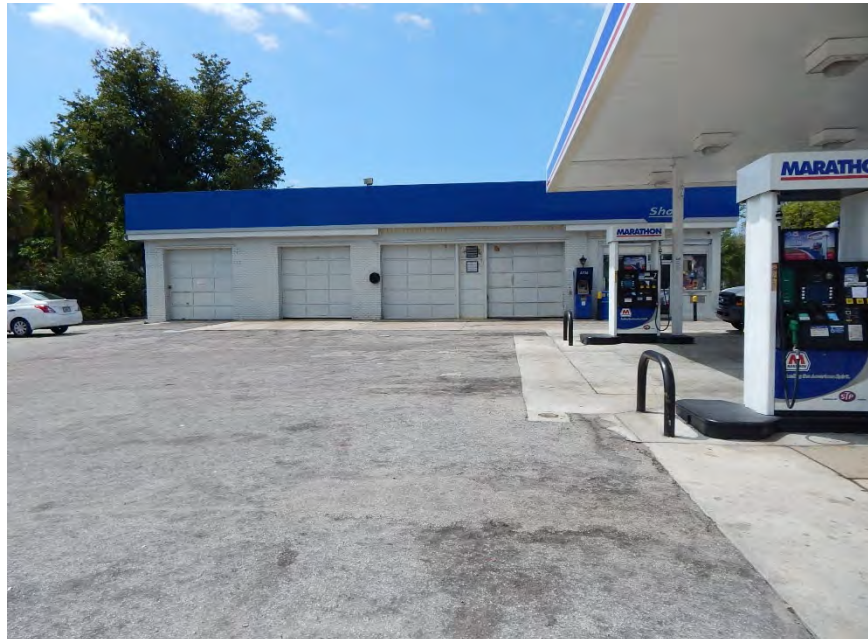
Photo 51-2

Site No. 51 - Marathon-Broward #572 – View Towards the Southeast

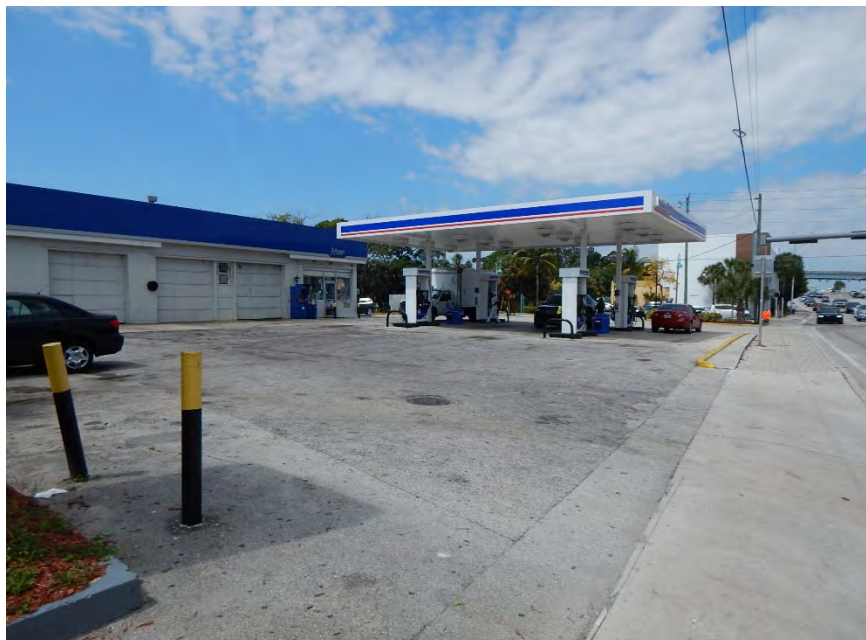
Photo 51-3

Site No. 51 - Marathon-Broward #572 – View Towards the South

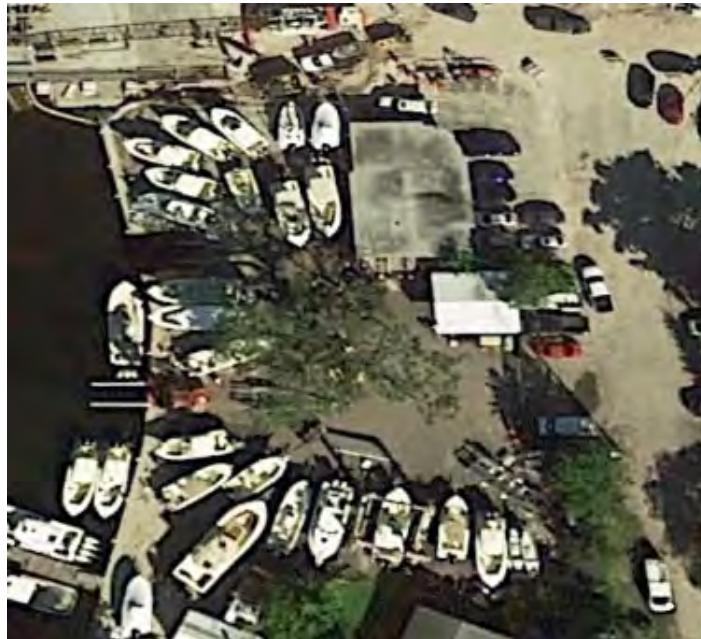
Photo 51-4

Site No. 51 - Marathon-Broward #572 – View Towards the Southwest

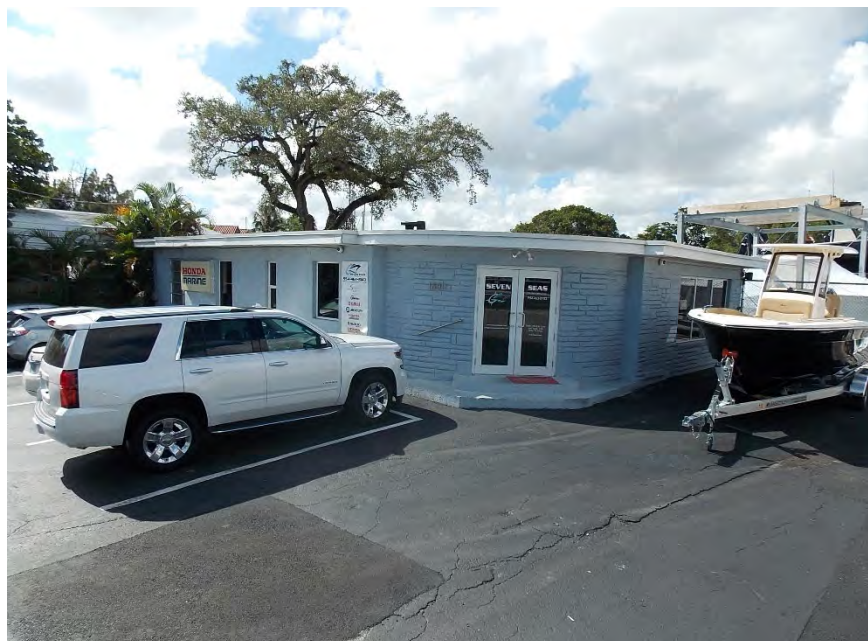
Photo 52-1

Site No. 52 – Seven Seas Yacht Sales, Inc.
Aerial December 2017

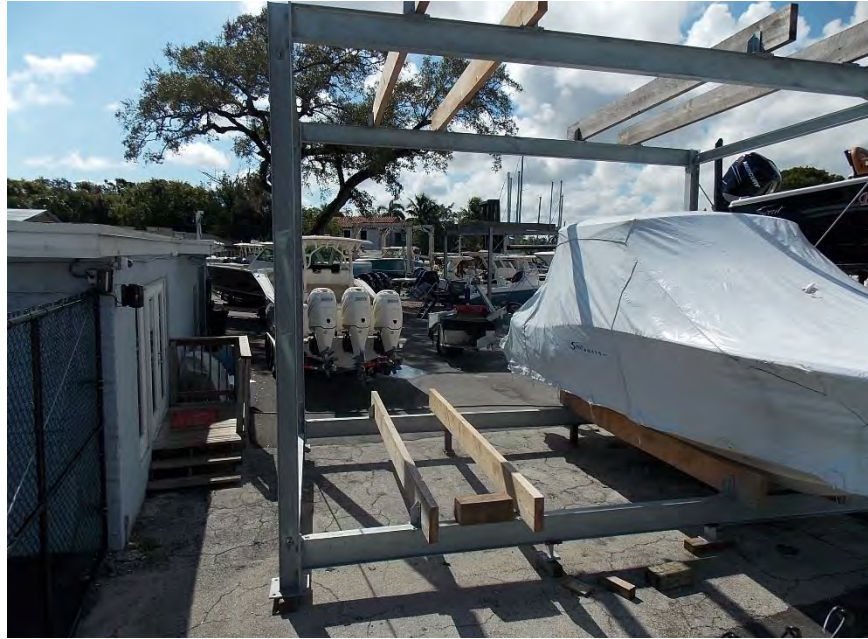
Photo 52-2

Site No. 52 – Seven Seas Yacht Sales, Inc.
View towards the Southwest

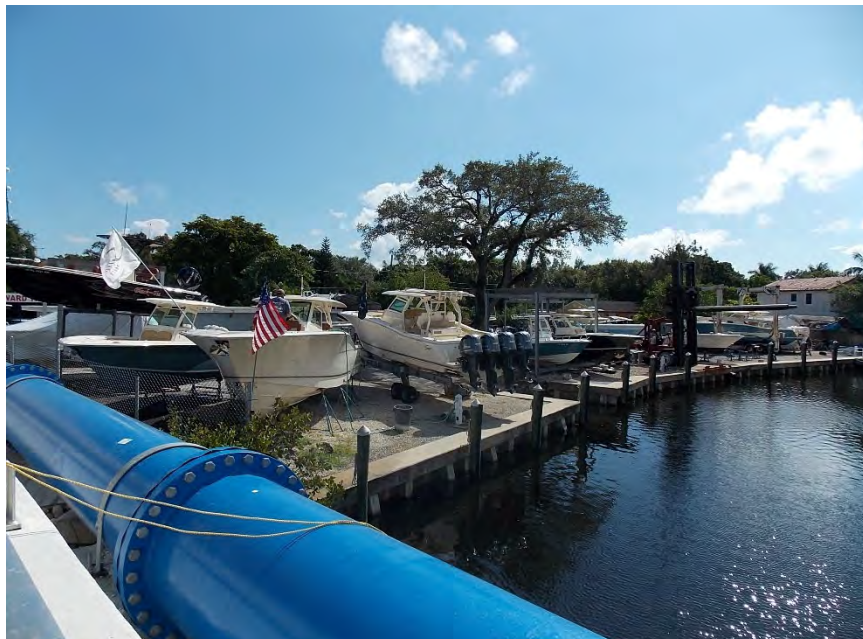
Photo 52-3

Site No. 52 – Seven Seas Yacht Sales, Inc.
View towards the South

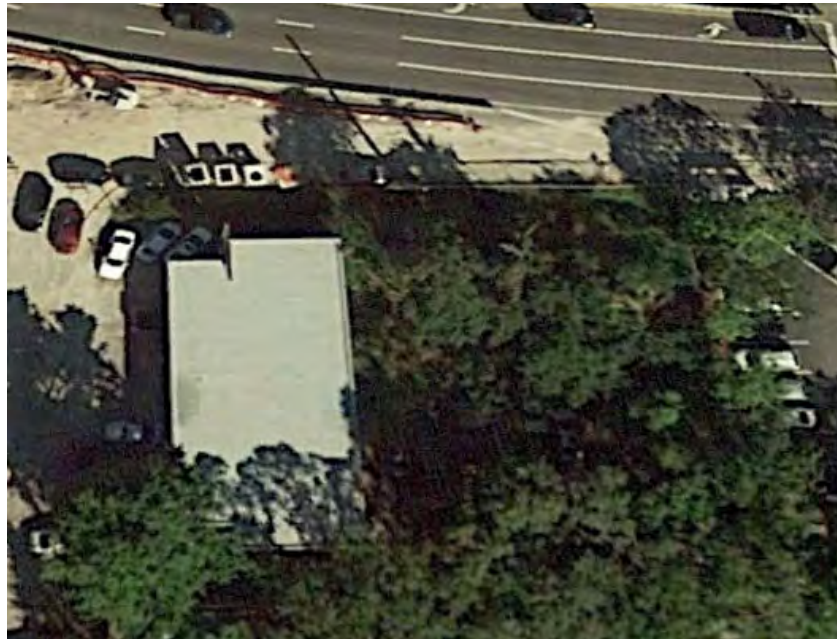
Photo 52-4

Site No. 52 – Seven Seas Yacht Sales, Inc.
View towards the Southeast

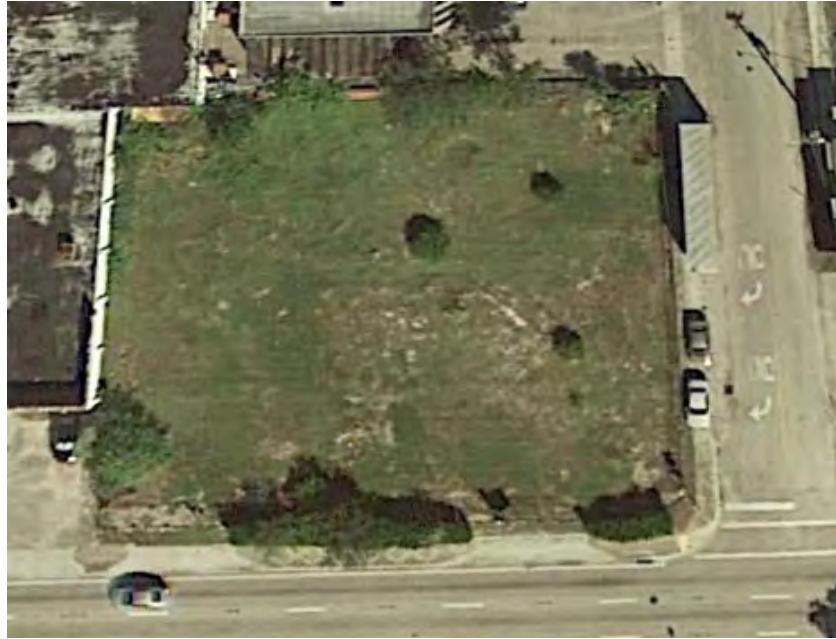
Photo 53-4

Site No. 53 – Broward Tires & Auto Repair
View towards the Southwest

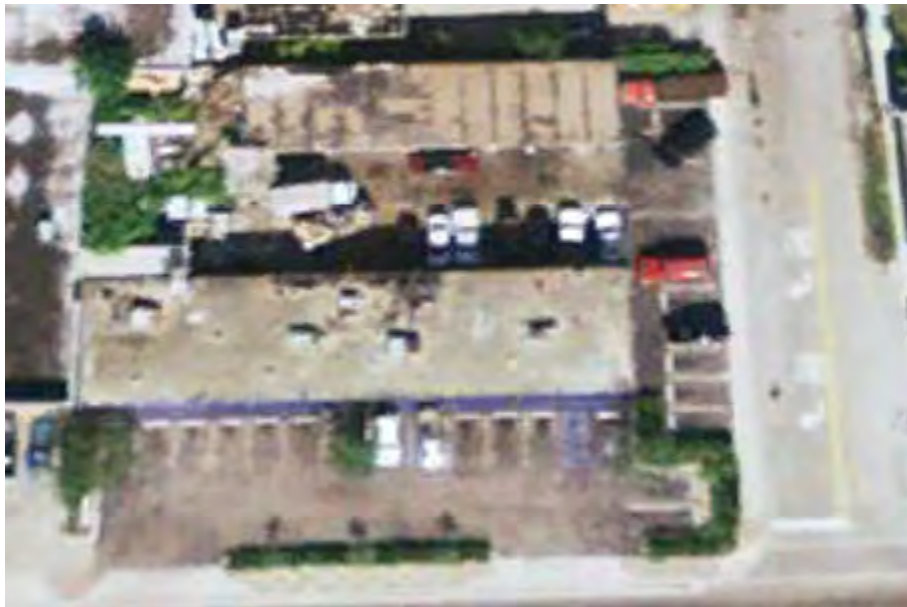
Photo 54-1

Site No. 54 – Vacant Lot, (Former) Transmission King
Aerial December 2017
