Contamination Screening Evaluation Report

**SR-9/I-95 @ SR 842/Broward Boulevard (Broward
Boulevard from West of SW 24th Avenue to East of
NW/SW 18th Avenue)
Project Development & Environment (PD&E) Study**

Efficient Transportation Decision Making (ETDM) No.: 14226

**Broward County, Florida
Financial Project ID Number: 435513-1-22-02**

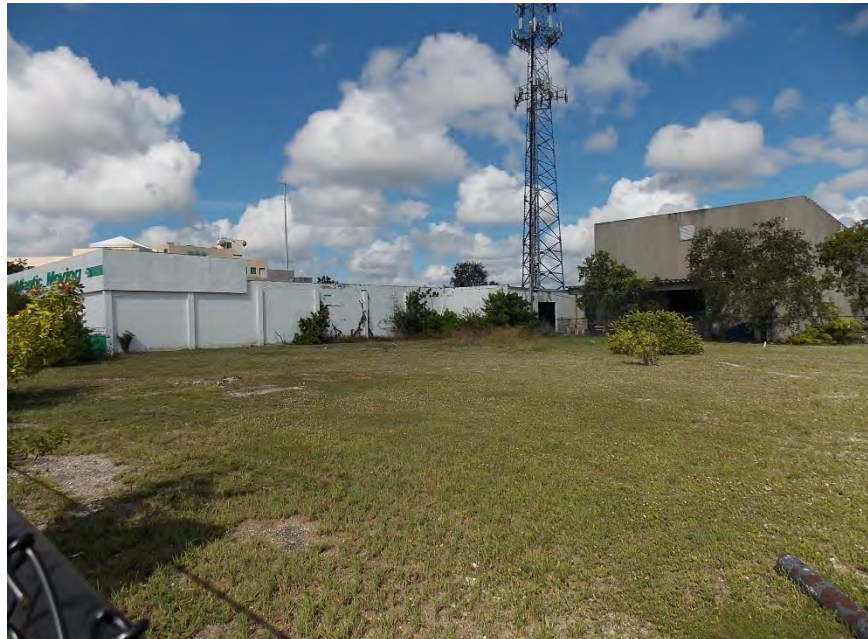
Photo 54-2

Site No. 54 – Vacant Lot, (Former) Transmission King
Aerial November 2005

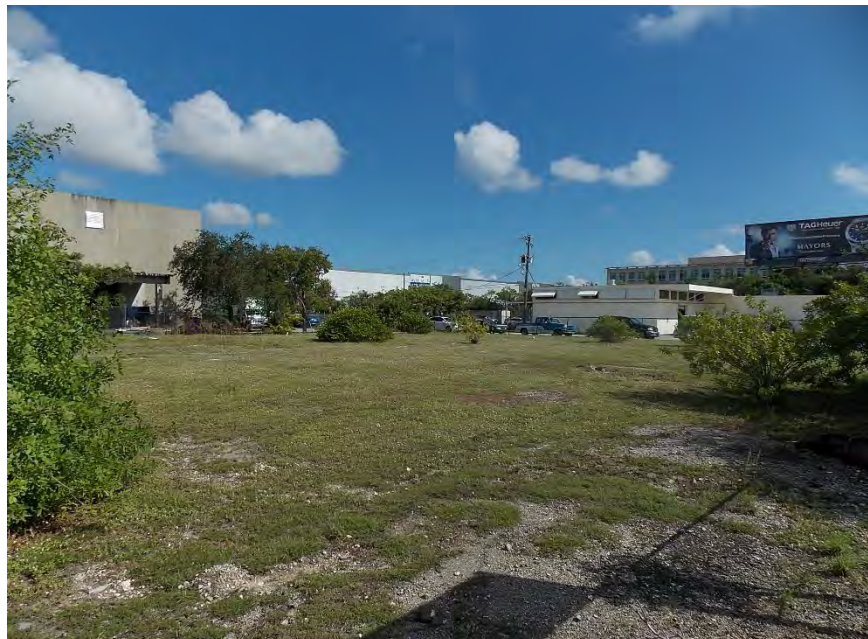
Photo 54-3

Site No. 54 – Vacant Lot, (Former) Transmission King
View towards the Northwest

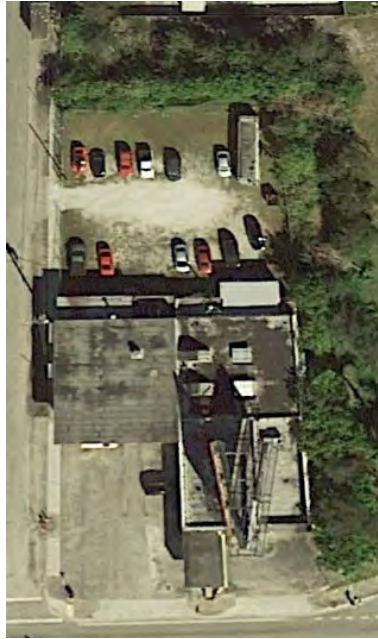
Photo 54-4

Site No. 54 – Vacant Lot, (Former) Transmission King
View towards the Northeast

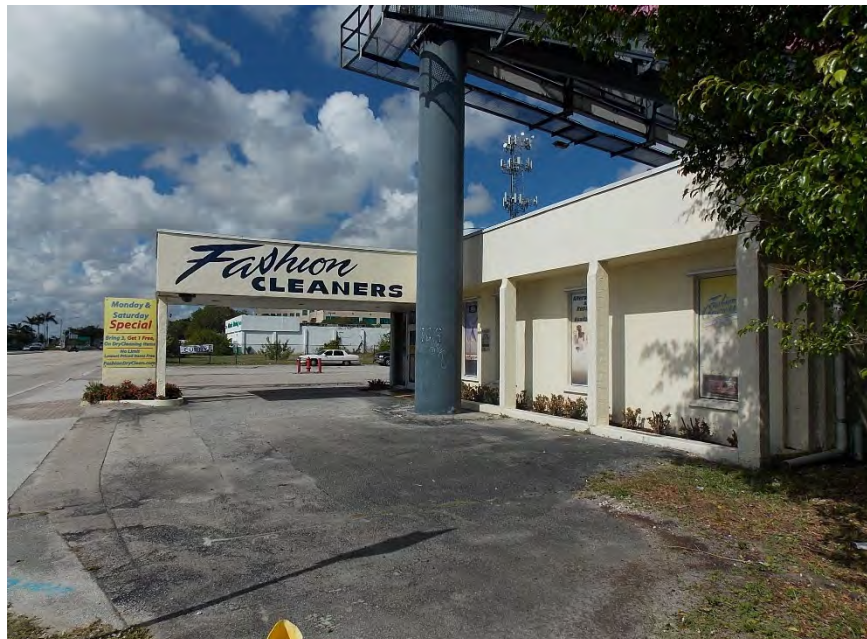
Photo 55-1

Site No. 55 – Fashion Cleaners, Inc.
Aerial December 2017

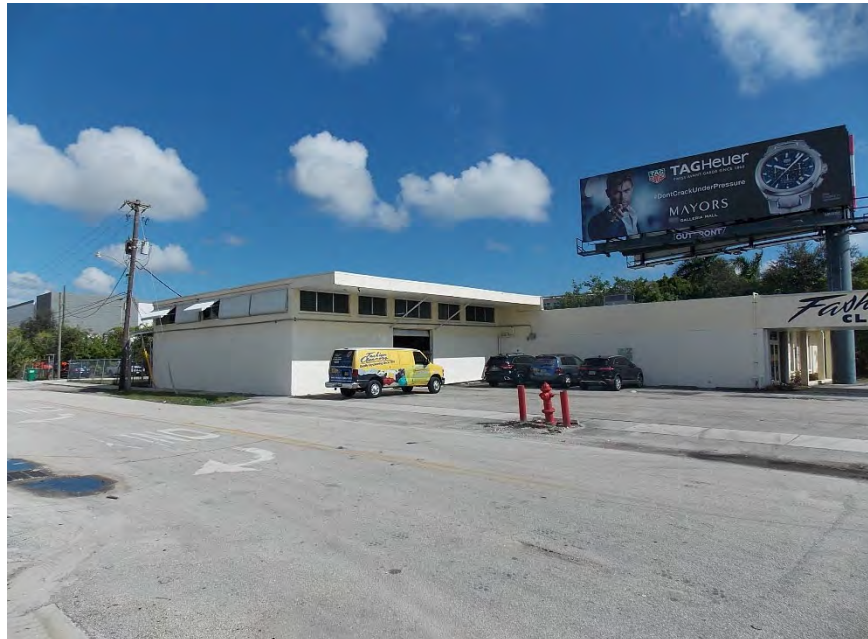
Photo 55-2

Site No. 55 – Fashion Cleaners, Inc.
View towards the West

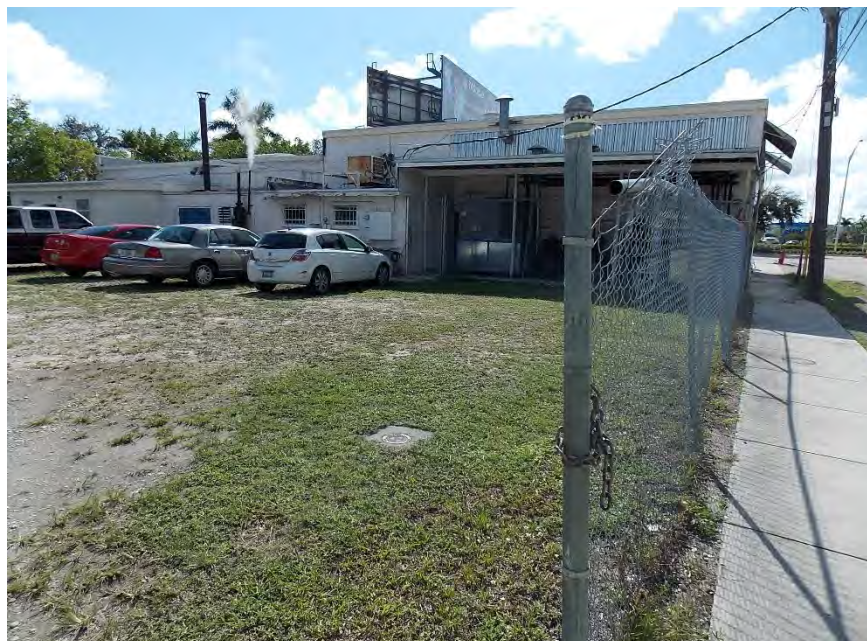
Photo 55-3

Site No. 55 – Fashion Cleaners, Inc.
View towards the Northeast

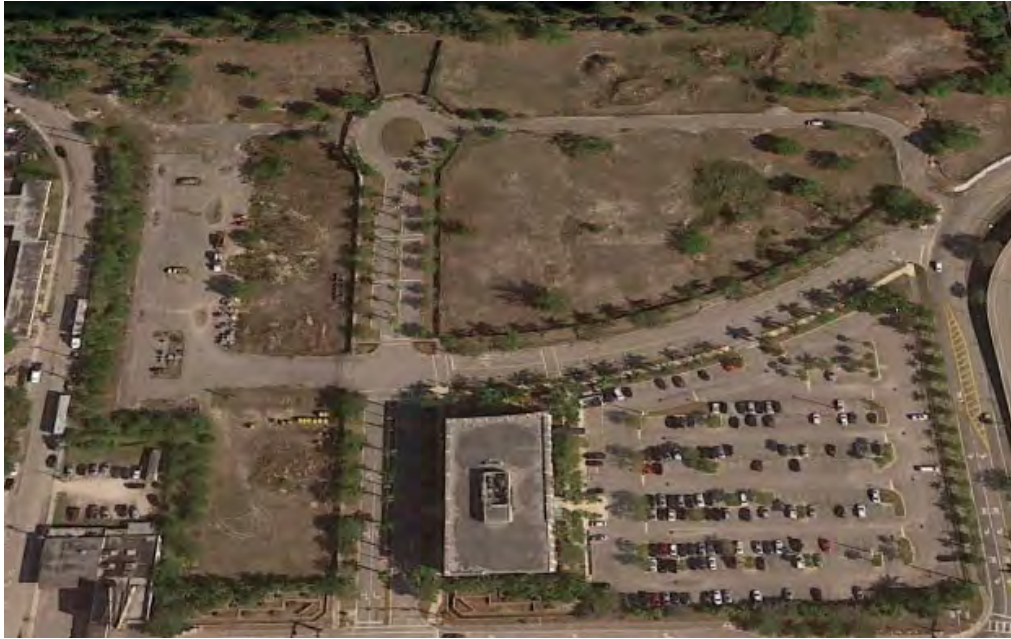
Photo 55-4

Site No. 55 – Fashion Cleaners, Inc.
View towards the South

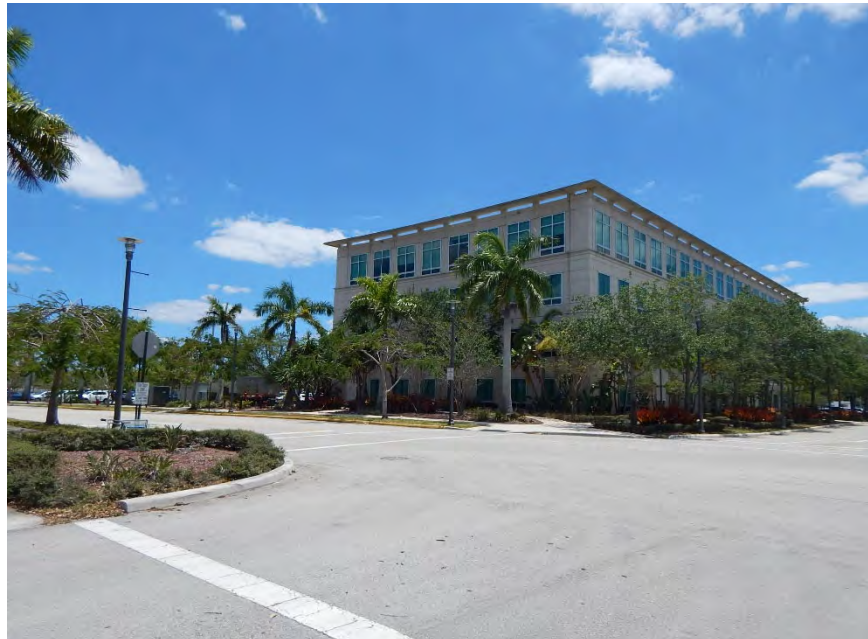
Photo 56-2

56	56-1 56-2 56-3 56-4 56-5	2	Riverbend Corporate Park (Former) Broward Boulevard Shopping Center (Former) Zayre Dept Store #691 (Former) Fashion Cleaners (Former) Frank's Spic N Span (Former) CL Coin Laundry (Former) Ted's Pure Oil Station (Former) Tony's Service & Repairs 2201-2327 W Broward Boulevard Ft. Lauderdale, FL 33312	8733224 9100153 BCEPD-13747	PCTS STCM FL UST FL LUST FL Cleanup Sites Broward Co. HM EDR Hist Auto EDR Hist Cleaners FDEP Contamination Locator Map	Office Building & Vacant Land Former Shopping Center	Adjacent	Petroleum Hazardous Waste	Eligible for ATRP Documented soil and groundwater contamination; Remediation Inactive	Medium	Conduct Level II sampling if site could impact construction. Potential dewatering concern due to documented groundwater contamination; site assessment maps are provided in Appendix B.	This site is assigned a Medium risk rating based on participation in the ATRP and documented contamination with no ongoing assessment activities. The Broward Boulevard Shopping Center was the former location of the Oasis Gas Station. This station had four USTs which were removed in 1986. An IRA conducted in 1990 removed contaminated soil and groundwater, and documented additional soil and groundwater contamination around the former tank farm. Groundwater flow direction in 1990 was southeast. The site was deemed eligible for the ATRP and there is currently funding available to conduct assessment activities. FDEP has contacted the property owner to gain site access to initiate an assessment.

Site No. 56 - Riverbend Corporate Park
Aerial January 1976

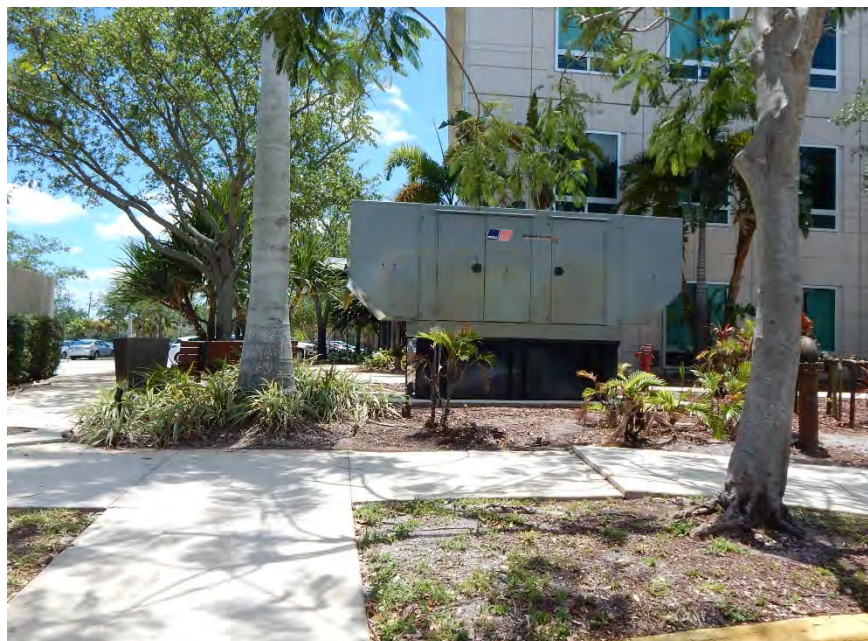
Photo 56-3

Site No. 56 - Riverbend Corporate Park
View Towards the Southeast

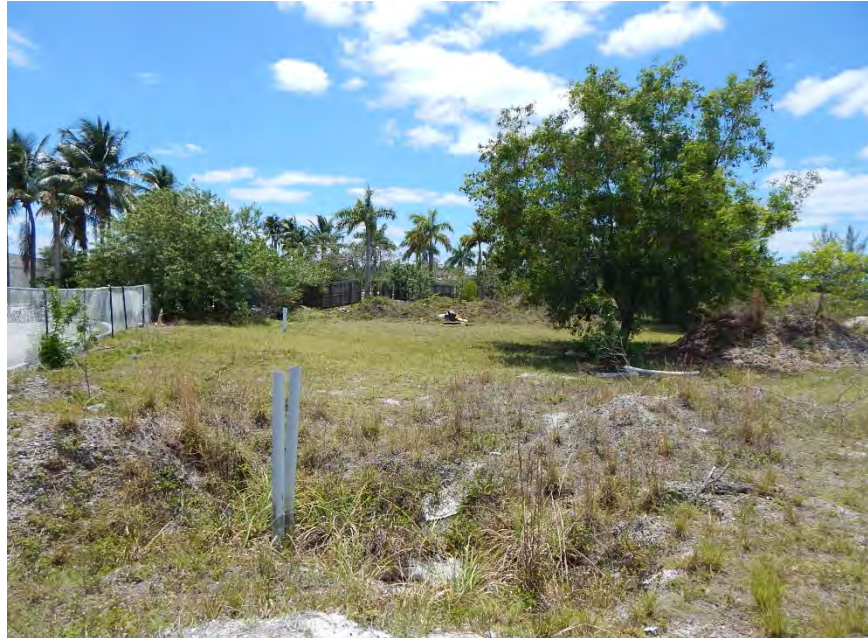
Photo 56-4

Site No. 56 - Riverbend Corporate Park
View Towards the South

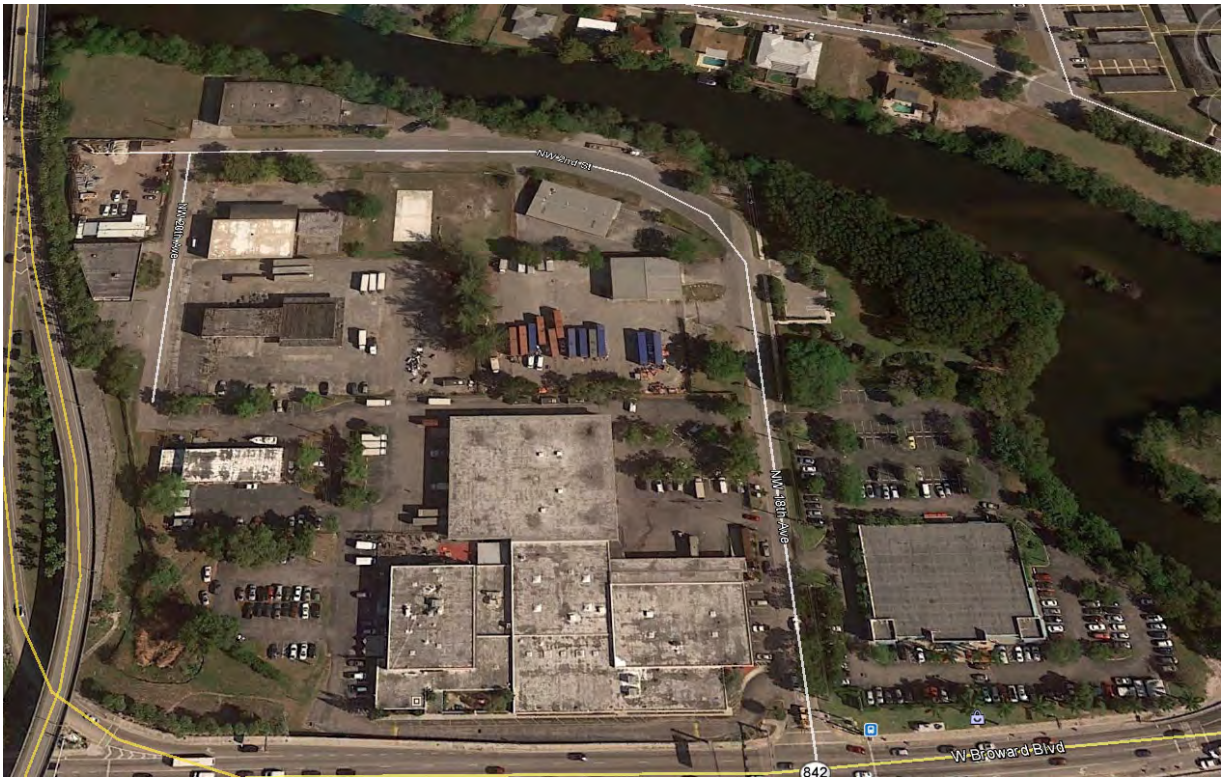
Photo 56-5

Site No. 56 - Riverbend Corporate Park
View Towards the South

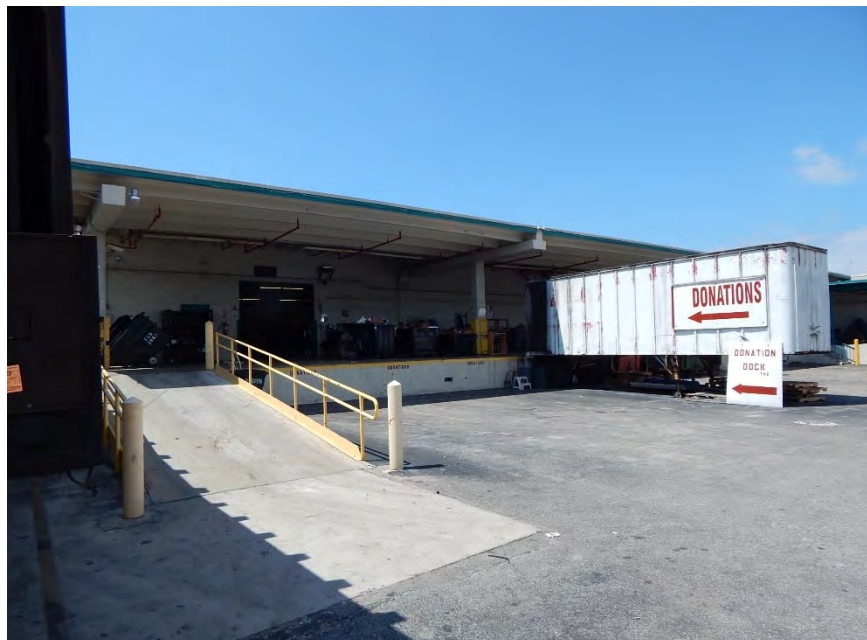
Photo 57-2

Site No. 57 - Salvation Army – Aerial March 2017

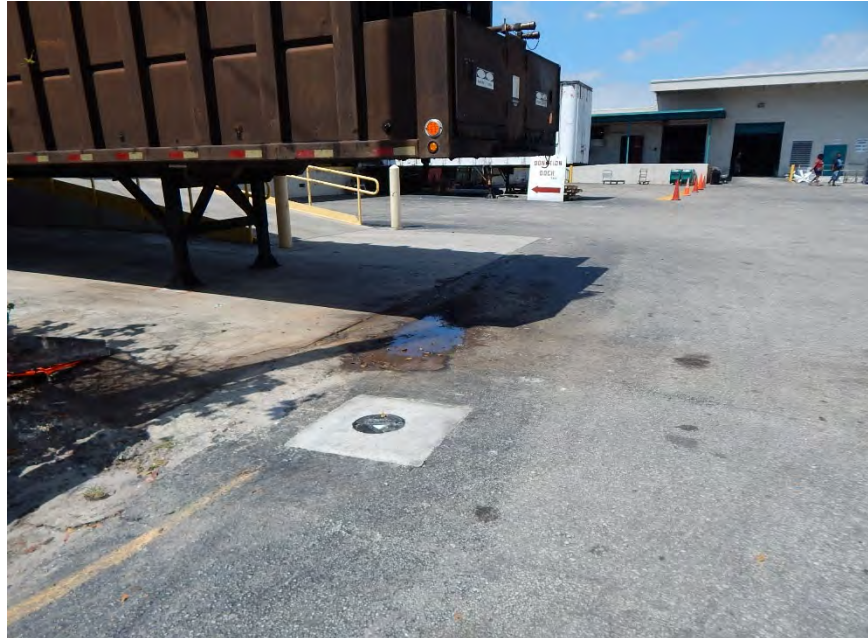
Photo 57-3

Site No. 57 - Salvation Army – View Towards the Southwest

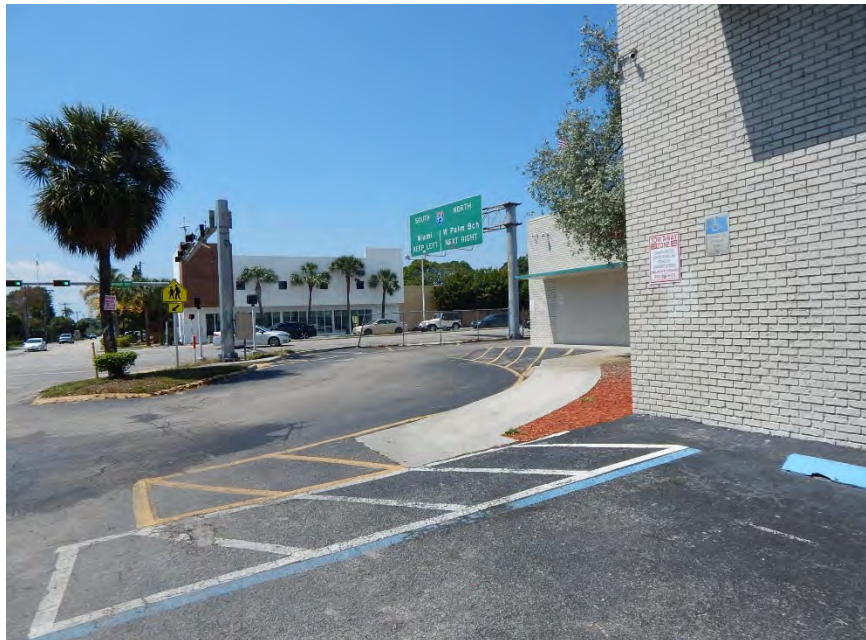
Photo 57-4

Site No. 57 - Salvation Army – View Towards the Southwest

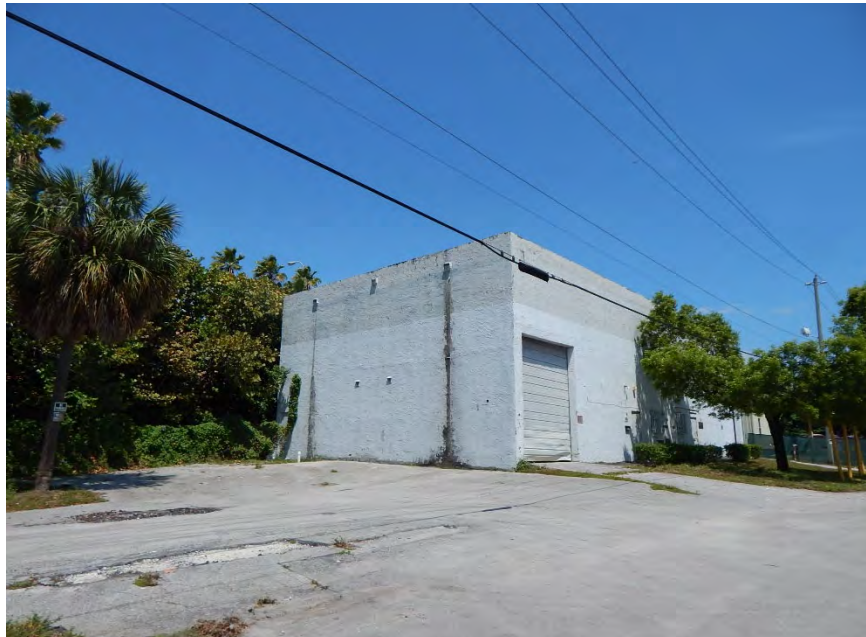
Photo 57-6

Site No. 57 - Vacant Building, (Former) Fabrications Plus
Aerial March 2017

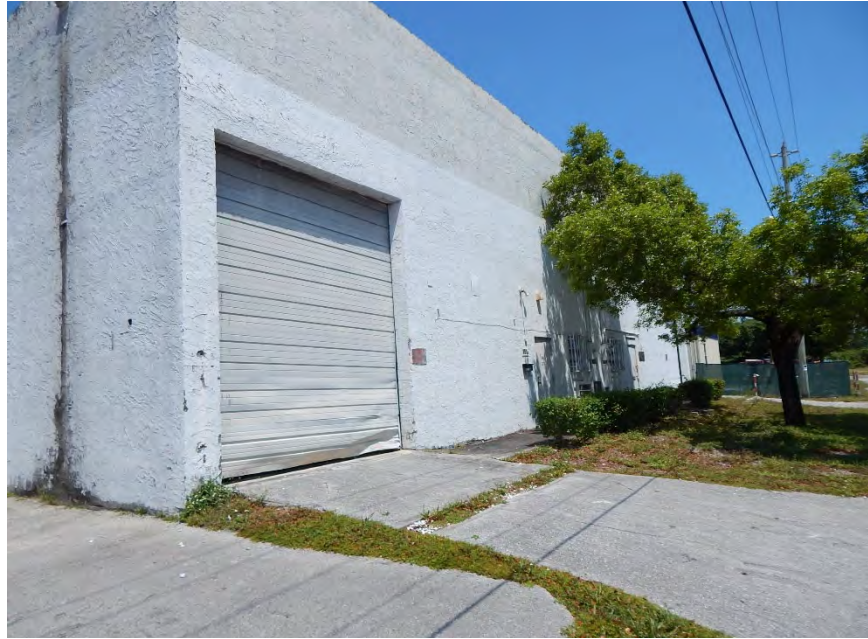
Photo 57-7

Site No. 57 - Vacant Building, (Former) Fabrications Plus
View Towards the Northwest

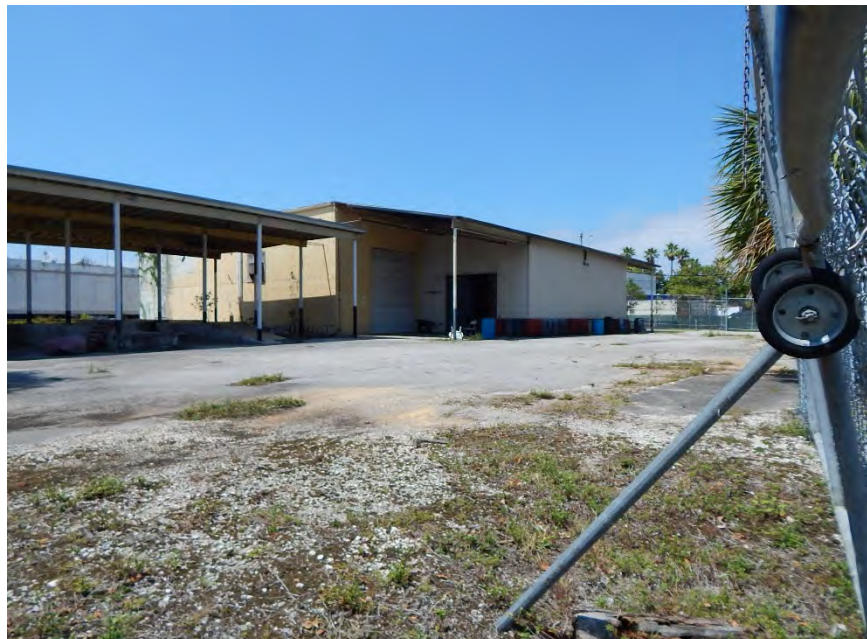
**Photo
57-10**

Site No. 57 - Vacant Building, (Former) Yellow Freight Systems Inc.
Aerial March 2017

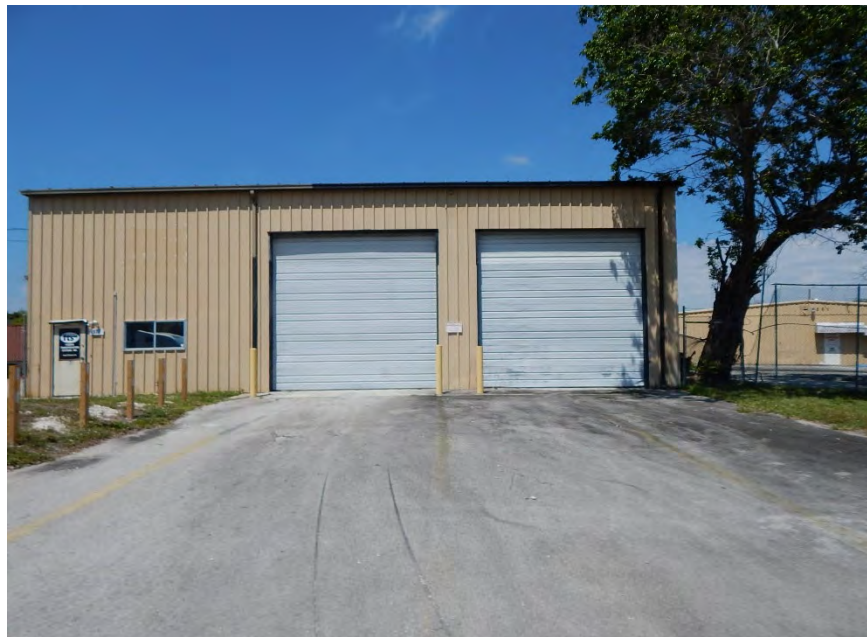
**Photo
57-14**

Site No. 57 - Corporate Connection Lines, Inc. (Land & Sea Petrol)
Aerial March 2017

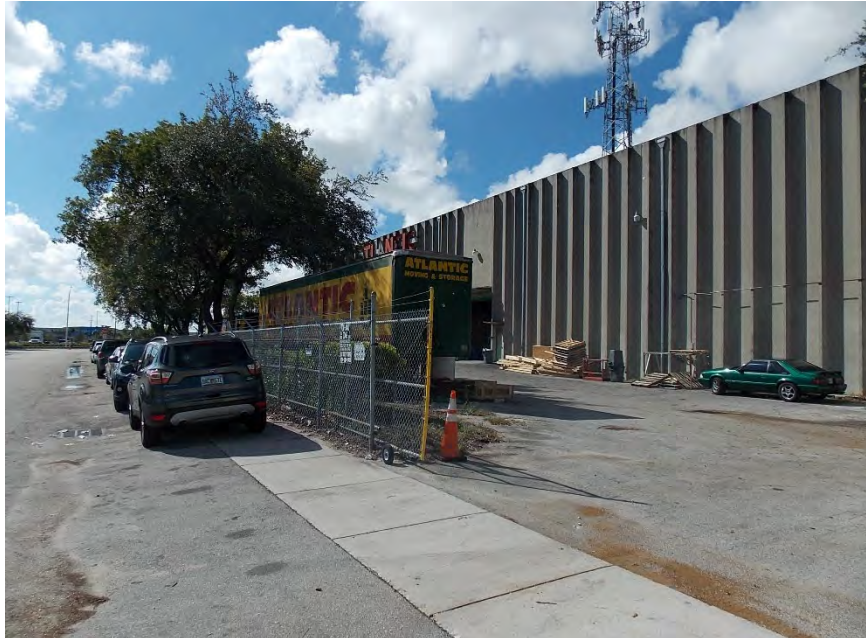
Photo 58-2

58	58-1 58-2	2	A1A Atlantic Moving & Storage 111 NW 25th Avenue Ft. Lauderdale, FL 33311	BCEPD-00341	Broward Co. HM	Moving -Relocation Company	444	Hazardous Waste	N/A No documented contamination	No	None	This site is assigned a No risk rating based on distance from the project corridor. The site is registered with BCEPD hazardous materials program. Site reconnaissance noted one 550 gallon diesel AST with secondary containment. No records were available in FDEP's Information Portal or internet search databases for review.
59	59-1 59-2	2	Broward Regional Juvenile Detention Center 222 NW 22nd Avenue Ft. Lauderdale, FL 33311	OHMIT Incident No. 54277	FL SPILLS	Juvenile Detention Center	113	Drilling Mud	N/A No documented contamination	Low	None	This site is assigned a Low risk rating based on a reported spill of 1,000 gallons of drilling mud in December 2015. The incident was investigated by the Fish and Wildlife Conservation Commission. No records were available in FDEP Information Portal or internet search databases for review.

Site No. 58 – A1A Atlantic Moving & Storage
View towards the Northwest

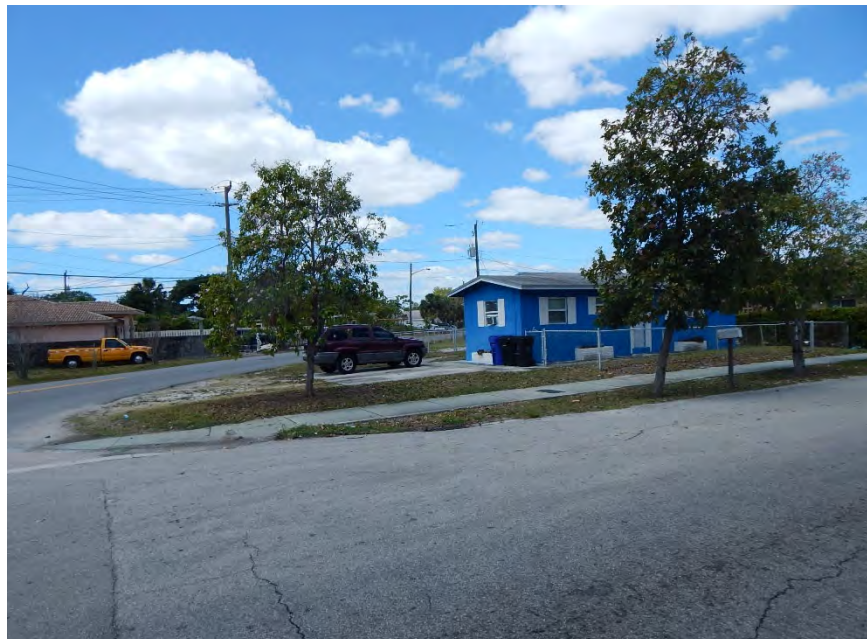
Photo 64-1

64	64-1 64-2	3	Residence (Former) Eluetts Service Station (Former) Taylor Bros Service Station 631 NW 22nd Road Ft. Lauderdale, FL 33311	None	EDR Hist Auto	Residential Former Gas Station	471	Petroleum Hazardous Waste	N/A No documented contamination	No	None	This site is assigned a No risk rating based on distance from the project corridor. Records indicate the site was a historical auto station from 1957-1962. The site could not be located in FDEPs Information Portal, therefore, no documents were available for review.

Site No. 64 – Residence, (Former) Eluetts Service Station
Aerial March 2017

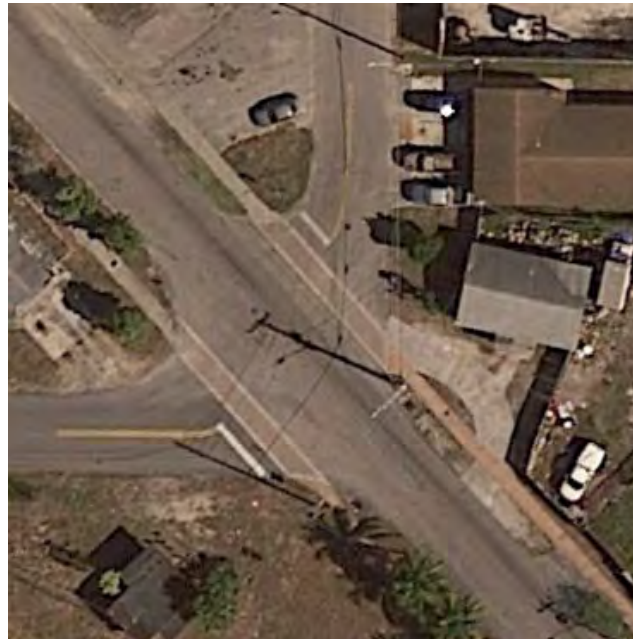
Photo 64-2

Site No. 64 – Residence, (Former) Eluetts Service Station
View Towards the West

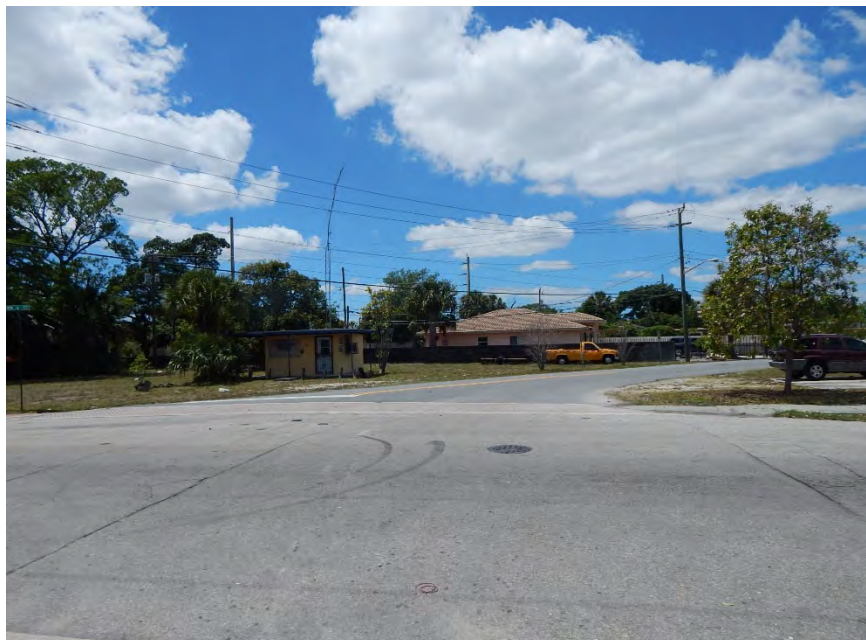
Photo 65-1

Site No. 65 - Spill – Aerial March 2017

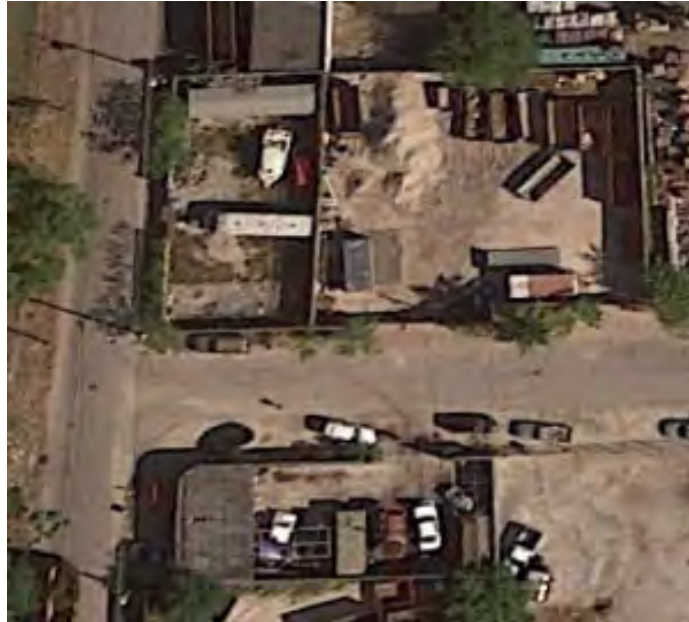
Photo 66-1

66	66-1 66-2	3	Salvage Auto Repair, Inc. / Salvage Auto Center 640 NW 21st Terrace 2115 NW 6th Place Ft. Lauderdale, FL 33311	SQG_5551 BCEPD-6641	Broward Co. HM EDR Hist Auto	Auto Service Shop	283	Hazardous Waste Petroleum	N/A No documented contamination	Low	None	This site is assigned a Low risk rating based on distance from the project corridor. The site has a record in FDEP's Information Portal and a SQG identification number, but no documents are available for review. Field reconnaissance personnel noted this site is an active automotive car repair facility. Numerous car parts were scattered on the property and apparent petroleum staining was noted on the asphalt.
67	67-1 67-2	3	Ferrous Processing and Trading Co., FPT Fort Lauderdale LLC, dba Sunrise Recycling 700 NW 21st Terrace Ft. Lauderdale, FL 33311	4985057 BCEPD-107	FL Tier 2 Broward Co. HM	Metal Recycling Collection & Staging	187	Hazardous Waste Petroleum	N/A No documented contamination	High	Conduct Level II sampling in braided ramp construction area.	This site is assigned a High risk rating based on site operations and field observations. This site operates as a metal recycling/salvage yard. Poor housekeeping practices, typical of salvage yards, were observed from the public right-of-way. Field reconnaissance personnel noted heavy machinery operating onsite and numerous piles of salvaged material scattered throughout the property. No documents were available for review in FDEP's Information Portal.

Site No. 66 - Salvage Auto Repair, Inc. – Aerial March 2017

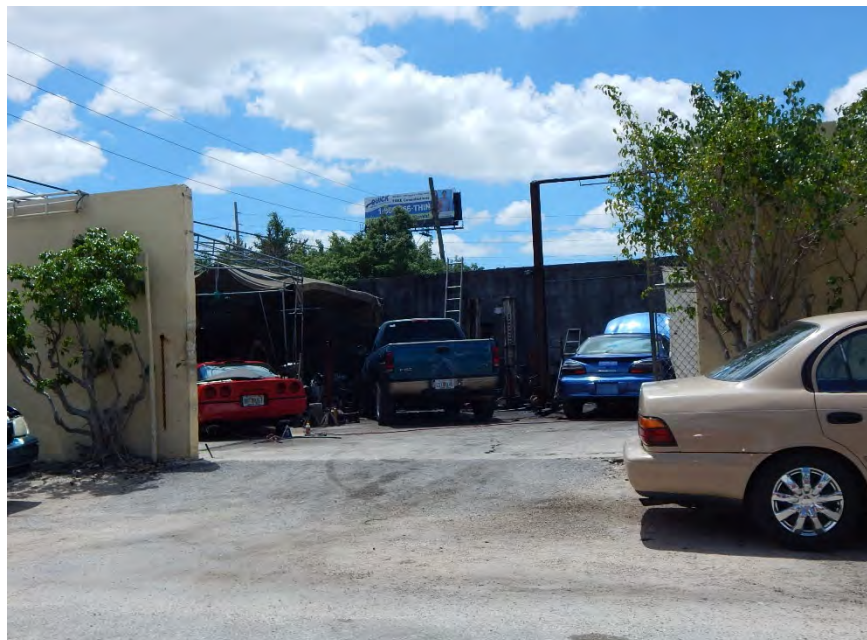
Photo 66-2

Site No. 66 - Salvage Auto Repair, Inc. – View Towards the South

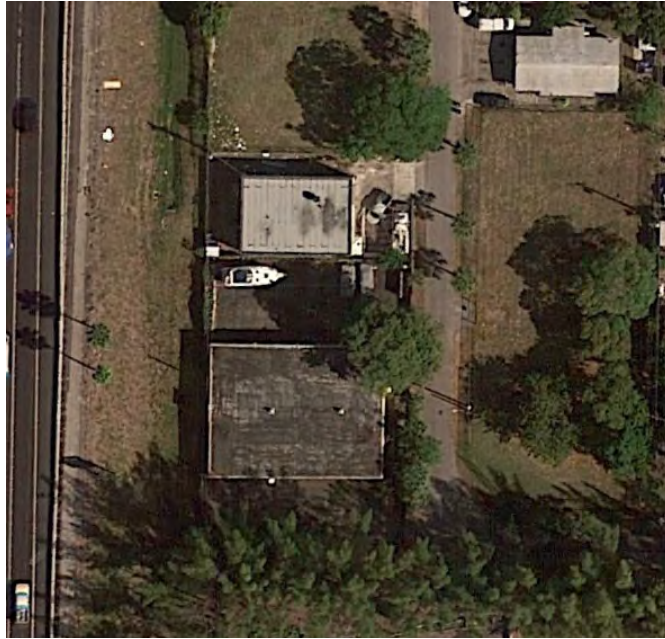
Photo 68-1

68	68-1 68-2	3	Auto Service/Storage Facility 701 NW 20th Avenue Ft. Lauderdale, FL 33311	None	Site Recon	Auto Service Shop or Storage Facility	68	Hazardous Waste Petroleum	N/A No documented contamination	Low	None	This site is assigned a Low risk rating based on field observations and no records of releases or contamination. Field reconnaissance personnel noted this site was an active car repair facility with approximately 8 garage/bay doors on each side of the building. Field personnel were unable to visually inspect behind the fence of the facility. No records were available in FDEP Information Portal or internet search databases for review.
69	68-1 69-1 69-2	3	Sign-D-Sign 715 NW 20th Avenue Ft. Lauderdale, FL 33311	None	Site Recon	Sign Fabrication Shop Former Auto Service Shop	66	Hazardous Waste	N/A No documented contamination	Low	None	This site is assigned a Low risk rating based on field observations and no records of releases or contamination. Field reconnaissance personnel identified this site as a sign fabrication facility. No environmental concerns were noted. No records were available in FDEP Information Portal or internet search databases for review.

Site Nos. 68 & 69 - Auto Service/Storage Facility and Sign-D-Sign
Aerial March 2017

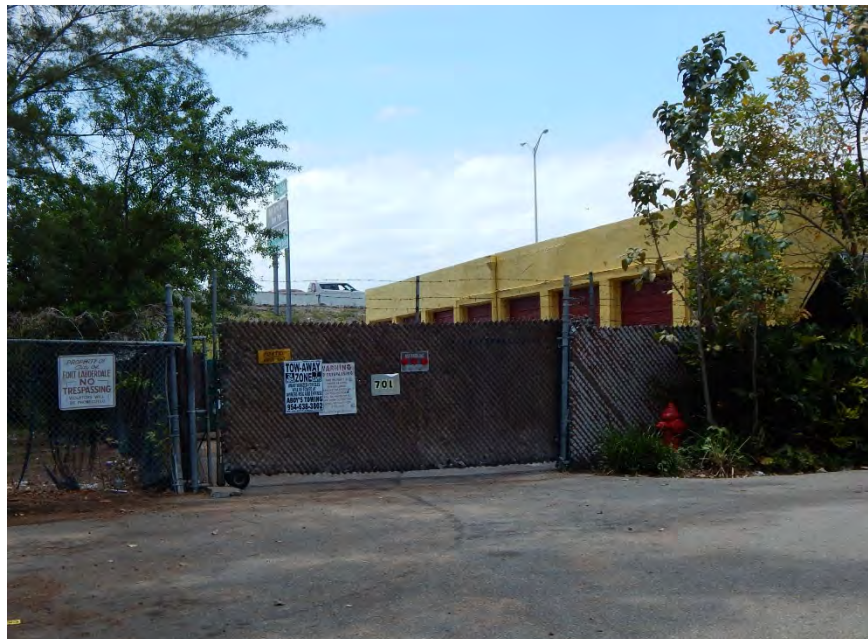
Photo 68-2

Site No. 68 - Auto Service/Storage Facility – View Towards the Northwest

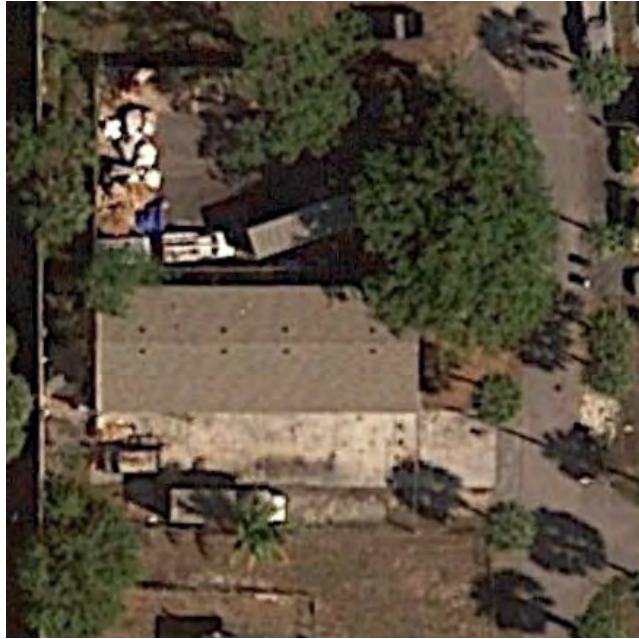
Photo 70-1

70	70-1 70-2	3	Rodney's Relocation Services Inc. (Former) Salt & Pepper Body Shop 2001 NW 7th Place Ft. Lauderdale, FL 33311	None	EDR Hist Auto	Moving -Relocation Company Former Auto Service Shop	59	Hazardous Waste Petroleum	N/A No documented contamination	Low	None	This site is assigned a Low risk rating based on operations as an auto service shop from 1999-2002 with no records of releases or contamination. Little documentation is available for review and no records were available in FDEP Information Portal or internet search databases. Field reconnaissance personnel noted this facility is currently a moving/relocation company. The building onsite has five garage bay doors.
71	71-1 71-2 71-3 71-4	3	Vacant Land (Former) Diamond Towing 2201 NW 8th Street Ft. Lauderdale, FL 33311	9046003	PCTS STCM FL UST FL LUST	Vacant Land / Residential Former Auto Service Station	286	Petroleum	Not eligible for EDI program N/A No documented contamination	No	None	This site is assigned a No risk rating based on distance from the project corridor. A Tank Registration Form, dated March 1990, indicated the facility was formerly Diamond Towing and had an unknown number of tanks removed prior to 1980. The cover letter for the Tank Registration indicated the facility had a Phase II audit indicating the property was clean; however, this document was not in FDEP's file and could not be reviewed and/or verified. An EDI Eligibility Review Checklist indicates the site was deemed ineligible for the program because of the lack of documented contamination.

Site No. 70 - Rodney's Relocation Services Inc. – Aerial March 2017

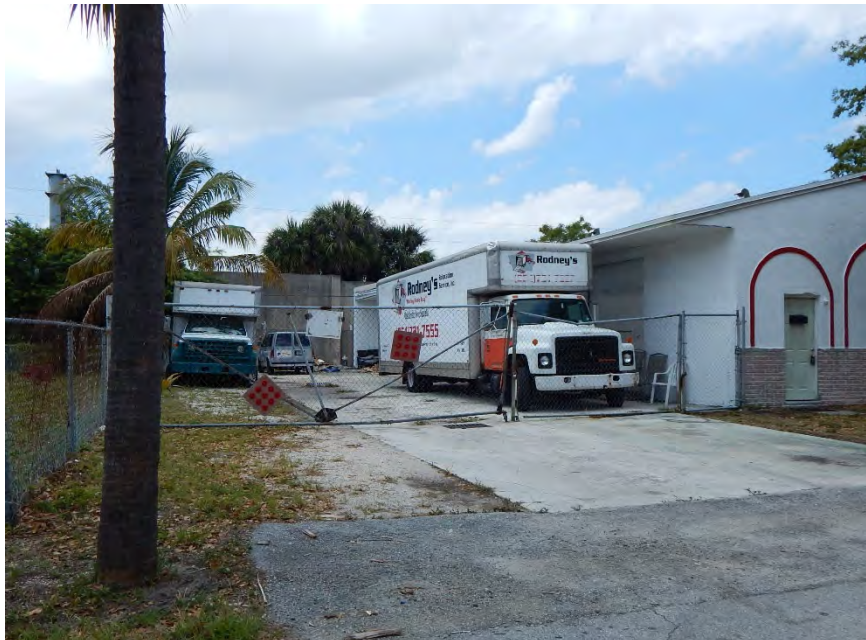
Photo 70-2

Site No. 70 - Rodney's Relocation Services Inc.- View Towards the West

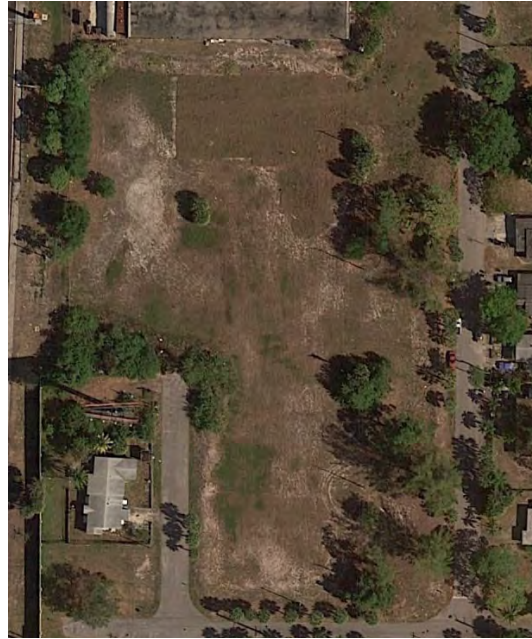
Photo 73-1

73	73-1 73-2 73-3 73-4	3	Vacant Lot 820 NW 20th Terrace Ft. Lauderdale, FL 33311	None	Site Recon	Vacant Lot	47	Unknown	N/A No documented contamination	Medium	Conduct Level II sampling if site could impact construction.	This site is assigned a Medium risk rating based on field observations noting a groundwater monitoring well onsite. This site could not be located in FDEP's Information Portal and no documents were available for review. Field reconnaissance personnel observed a monitoring well located on the southwest corner of this property indicating contamination may be present onsite. A soil berm was also present around the property.
74	74-1 74-2 74-3 74-4	3	Battery Express Well Made Cabinets T-Shirt Screen Printing (Former) CJ Paint & Body Shop 1920-1922 NW 9th Street Ft. Lauderdale, FL 33311	None	EDR Hist Auto	Multi-tenant Light Industrial Warehouse / Auto Service Shop	47	Hazardous Waste Petroleum	N/A No documented contamination	Low	None	This site is assigned a Low risk rating based on historical operations as an auto service shop from 1999-2010. No records were available in FDEP Information Portal or internet search databases for review.

Site No. 73 - Vacant Lot – Aerial March 2017

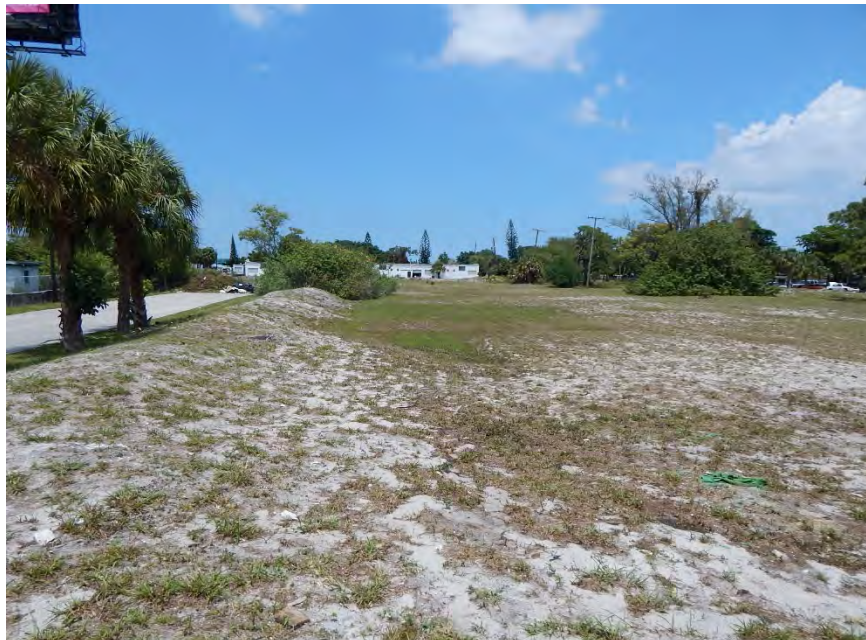
Photo 73-2

Site No. 73 - Vacant Lot – View Towards the North

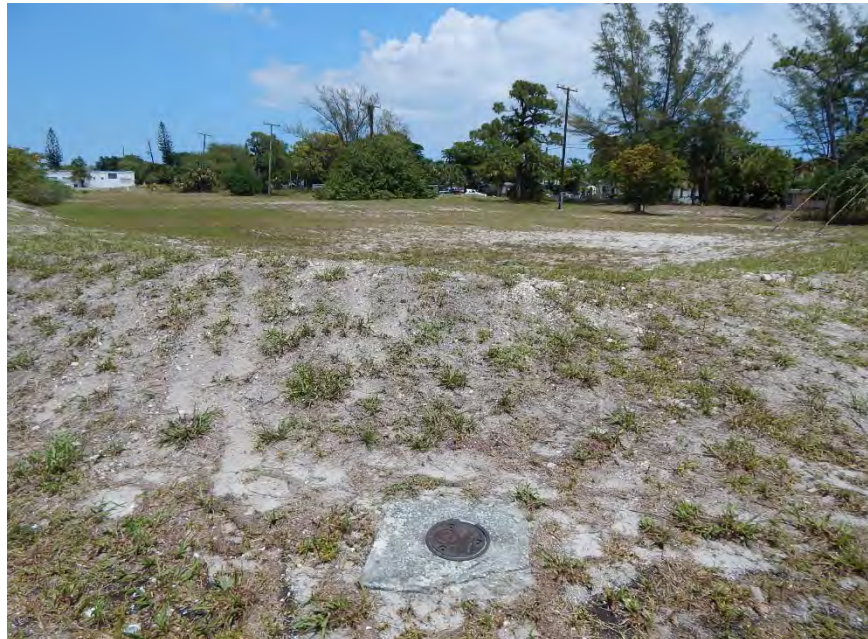
Photo 73-3

Site No. 73 - Vacant Lot – View Towards the Northeast

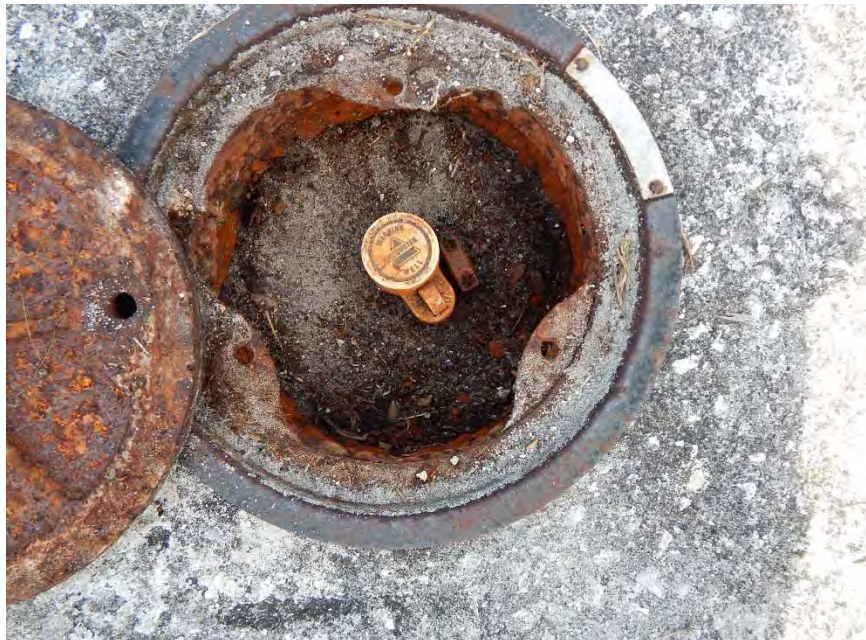
Photo 73-4

Site No. 73 - Vacant Lot – View of Piezometer / Monitoring Well

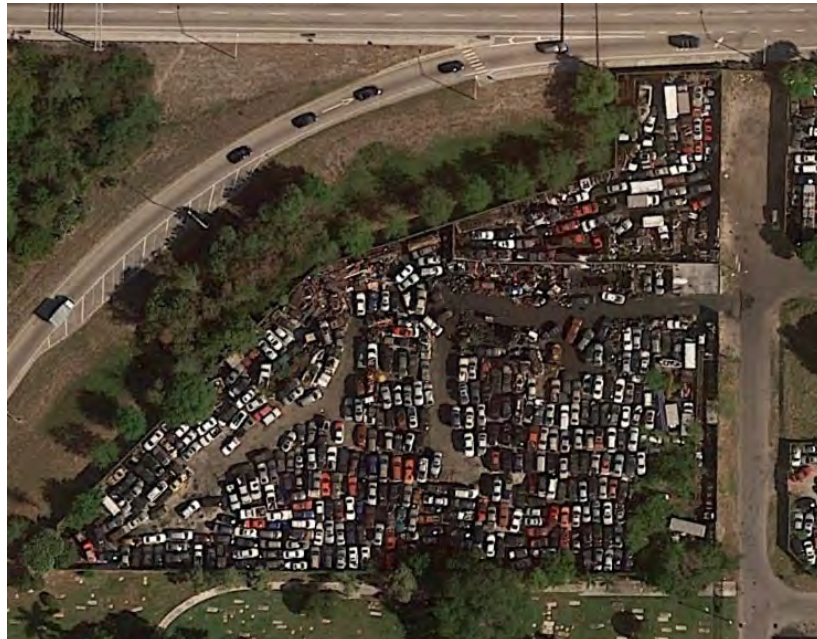
Photo 75-1

75	75-1 75-2	3	Sunrise Used Auto Parts 977 NW 19th Avenue Ft. Lauderdale, FL 33311	BCEPD-1135 ERNS 590684 OHMIT Incident No. 16092	ERNS FL SPILLS Broward Co. HM	Junk Yard/ Auto Salvage Yard Former Spill Site	157	Petroleum	N/A No documented contamination	High	Conduct Level II sampling if site could impact construction.	This site is assigned a High risk rating based on field observations and records indicating poor housekeeping operations onsite. This site operates as an automotive and truck parts recycling/salvage yard. Poor housekeeping practices, typical of older salvage yards, were observed from the public right-of-way. A report filed with ERNS in August 1998, referenced the following: "oily mess all over lot coming from tanks and cars." The site has no records of assessment and/or remedial actions. Field reconnaissance personnel noted this facility has numerous auto parts scattered throughout the property. Several drums and apparent petroleum staining were also noted at the facility.

Site No. 75 - Sunrise Used Auto Parts – Aerial March 2017

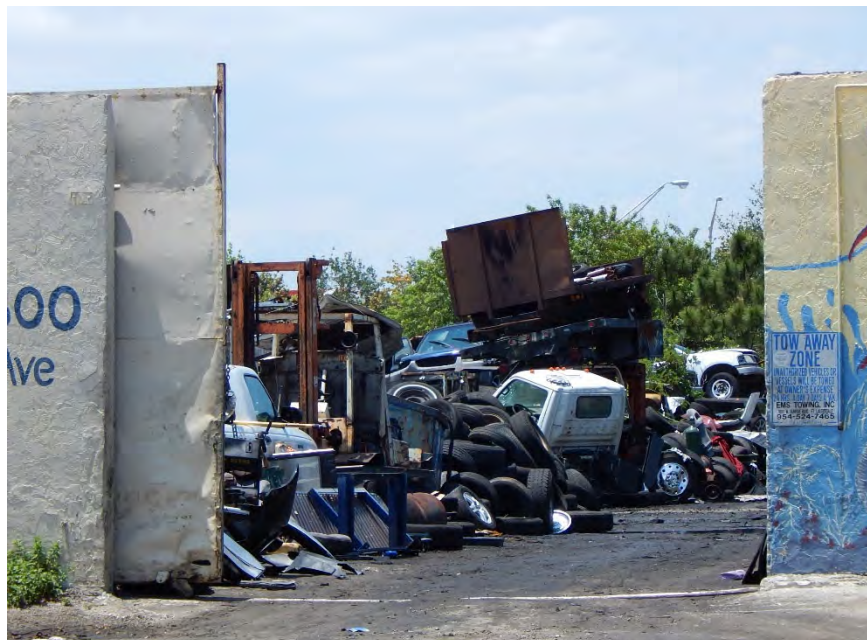
Photo 75-2

Site No. 75 - Sunrise Used Auto Parts – View Towards the West
